# HERITAGE DESIGN AND ACCESS STATEMENT FOR PROPOSED REPAIR WORKS TO THE MANOR, POSTLING

30th April 2019

### Document Reference – SC19-022

This heritage, design and access statement has been prepared in support of an application for listed building consent to underpin using traditional methods a Bay window and repair associated cracking. It is Grade II listed and lies within the Postling Conservation Area and Kent Down Area of Outstanding Natural Beauty (AONB).

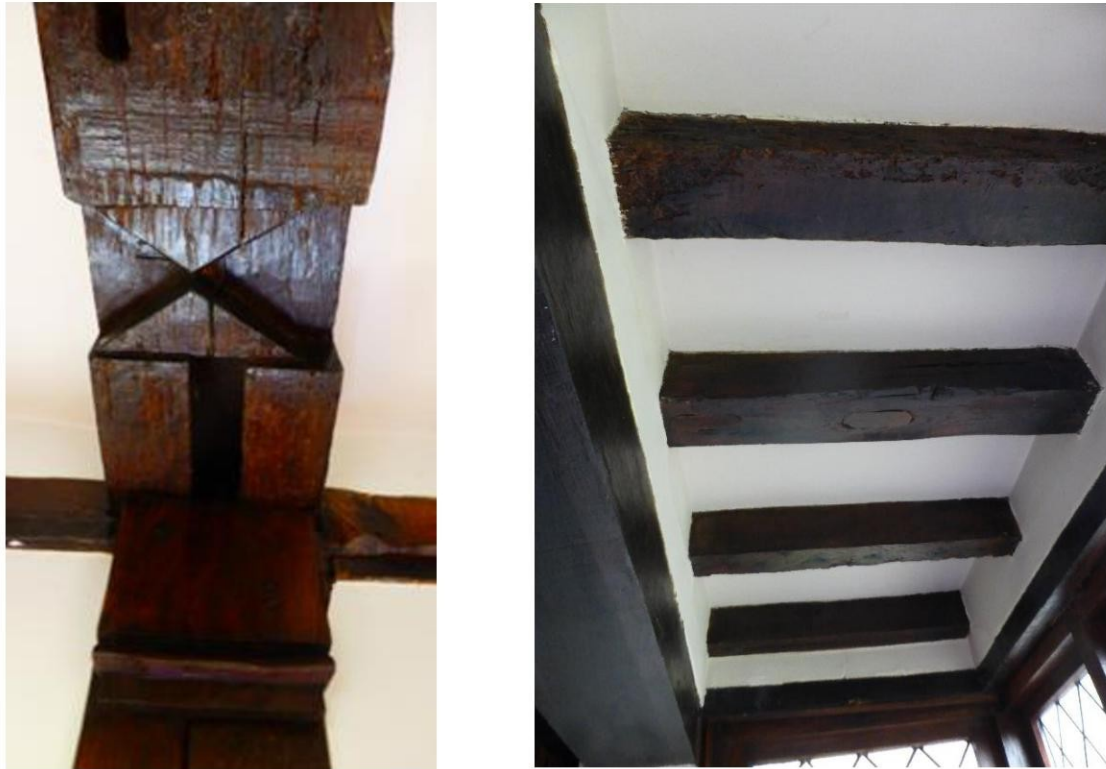
**FIGURE 3 - DOUBLE DOVE TAIL JOINT AND REUSE OF TIMBERS IN BAY**

There is, however, clear evidence in other area of the reuse of timbers as shown at Figure 3 in the Bay window.

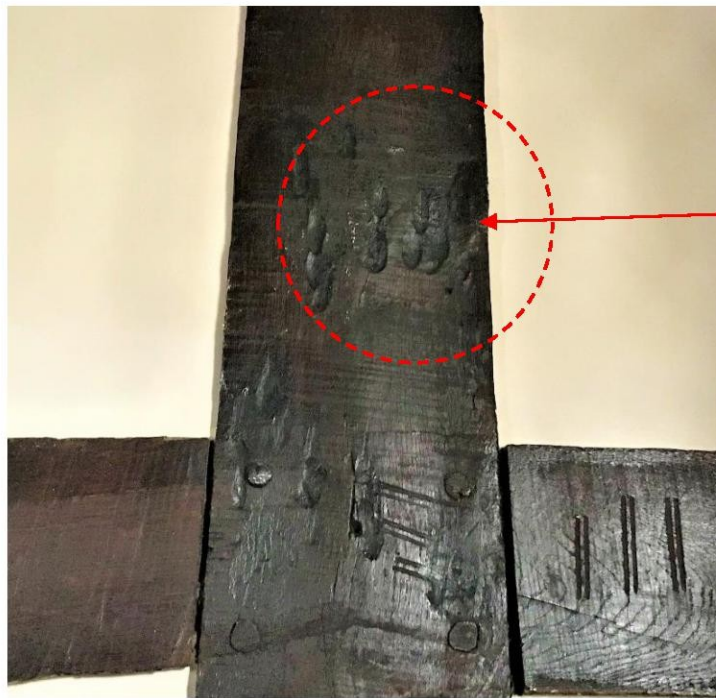
**FIGURE 5 - EXAMPLE OF RITUAL BURNING MARKS FOUND ON TIMBER FRAME**

Along with the carpenter's marks adjacent to the first floor it was noted that there were a number of significant burn marks along the frame in this location. The pattern of these marks are similar to those found in other properties of this age that have been identified as ritual burn marks or taper burn marks. (Champion, 2018). Original studies suggested that these markings

Example of Ritual burning marks found on timber frame adjacent to the staircase

These markings would be worthy of further investigation and recording.

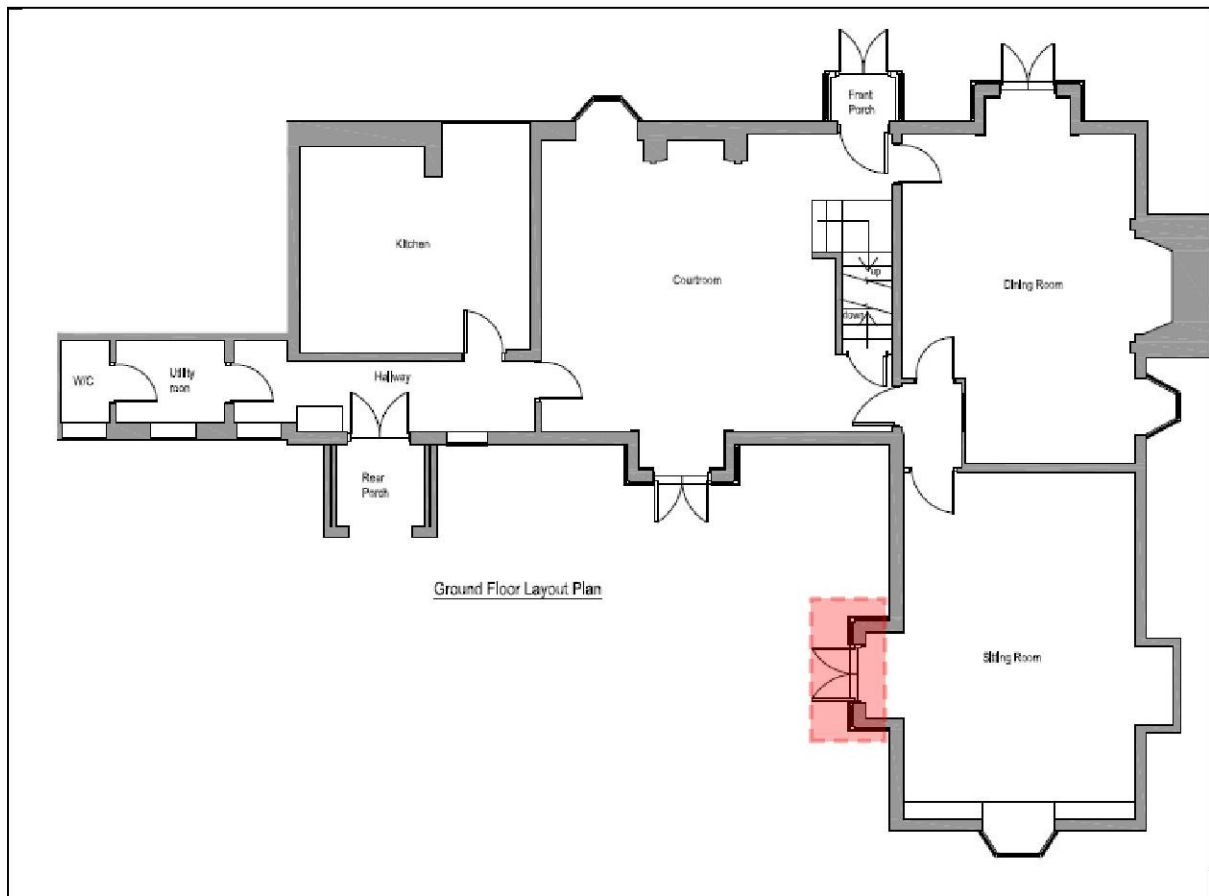
**FIGURE 9 - PLAN SHOWING LOCATION OF BAY REPAIRS**

The diagram at Fig. 9 shows the area subject of the repairs. Internally there are minor repairs to localised areas within the bay.

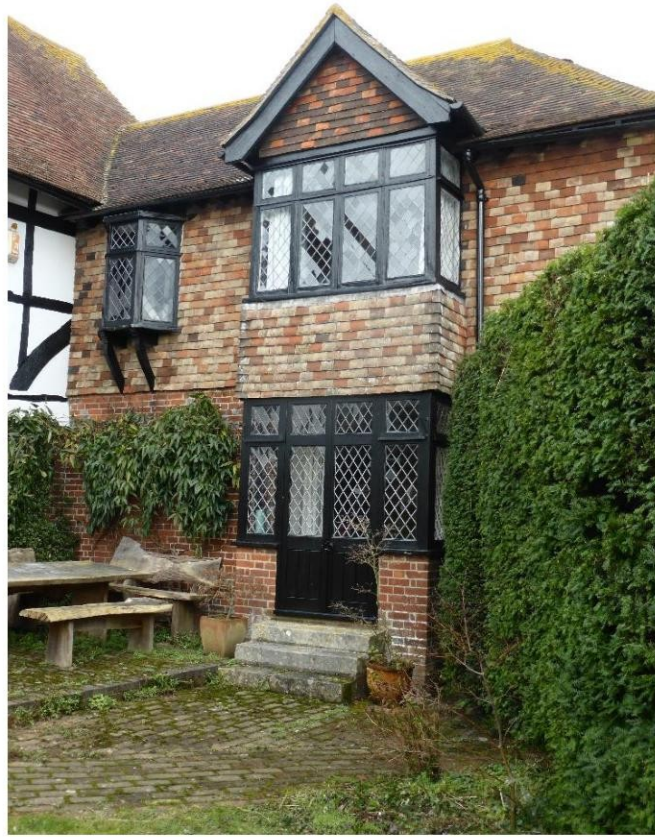
**FIGURE 10 - BAY WINDOW SUBJECT OF REPAIRS**

The proposed repairs are the subject of an insurance claim as a result of recent subsidence damage.

The repair specification is limited to the areas that have sustained localised subsidence damage to the bay window.

The intention is to carefully dismantle the section requiring repair whilst supporting the corner of the bay above. All the bricks will be cleaned of mortar and set aside for reuse. Should additional bricks be required for the localised rebuilding of the corner of the bay then a sample will be provided for approval prior to installation.
