BUILDING CONDITION AND REQUIRED REPAIRS:

Project | THE LEAS PAVILION, THE LEAS  
FOLKESTONE

Title | LISTED BUILDING APPLICATION: EXISTING ELEVATIONS 1

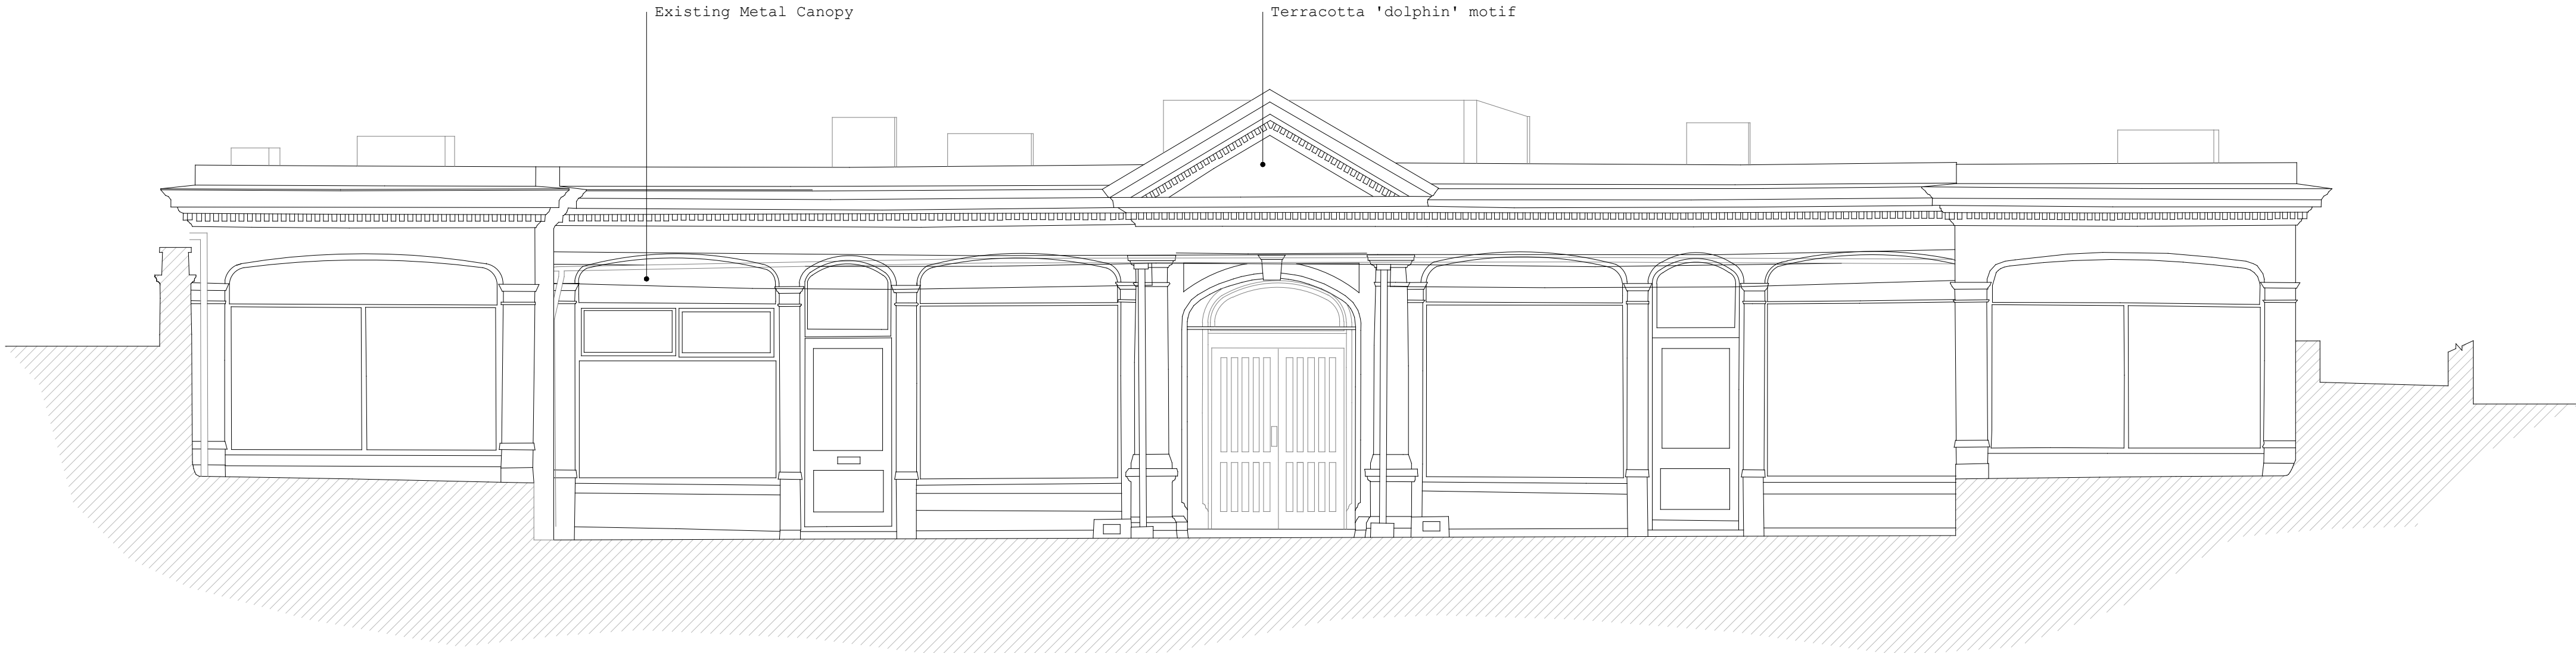
Existing South Elevation (Elevation A)

There is evidence of movement of the principal south elevation, the two elevations of the south east and south west wings that face into the forecourt, and the south facing elevation of these wings. This is particularly visible in the lines of the cornices and distortion of the segmental arches over the windows.

The principal south elevation appears to have settled between the west end and the central pediment and between the east end and the central pediment. There is small vegetation growing from the joints between the terracotta blocks.

In addition, the removal of the basement wall, which supported the principal front elevation, and the insertion of steel beams to support the slab and wall above, seem to have caused settlement of this elevation. This may have occurred almost immediately at the time of the works if there had been inadequate jacking of the new beams upwards to pick up the load of the wall above.

Therefore, in summary, it appears that the settlement and flattening of the cornices and arches respectively at the southern ends of the wings are due not only to the outward movement of the corner piers caused by a lack of mass (the piers are skinny), but also the downward movement resulting from the removal of supporting walls, probably in 1986.

One arch should be partially dismantled to determine the exact form of construction and support for the terracotta blocks. The temporary works should be adapted to allow this. Repair works should be developed. Options include removal of vegetation, repointing in matching lime mortar, careful pinning of the arches in place, insertion of internal concealed stainless steel ties to restrain the arches (particularly at the corners of the wings), relaying of the cornices and parapet blocks where they have moved, stiffening of the steel supporting beams at basement level, jacking the deflected beams and settled piers up to their original level, dismantling and rebuilding of the facades, and monitoring movement. These will be explored following further inspection, investigation and analysis.

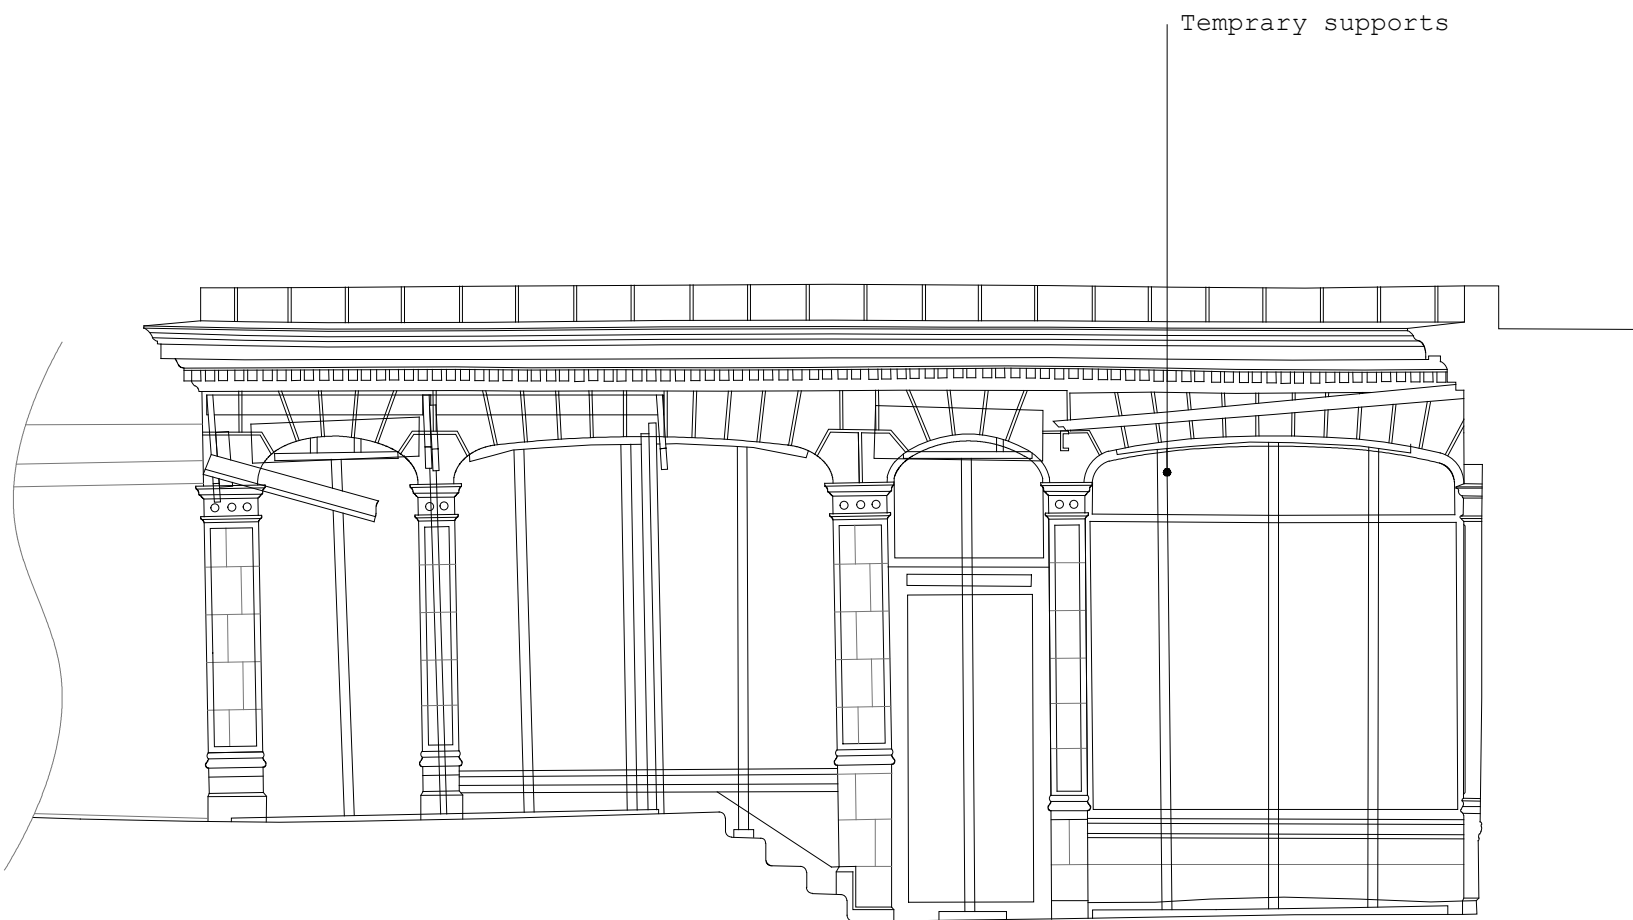
Existing South Courtyard Elevation (Elevation A1)

Timber diagonal propping that provides lateral restraint to the elevations of the wings has been installed since the 2017 inspection, and the arch openings of the wings have also been back propped. These temporary works are assumed to have been installed to prevent further flattening of the segmental arches. The efficacy and condition of the temporary works were not inspected.

It appears that the lack of mass at the corners of the wings is the cause of inadequate lateral support to the springing of the arches which is evident in their spreading and flattening.

After careful inspection of terracotta cladding by the terracotta specialist, Structural engineer to provide a design for steelwork sufficient to provide restraint to the arches over the various openings on the east, west and south elevation which appear to be failing (please refer to the section below).

Fabricate and fit support and restraint steelwork in accordance with SE drawings, all fabricated to take into account the marine environment and lack of cover.
