## **Tree survey to BS 5837 (2012): with constraints and impacts**

### **Cautley House, 95 Seabrook Road, Hythe CT21 5QP**

**Report:**            170606 v2 of 31 July 2017.

**Author:**           Philip Wilson BSc (forestry) MSc PhD MArborA.

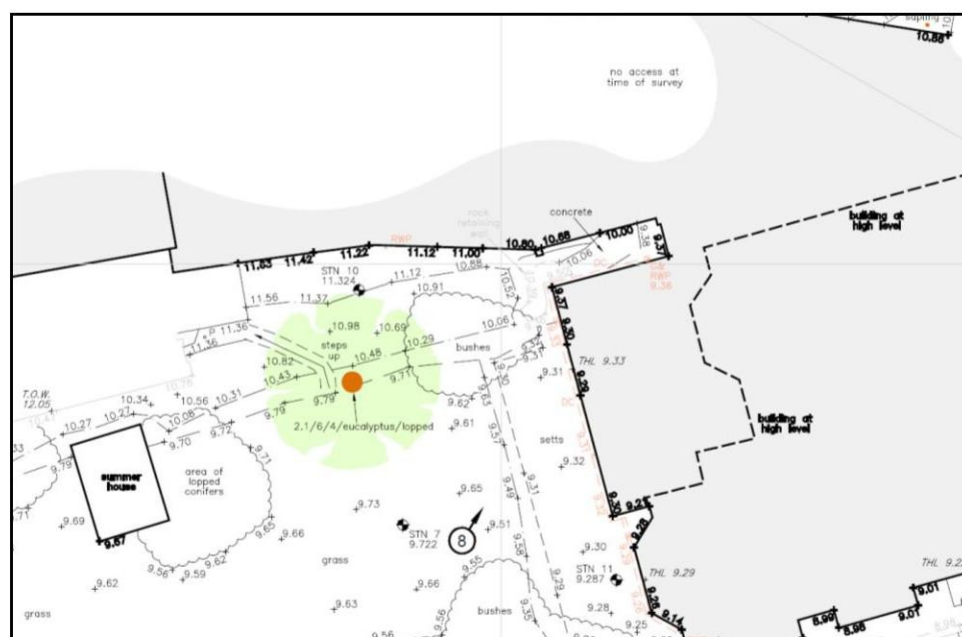
The change in level is the feature one can navigate by when approaching from the south, as shown on the extract from the topographical survey below.

The coloured tree shown in the plan above is T7 Bay laurel.

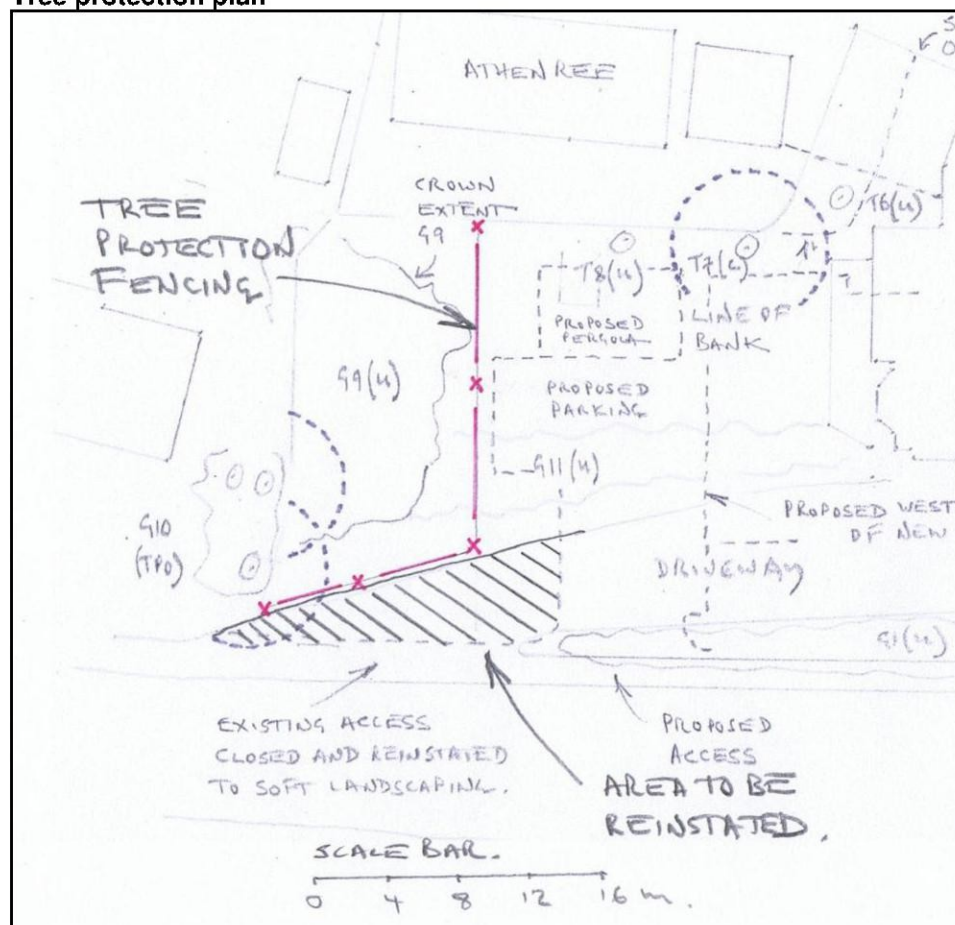
#### Tree protection plan

The fencing is to be installed at the edge of the crowns of G9 (rather than being governed by G9's RPA). See Protection plan below.

*The RPA is an arbitrary guideline. It would be helpful if the following recommendations are applied to the whole of the shaded area ('Area to be reinstated') on the Protection plan.*

The wearing course of the existing bitmac surface is to be removed from within the RPA of G10 by disc-cutter, jack-hammer and small machine working by *pull-back*. The machine driver is to have an assistant drawing attention to any woody roots (for instance between the wearing course and the bedding course) *before* they are pulled up by the machine, as this is likely to cause longitudinal shattering of the root. The assistant is to hand-dig round such roots.

Any broken roots exposed in the excavation are to be severed cleanly with secateurs or a pruning saw. Cross-cut roots or broken roots of whatever size are not to be allowed to dry out. If necessary they should be covered with damp hessian or a membrane.

The sub-base is to be loosened with hand-tools without causing root damage to the extent possible. As much of the loosened sub-base as possible is to be removed by hand, conserving the roots to the extent possible.

The subsoil, below the surface removed in 10.3, will lack biological activity. I recommend (but do not prescribe) that a 10cm layer of *topsoil* (excluding Grade III) be laid on the newly unsurfaced area to promote the growth of the proposed soft landscaping (as indicated in the Design & Access Statement).
