# BS5837:2021 Arboricultural Survey and Impact Assessment

**Site address:** Selsted Farm, Stockham Lane, Dover  
**Prepared on behalf of:** DHA Planning

| Document ref: | 2137 | Survey date | May 2022 |
| Survey type | Arboricultural Tree Condition Survey | | |

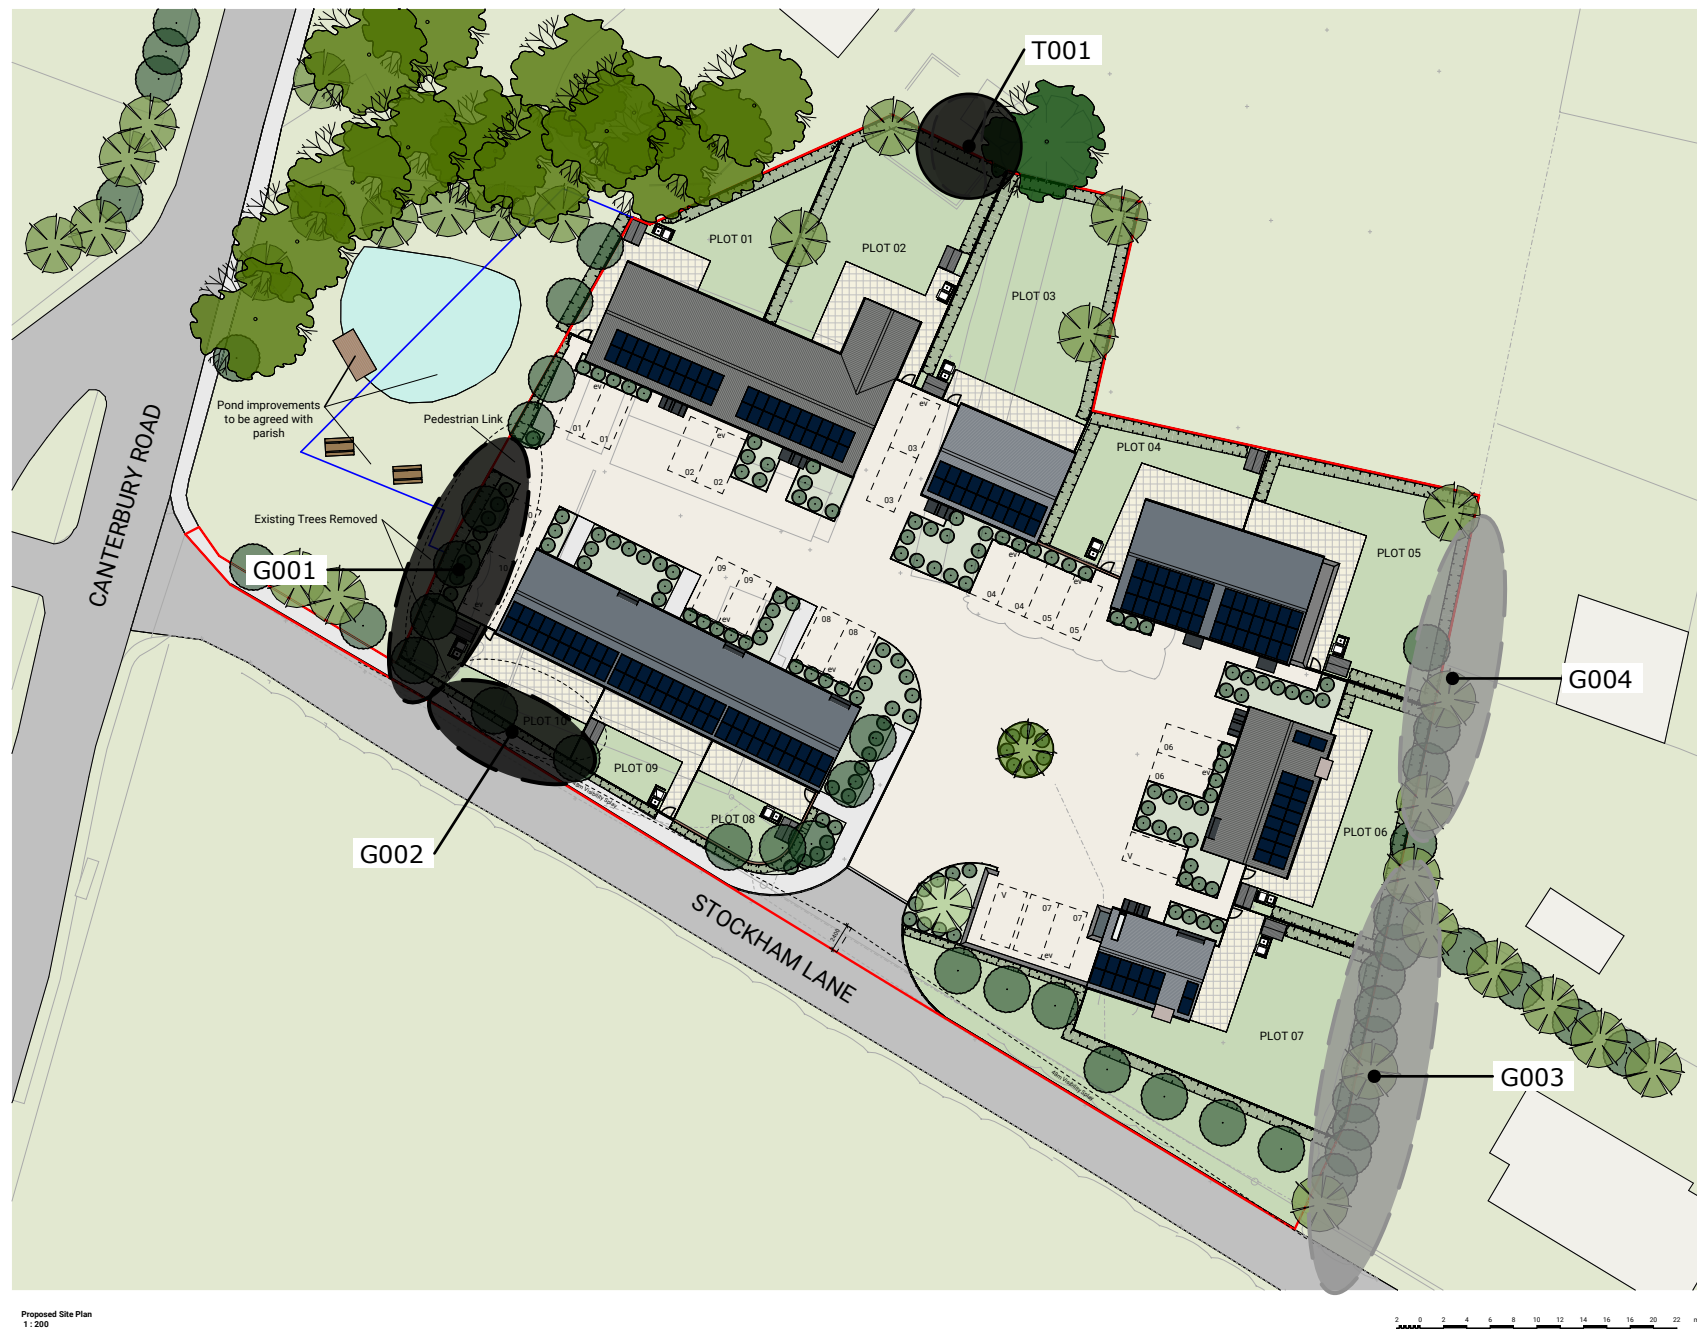
Removal plan - Appendix 4

The overall impact of the proposal on the localised tree population is low with three removals recommended to accommodate the proposal: G001, G002, T001 with management of G003 and G004.

1. *Removals of T001, G001 and G002.*
  2. *Protection fencing around G003 and G004*
  3. *A robust landscape plan to show site enhancements.*
-
