Canterbury Archaeological Trust Ltd

13<sup>th</sup> September 2023

## RE: Spicers Farm, Etchinghill, Kent

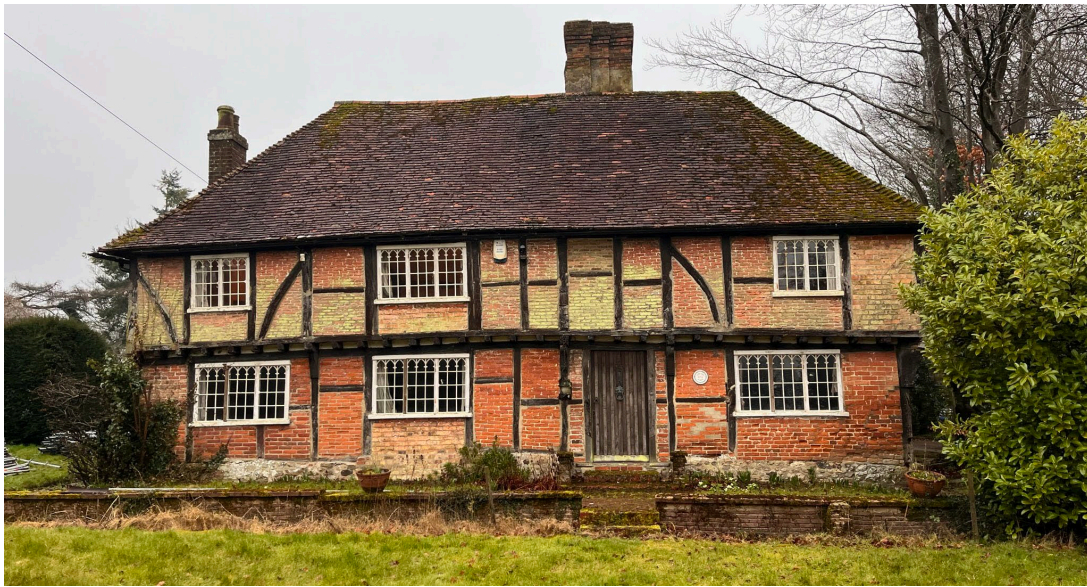
View of main seventeenth-century range of house, looking south (Photo Clague Architects)
