**Ref: 3536/18**

**PROPOSED REDEVELOPMENT AT  
106 HIGH STREET, HYTHE,  
KENT CT21 5LE.**

**PHASE I GEO-ENVIRONMENTAL DESK STUDY AND  
REPORT ON PHASE 2 SUBSOIL INVESTIGATIONS**

**February 2018**

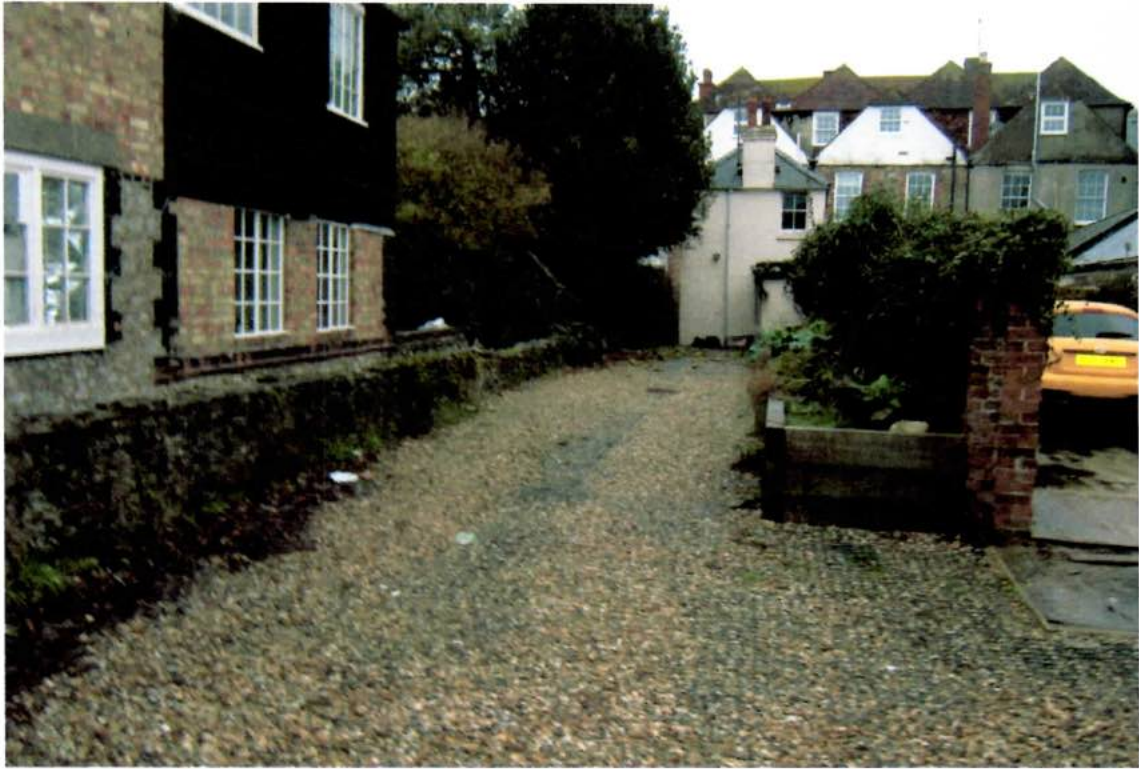
**Plate 1**

- 7.4 Ground surface at the site was of a relatively level contour, the majority of the ground surface consisting of shingle contained by a grid of plastic mesh (Plate 1). A series of drainage inspection chamber covers ran centrally from the north to the south end of the site.

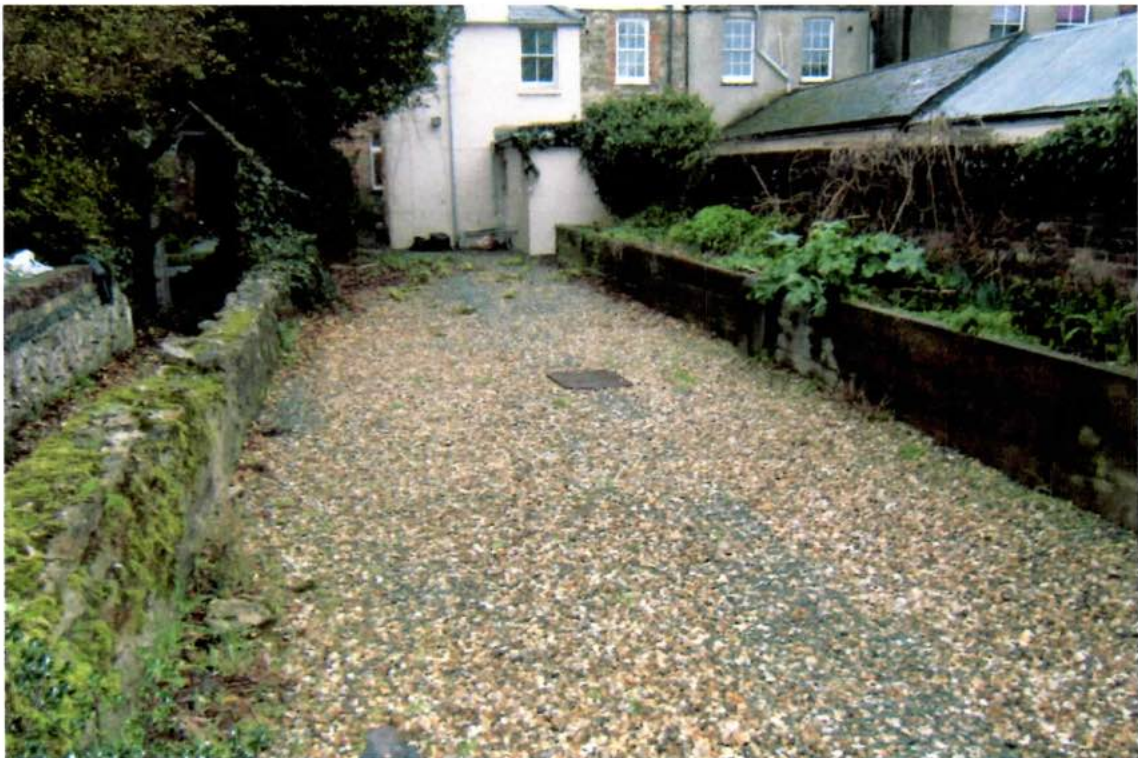
**Plate 2**

- 7.5 The west boundary of the site comprised a stone wall approximately 0.75m in height whereas the east boundary consisted of a 1.5m high brick wall. An area of raised planting formed from timber sleepers was present alongside the site's east boundary (Plate 2).

- 12.13 Alternatively, areas of proposed garden could be replaced by permanent hard standing which would sever pollutant linkages between end users and contaminated soil. Raised planters could then be installed on the hardstanding in keeping with the area of raised planting currently present upon the site.
