Spicers Farm  
Canterbury Road  
Etchinghill  
Folkestone  
Kent, CT18 8DE

Schedule of Repairs  
Existing South East Elevation  
External

30681A\_121      A

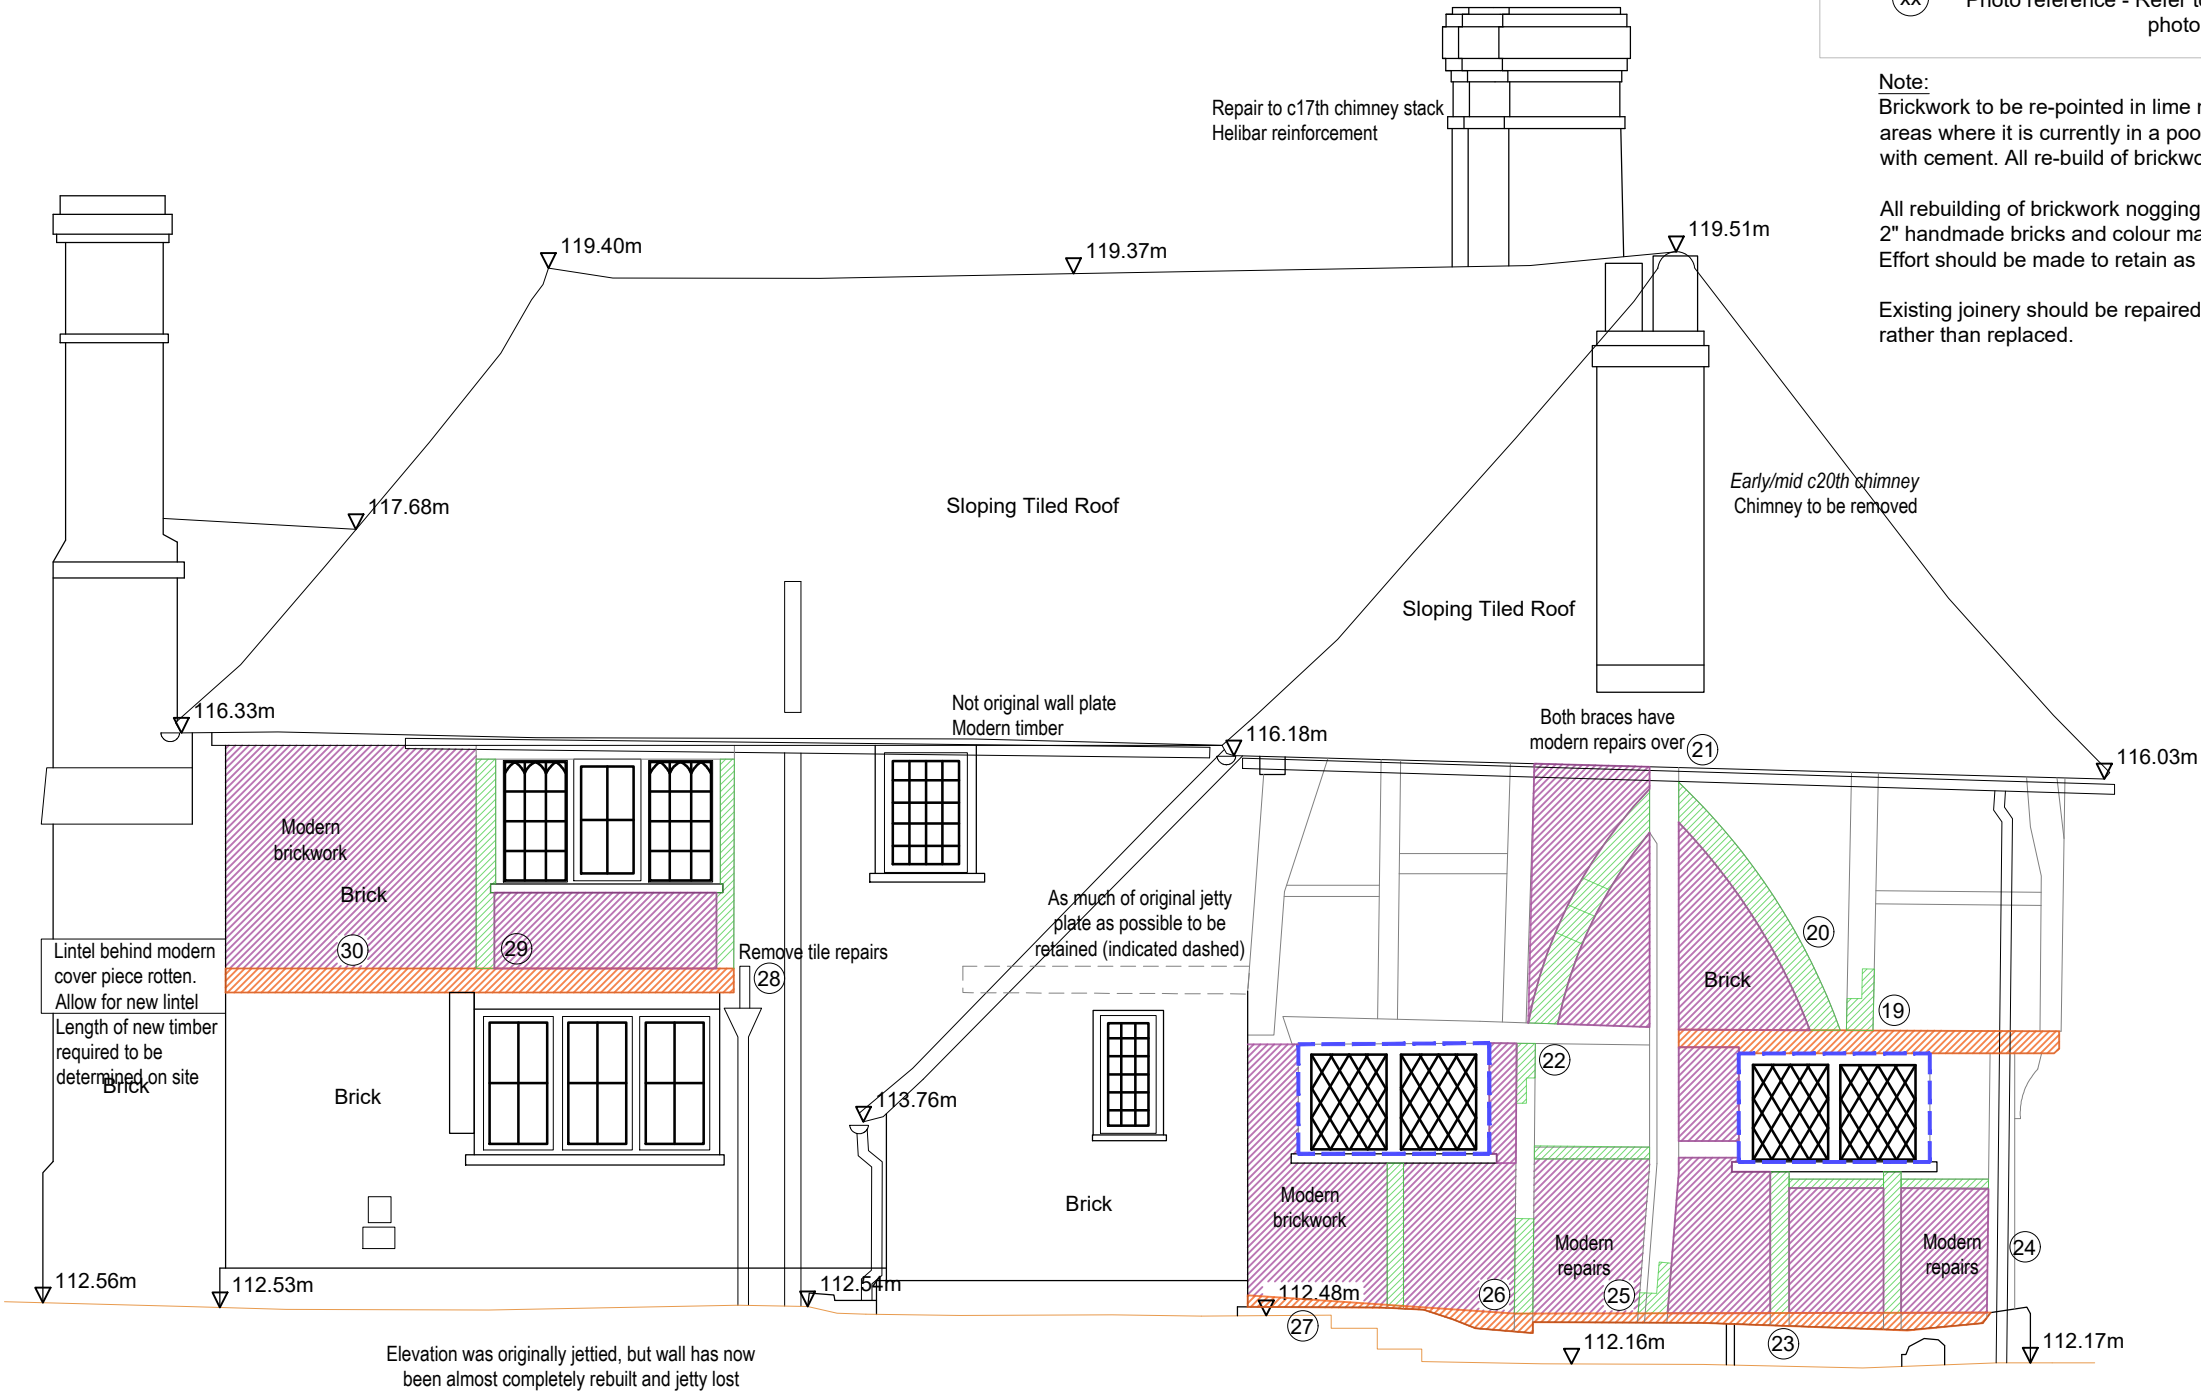
Existing South East Elevation  
Scale 1:50 @ A3

Rebuild area of brick wall

Timber repair

Allow for timber replacement

Cement mortar removal

Allow for replacement of window

Brick repair

Re-point plinth

Assumed line of hidden sole plate

Note:  
Brickwork to be re-pointed in lime mortar (NHL 3.5) in areas where it is currently in a poor condition or pointed with cement. All re-build of brickwork to use lime mortar.

All rebuilding of brickwork nogging is to be carried out in 2" handmade bricks and colour matched to the existing. Effort should be made to retain as much as possible.

Existing joinery should be repaired where possible, rather than replaced.
