## **Tree survey to BS5837 (2012): Constraints, impacts and Protection measures**

### **1 – 2 Ark Cottages, Etchinghill, Kent CT 18 8DE**

**Report:**        No. 191205 of 10 December 2019.

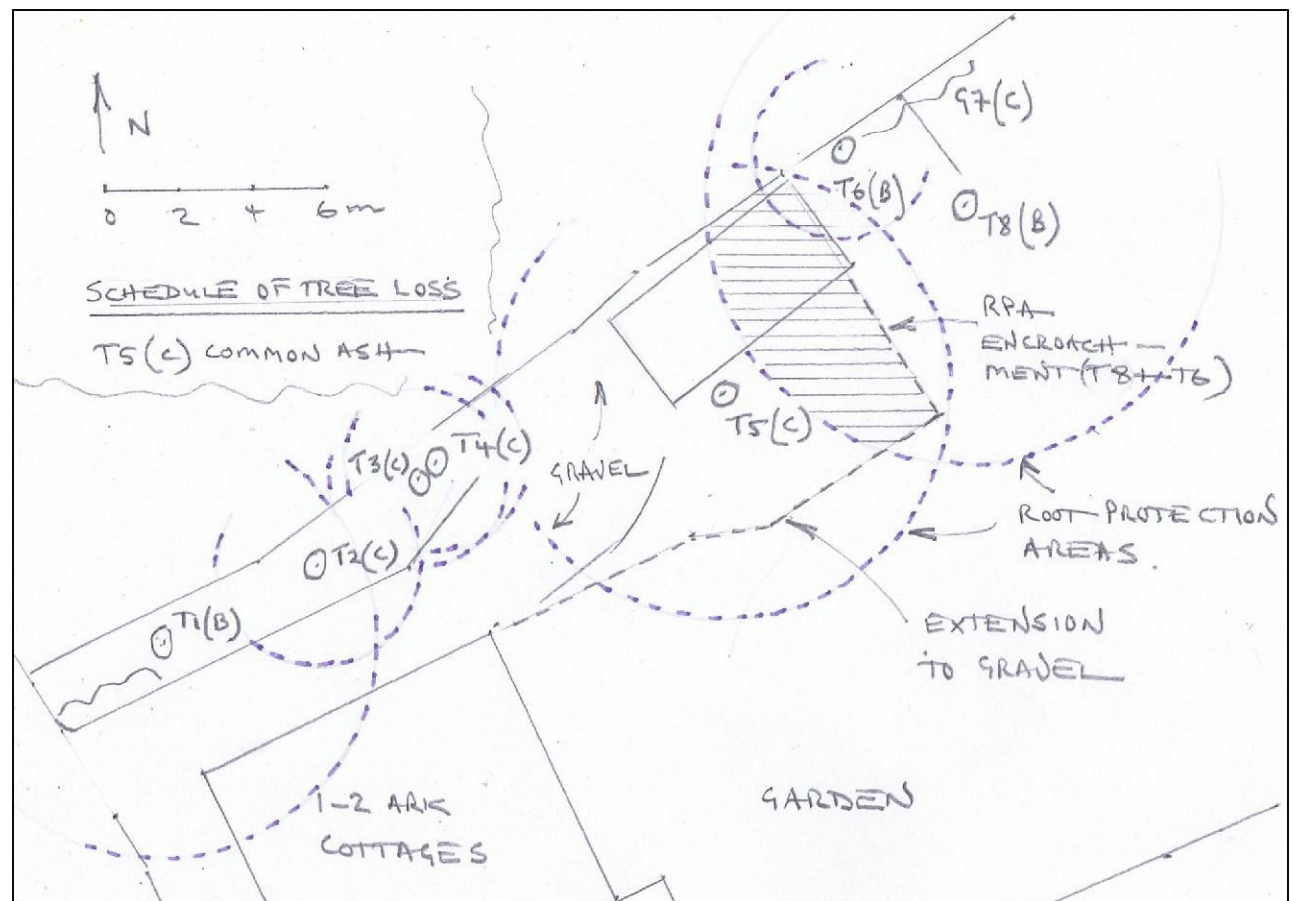
### 9.1. Tree position and constraints plan

On the plan above, solid lines are existing, dashed lines are proposed. The existing gravel drive leading to the garage and outbuildings is to be extended to the north-east, and widened to the south.

| Tree | Reason |
|---|---|
| T5 (C) Common ash | Within footprint of proposed car parking area |

The loss of this tree is not a significant constraint to the proposal.

| Tree | RPA<br>(m <sup>2</sup> ) | Encroachment<br>(m <sup>2</sup> ) | (%) | Nearest<br>Approach | Reason |
|---|---|---|---|---|---|
| T6 | 15 | 0.8 | 5 | 1.5m | Proposed parking area |
| T8 (B) Common ash | 145 | 26 | 18 | 3.6m | Proposed parking area |

The impacts of these RPA area encroachments depend on the depth of excavation for the proposed parking area.

(i) The vegetation and topsoil is to be removed (it is relatively compressible).

(ii) The permissible depth of excavation is 10cm below the existing ground surface, allowing underlying roots to persist. This might involve building the surface up slightly from the existing ground level.

In addition, I recommend edge restraint at the north-east edge of the proposed parking area but not a conventional kerb (which requires a relatively deep excavation to be fixed in position). Instead, by reference to the edging of the existing gravel surface in the vicinity of T2–T4, I suggest large stones placed on the ground surface (or sunk no deeper than 10cm), or sleepers positioned similarly and kept in place with pins (welding rods or similar).

The north-east edge of the proposed parking area (nearest T6 Beech and T8 Common ash, an 8m length), is to be dug with hand tools.

Any woody roots exposed are to be severed cleanly with secateurs or a pruning saw. Cross-cut roots or broken roots of whatever size are not to be allowed to dry out. If necessary they should be covered with damp hessian or a membrane.

An edge restraint at the north-east edge of the proposed parking area, if constructed before the main excavation, would serve as an effective tree protection measure for T6 Beech and T8 Common for the remainder of the excavation and other site works.
