**BARN  
AT  
THRIFT FARM  
BROOKLAND  
KENT:  
BAT BUILDING SURVEY**

MARTIN NEWCOMBE

20<sup>th</sup> August 2024

D115. Brookland (TQ998264)R2

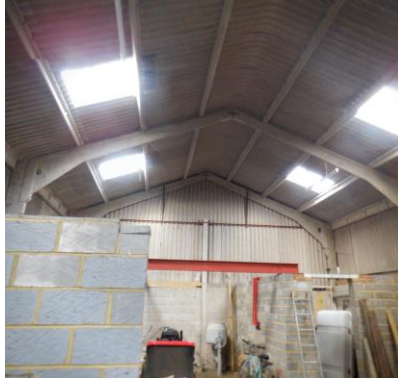
**4.3** The absence of any evidence of **bat roosting** from the building was not surprising insofar as the building lacked any suitable roosting habitat; it was very light as a result of the presence of skylights, it was very dry and ventilated and the structure of the barn was simple and without any suitable roosting places, with no architectural features that could hold roosting bats. The roof was unsuitable being tightly attached with open eaves spaces, and because of its type of construction, the whole building would lose heat during the night, and be hot from insolation during the day. The building was warm enough during the visit to make it seem possible that bats could use it, but the roof and the rest of the building lacked any insulation so would be cold at night; conditions for maternity roosting were therefore non – existent. There were no features, either internally or externally which could allow bats to hibernate either and thus it is considered that the building was unsuitable for bats' use.

**FIGURE 5: SHOWING THE ROOF AND SKYLIGHTS.**

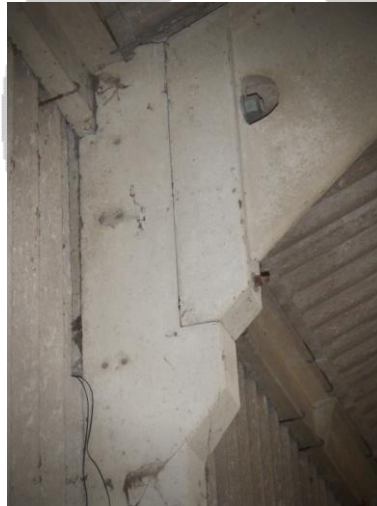
**FIGURE 7: ONE OF THE SUPPORTING PIERS SHOWING THE LACK OF ROOSTING SPACES.**

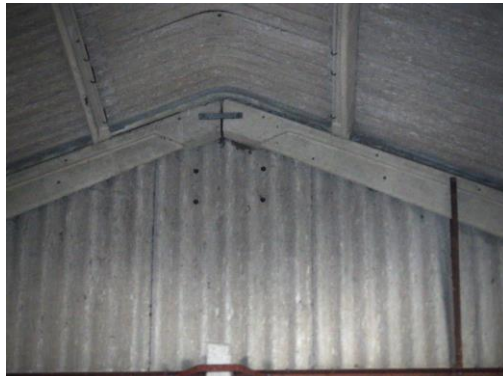
**FIGURE 8: THE BEAMS ARE SEVERAL CENTIMETRES PROUD OF THE ROOF AND WALL.**

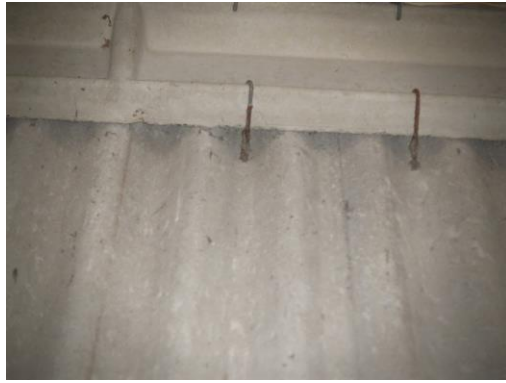
FIGURE 9: THE GAP BETWEEN THE BEAMS AND THE ROOF.
