# Misling Farm, Canterbury CT4 6DE

BS 5837 Arboricultural Impact  
Assessment Report (AIA)

30th March 2026

| Report reference: | DTE #RF25781 |

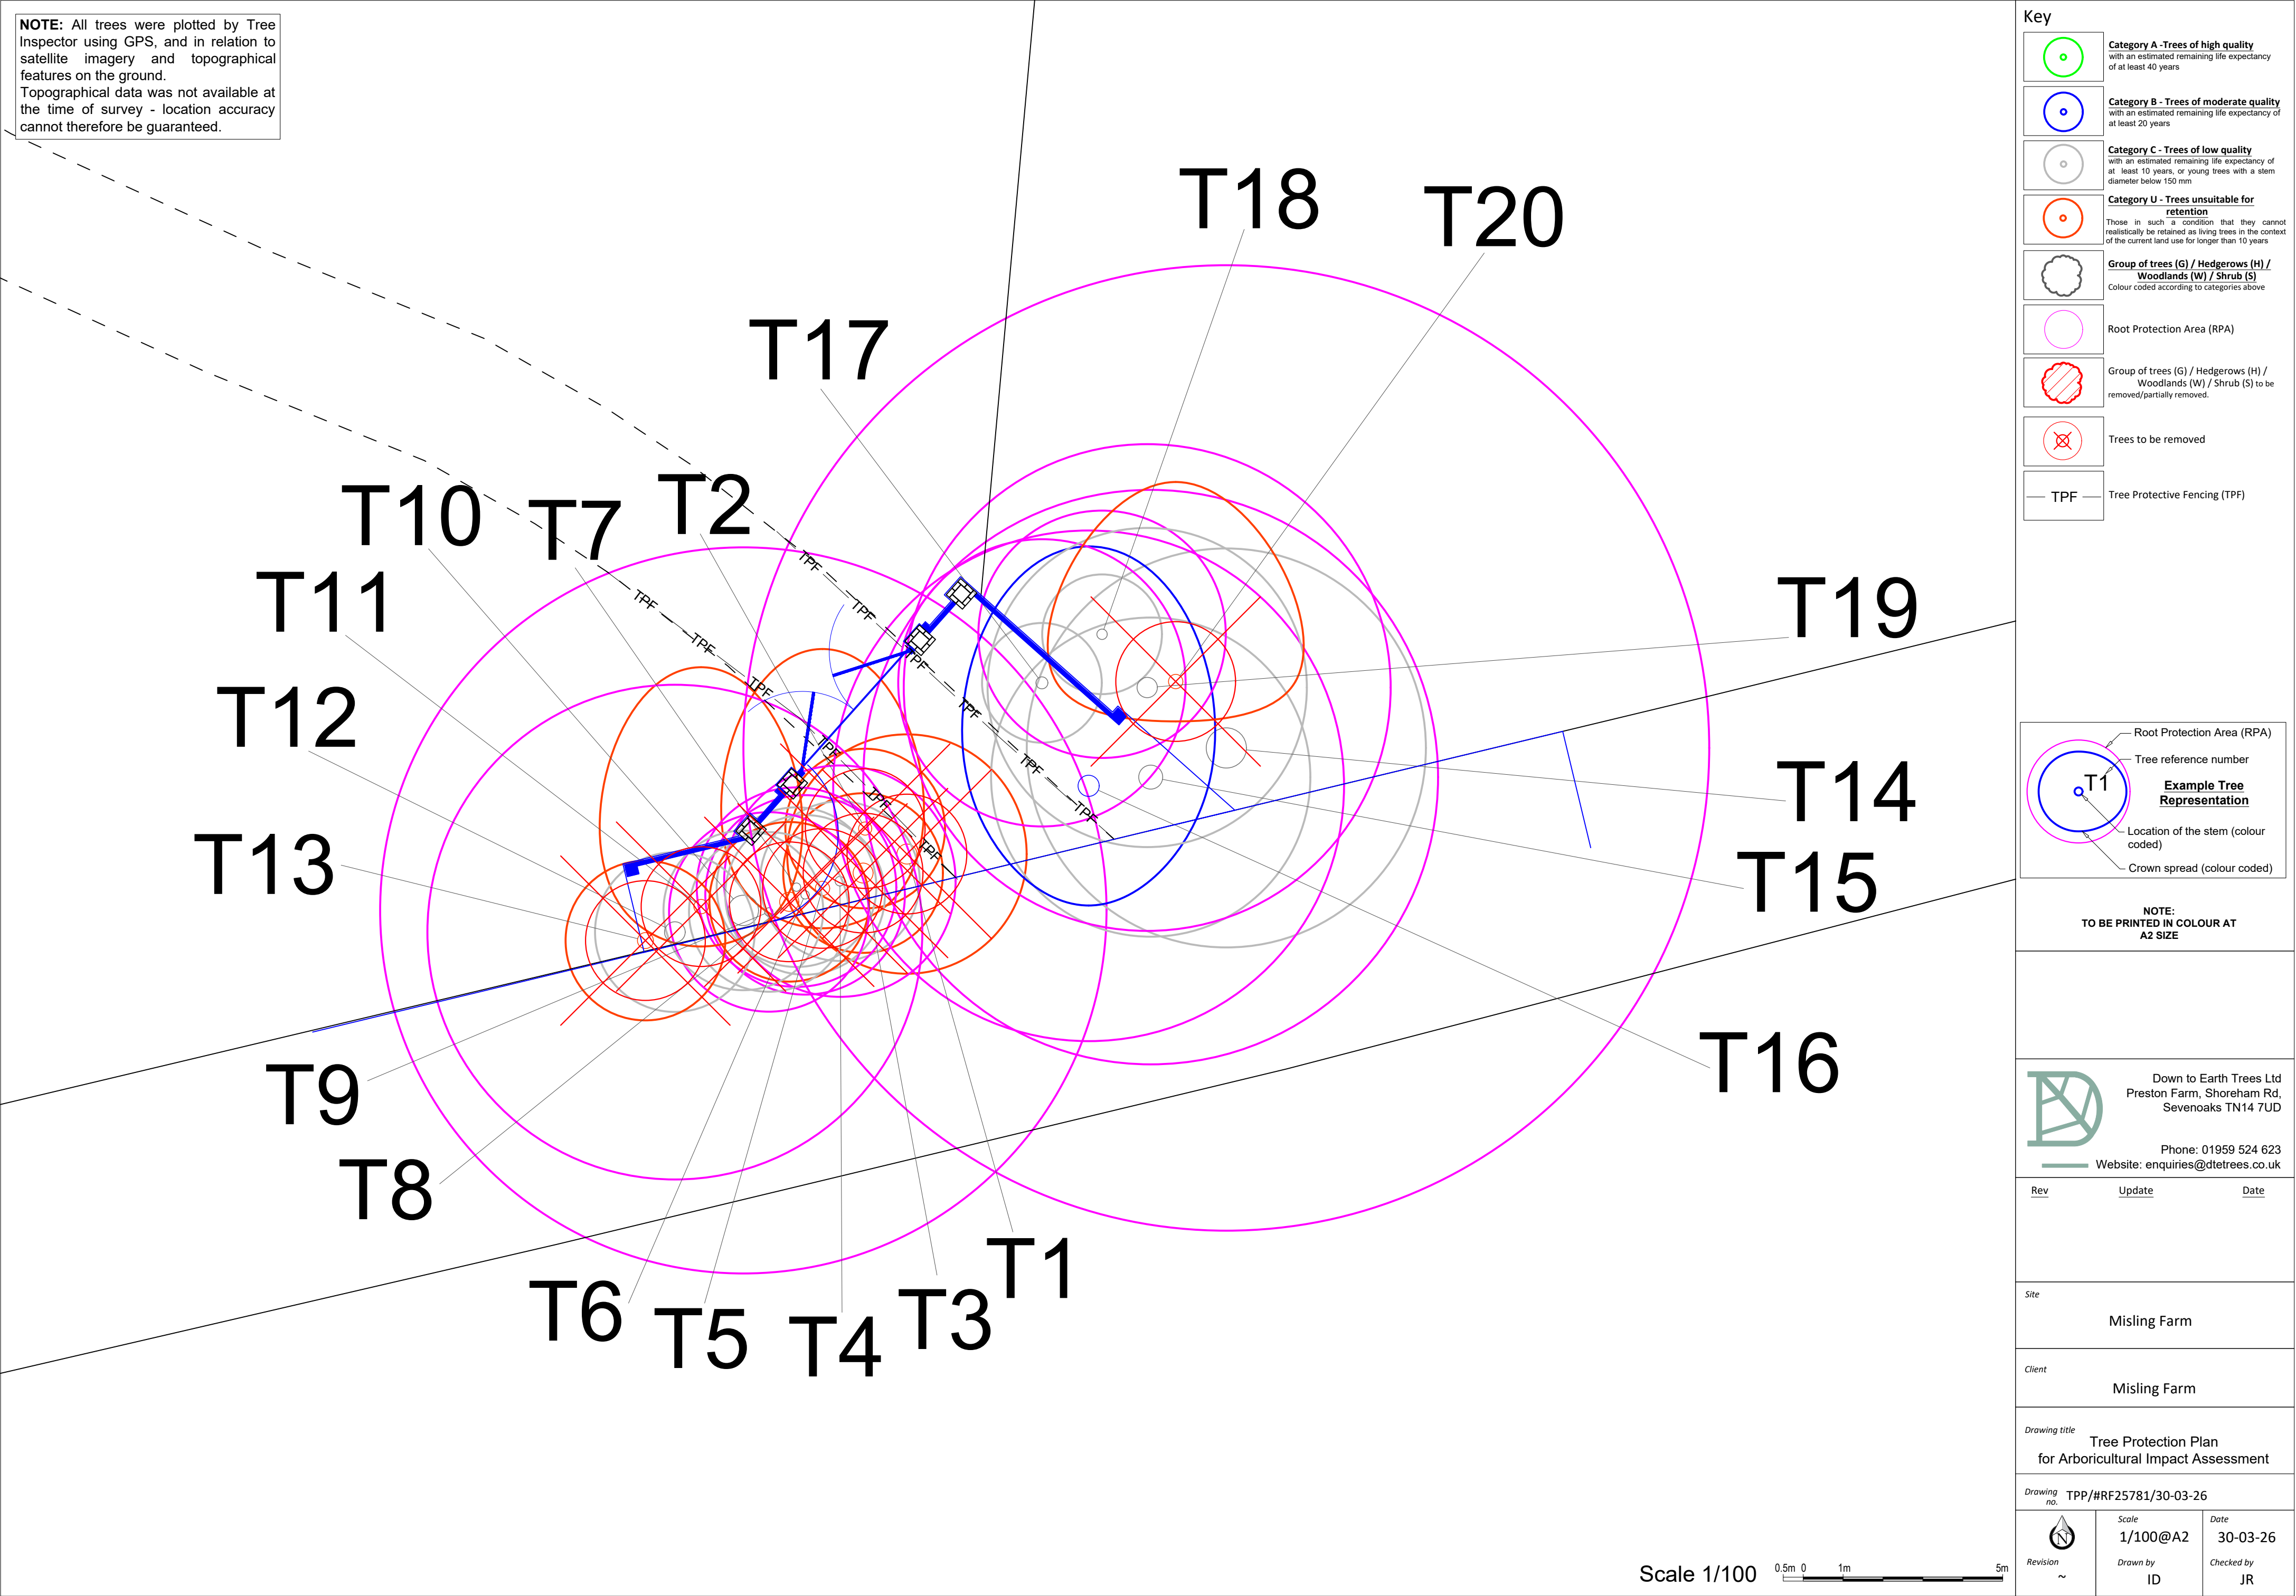
## Appendix 4 Tree Protection Plan

- 6.2.3** Tree Protection: Protective fencing and, where required, ground protection will be installed prior to commencement to prevent accidental damage to retained trees. The protective fencing will be erected along the edge of the driveway to define a clear exclusion zone within the adjacent rooting area, preventing access by plant, machinery and materials storage. Access through the fenced line will be controlled to allow the proposed hand-digging for post-holes and any localised excavations, with works undertaken carefully and under arboricultural supervision. (See Appendix 4 – Tree Protection Plan).
