## **Tree survey to BS5837 (2012) with constraints, impacts and Tree protection plan**

**Castle House, Castle Hill Avenue, Folkestone CT20 2TF**

**Report:** 260904 dated 25 September 2026.

**Reference:** Planning application 26/1312/FH.

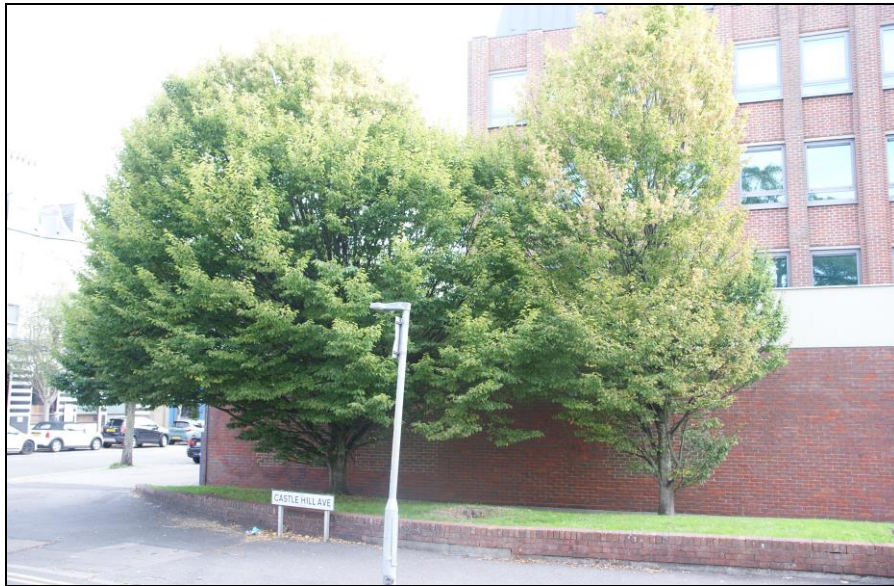
**Photo 2.** The view eastward of T1 and T2, fastigate hornbeams.

| Tree/<br>Group | Species | Diam<br>(cm) | Ht.<br>(m) | Crown<br>radius<br>(m) | Head-<br>room<br>(m) | Value | RPA<br>radius<br>(m) | Comments | Photo |
|---|---|---|---|---|---|---|---|---|---|
| T1 | Fastigate hornbeam | 29 | 9 | 5 | 2 | B | 3.5 | Early-mature, crown extends for 3m over the public footway. Slightly overbearing, headroom could be increased. Trunk diameter measured 0.5m above ground level. | 2 |
| T2 | Fastigate hornbeam | 24 | 10 | 3 | 1–2 | B | 2.9 | Early-mature. Slender crown. Trunk diameter measured 0.5m above ground level. | 2 |

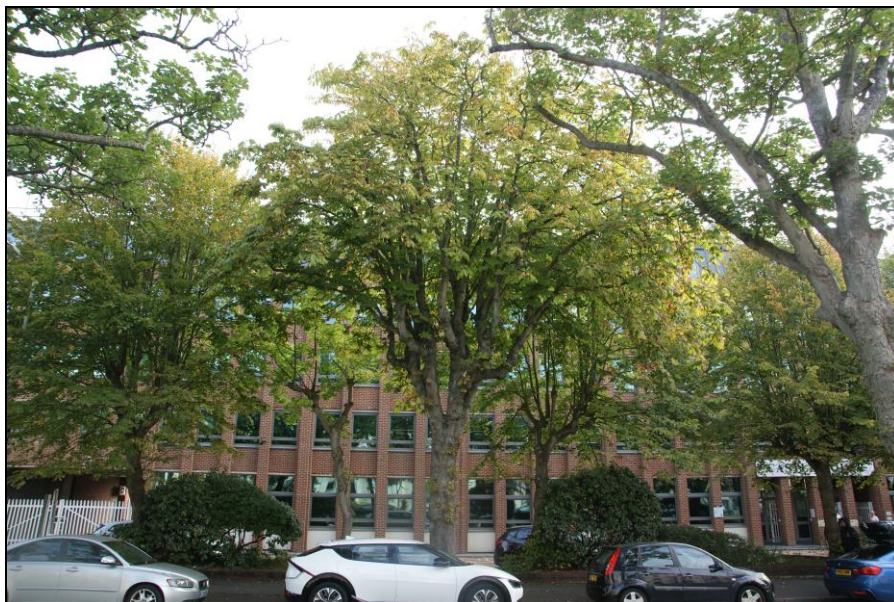
**Photo 3.** The view eastward of T4 Lime on the left (at the north end of the raised bed), with S5 at its base.

T7 (TPO) Horse chestnut is in the middle of the photo, with the suppressed T6 Sycamore to its left and T8 Lime to its right, with S9 at its base.

| Tree/<br>Group | Species | Diam<br>(cm) | Ht.<br>(m) | Crown<br>radius<br>(m) | Head-<br>room<br>(m) | Value | RPA<br>radius<br>(m) | Comments | Photo |
|---|---|---|---|---|---|---|---|---|---|
| T4 | Lime | 40 | 17 | 5 | 2.5 | B | 4.8 | Early-mature, dense globular crown. | 3 |
| T6 | Sycamore | 26 | 12 | 0 over<br>footway | 2.5–3 | C | 3.1 | Early-mature. Suppressed and crown unbalanced to east owing to competition from neighbours, mainly T7 Horse chestnut. | 3 |
| T7 | Horse chestnut | 62 | 20 | 6 | 6–8 | TPO | 7.4 | Mature, condition good, 2m from raised bed. | 3 |
| T8 | Lime | 42 | 19 | 4 | 2.5 | B | 5.0 | Early-mature. Crown unbalanced owing to competition from neighbouring trees, especially T7 Horse chestnut. Crown extends to outer edge of public footway. | 3 |

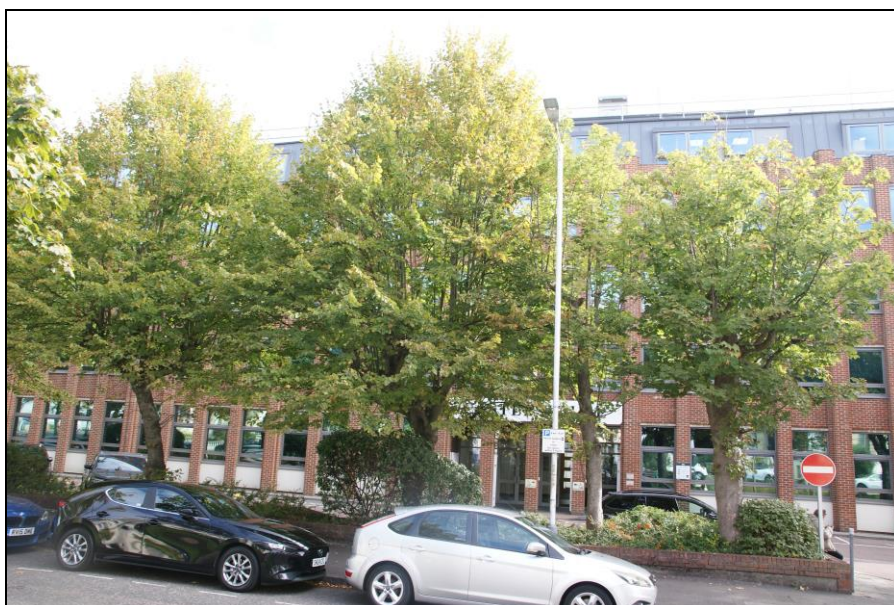
**Photo 4.** The view eastward showing, from left to right, T10 Lime, T11 Lime with S12 at its base, T13 Sycamore and T14 Sycamore.

The low retaining wall of the raised bed can be seen, and the southern end of the raised bed where it meets the exit from the Castle House carpark.

| Tree/<br>Group | Species | Diam<br>(cm) | Ht.<br>(m) | Crown<br>radius<br>(m) | Head-<br>room<br>(m) | Value | RPA<br>radius<br>(m) | Comments | Photo |
|---|---|---|---|---|---|---|---|---|---|
| T13 | Sycamore | 30 | 15 | 2 | 2–4 | B | 3.6 | Early-mature. Vigour low. Spindly, narrow crown. | 4 |

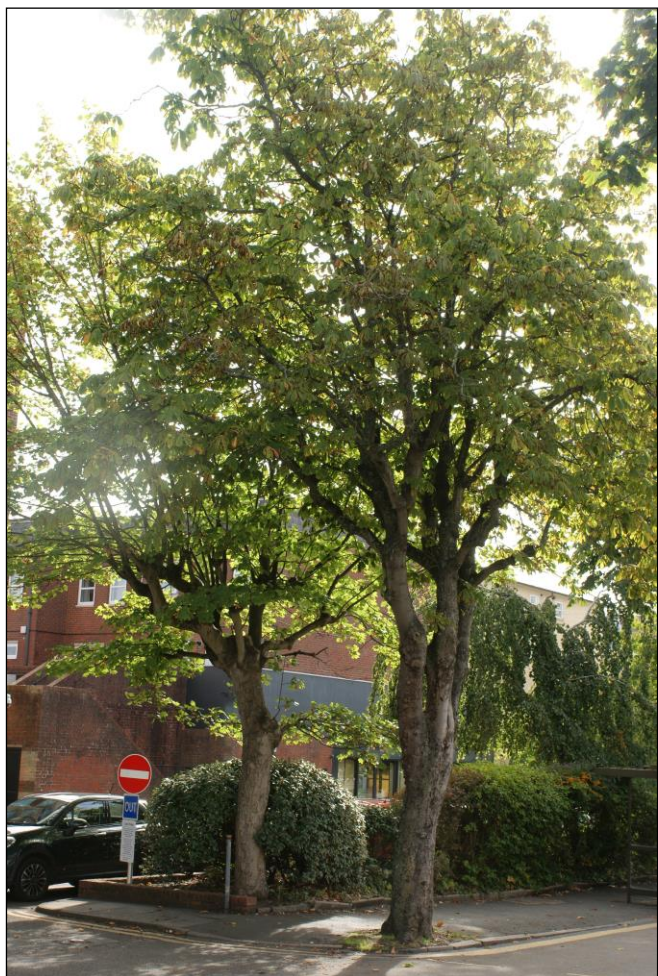
**Photo 5.** The view southeastward of T16 (TPO) Horse chestnut in the foreground, with T15 Sycamore behind, and the almost continuous S17 extending to the right towards T18 Weeping beech.

| Tree/<br>Group | Species | Diam<br>(cm) | Ht.<br>(m) | Crown<br>radius<br>(m) | Head-<br>room<br>(m) | Value | RPA<br>radius<br>(m) | Comments | Photo |
|---|---|---|---|---|---|---|---|---|---|
| T15 | Sycamore | 40 | 16 | 1.5 | 2.5–3 | B | 4.8 | Early-mature. Crown unbalanced to the east owing to competition from T16 Horse chestnut. | 5 |
| T16 | Horse chestnut | 53 | 18 | 3.5 | 6 | TPO | 6.4 | Mature. Fine specimen | 5 |

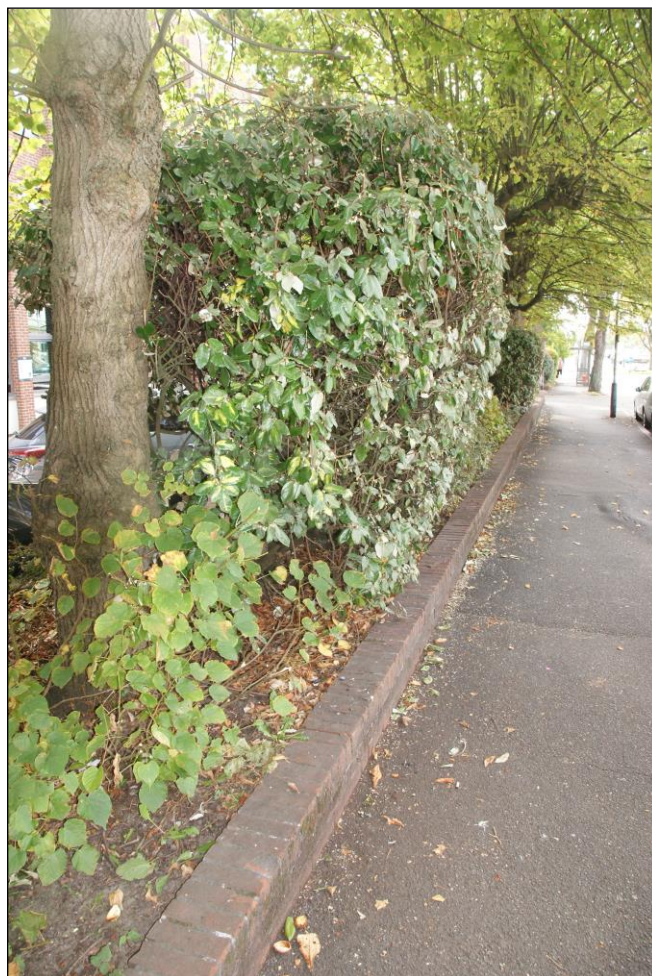
**Photo 6.** The view southward along the western boundary of Castle House, showing the raised bed on the left and the public footway of Castle Hill Avenue on the right. The fencing is proposed to be adjacent to the inner face of the low brick retaining wall.

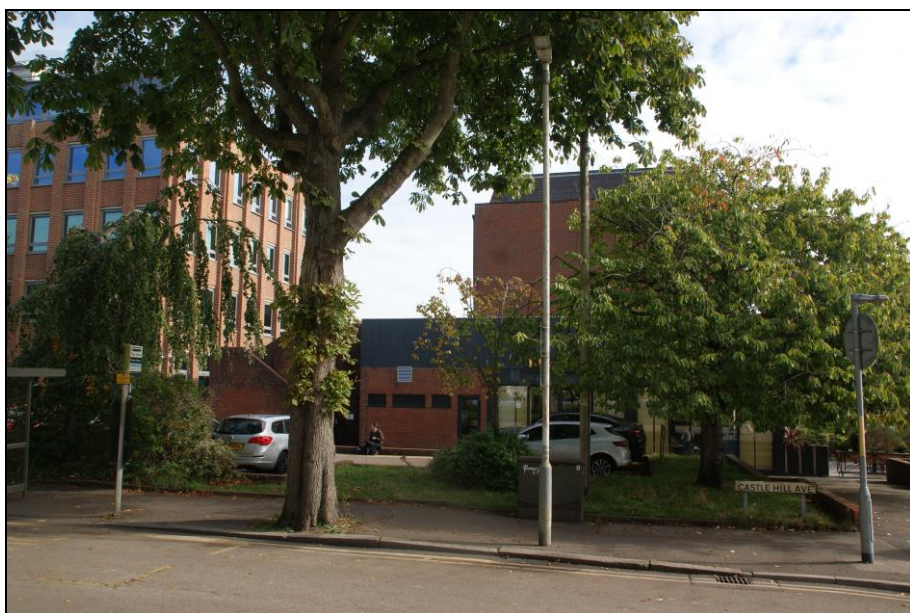
**Photo 7.** The view eastward showing the south end of S17 and T18 Weeping beech in shadow on the left.

The large T19 (TPO) Horse chestnut is in the public footway adjacent to the carriageway of Castle Hill Avenue.

On the right is the broad crown of T21 Cherry, with the small and half-dead T20 Cherry barely visible by the left edge of T21's crown.

| Tree/<br>Group | Species | Diam<br>(cm) | Ht.<br>(m) | Crown<br>radius<br>(m) | Head-<br>room<br>(m) | Value | RPA<br>radius<br>(m) | Comments | Photo |
|---|---|---|---|---|---|---|---|---|---|
| T20 | Cherry | 9 | 5 | 0–1 | 1.5 | U | – | Spindly, half-dead. | 7 |
| T21 | Cherry | 39 | 8 | 5 | 1.5 | B | 4.7 | Late-mature, broad crown. Large wound on west side at height 1.5m, no decay detected by forcible probing. | 7 |

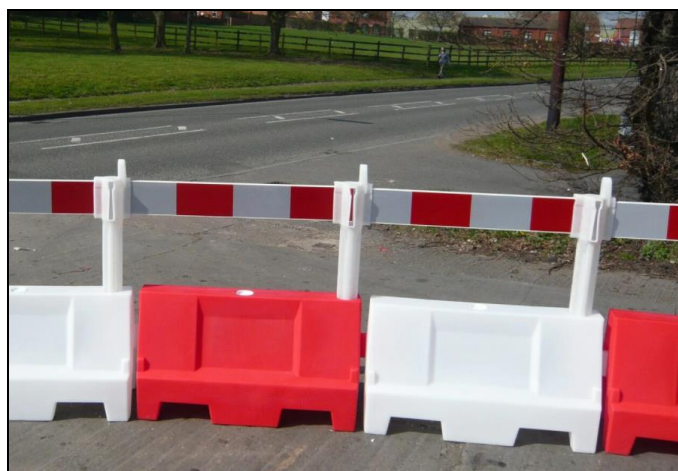
**Photo 8.** Evo barriers, an option for protecting the TPO trees T7, T16 and T19 Horse chestnuts.

Alternatively, individual trees could be isolated using barriers such as those shown in Photo 8.

They can be filled with water for high impact resistance.

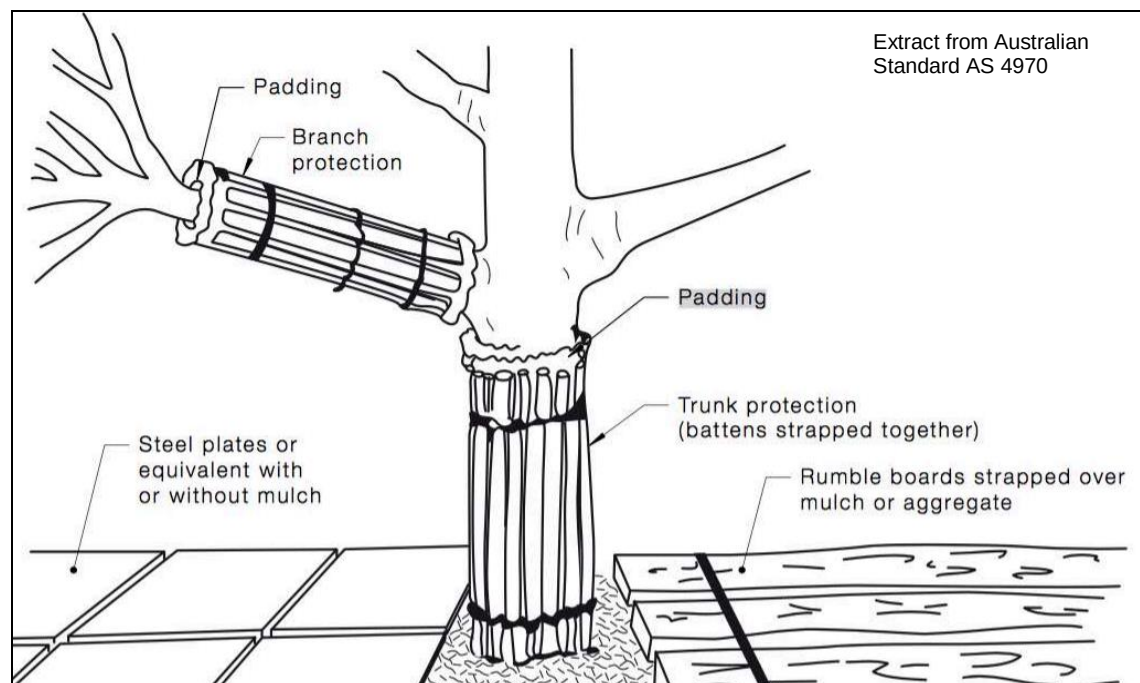
The fencing construction works will be very close to the non-TPO trees, indicating the need for trunk protection. The height of the protection depends on the height to the first branch, up to 1.3m. A suitable design is shown in Figure 1 below.

**Figure 1.** A suitable design for trunk protection. The protection must be thick enough to give some impact resistance and to entirely cover the root buttresses at the base of the tree. It should also be conspicuous to increase the visibility of the trees.

Trunk protection is required to height 1.3m, whether from fencing on the east side of the trees or from the design shown in Figure 1 above.
