# **PHASE 1 PRELIMINARY RISK ASSESSMENT**

## **THE OLD PUMP HOUSE DYMCHURCH**

**MR STEVE ADLINGTON**

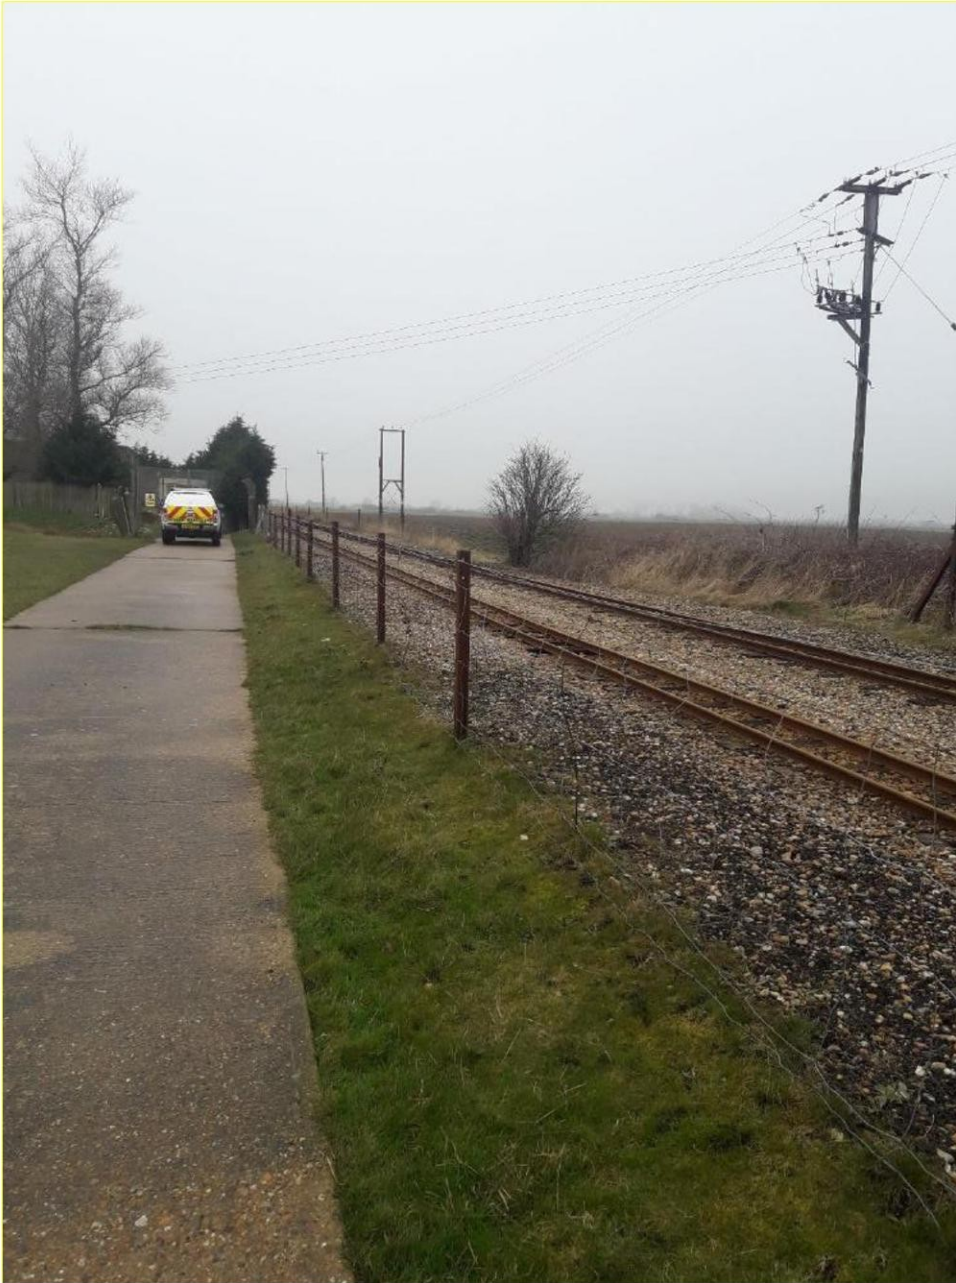
Zone 1 is a roughly triangular piece of land with the longest edge bounded by the heritage rail track that runs roughly northeast to southwest (Plate 2). A hedge of *Ieylandii* greater than two metres height and a chain link fence separates the site from the railway. At the northeast corner, Zone 1 meets Zone 2 at a tall metal access gate greater than two metres in height and securely locked. The north – south trending edge of the site is bounded by a wooden fence less than two metres height, in poor repair and with some panels partially fallen. Two to three metres from the fence is a drainage channel more than one metre wide and vegetated. The land to the far side is agricultural land currently in use as sheep pasture. The southerly edge of the site is also bounded by a similar wooden fence in poor repair, with a drainage channel separating the site from the agricultural land beyond, which is currently used for arable farming. At the southeast corner of the site, there is a confluence of three drainage channels, which demarcate the land parcels of three different owners. Anecdotal evidence indicates that the ownership boundary is at the centre of these channels.

Plate 2: Railway adjacent to site

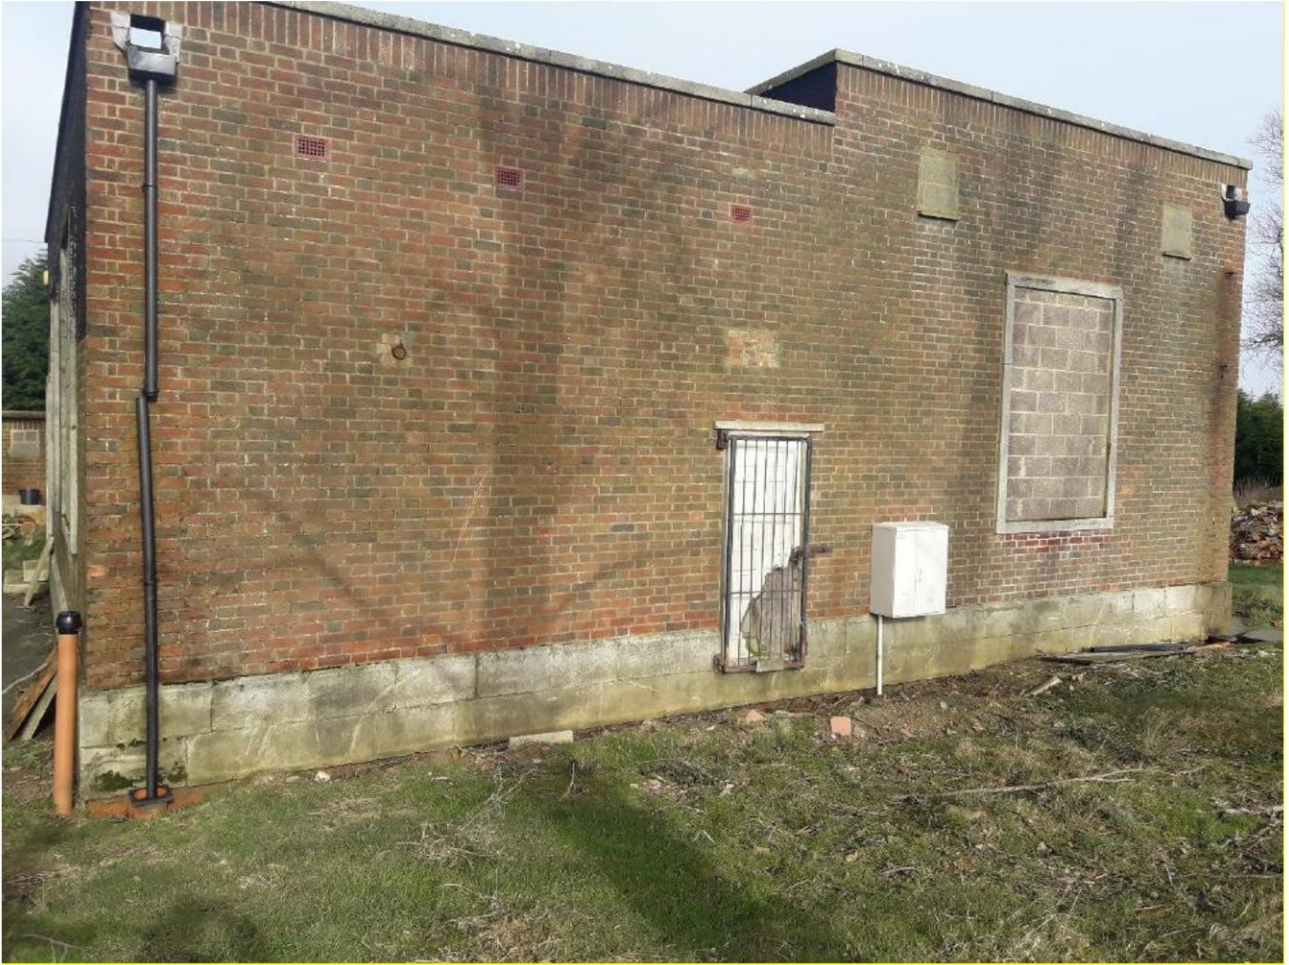
Within Zone 1 there is an existing brick building (Plate 3) in the centre of the site which was reported by the owner to have suffered some internal fire damage, although this was not evident from the exterior. An

Plate 3: Existing Building

It is recommended a Demolition or Refurbishment Asbestos Survey (previously known as a Type 3 Asbestos Survey) be undertaken prior to development, to reduce the risk of exposure to any asbestos present within the existing on-site building.

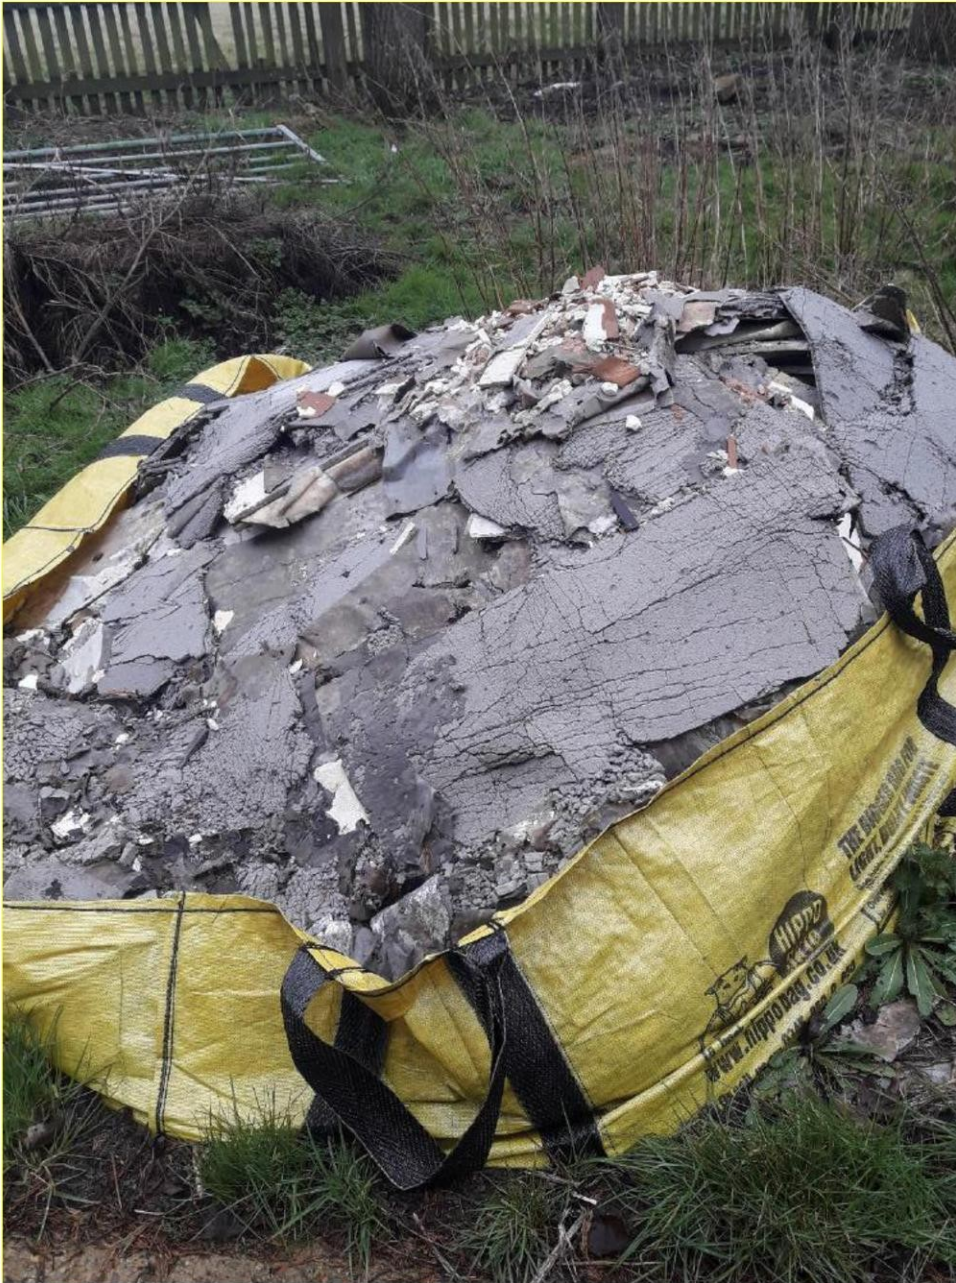
occupied mobile home was situated adjacent to the west of the building. To the northeast of the building is a strip of hardstanding leading from the building to the gate, and several stockpiles of materials including orange clay or terracotta tiles and bricks, large fragmented concrete blocks, engineering bricks, and recently felled tree limbs. Additionally, there were large rubble bags containing various materials (Plate 4) that were reported to have been brought temporarily on site for storage purposes. Nearby the stockpiles was evidence of a large bonfire (Plate 5) that included glass, clay beads, box files, plastic ducting, scrap wood and timber, and other general refuse.

Plate 4: Material stockpiles on site

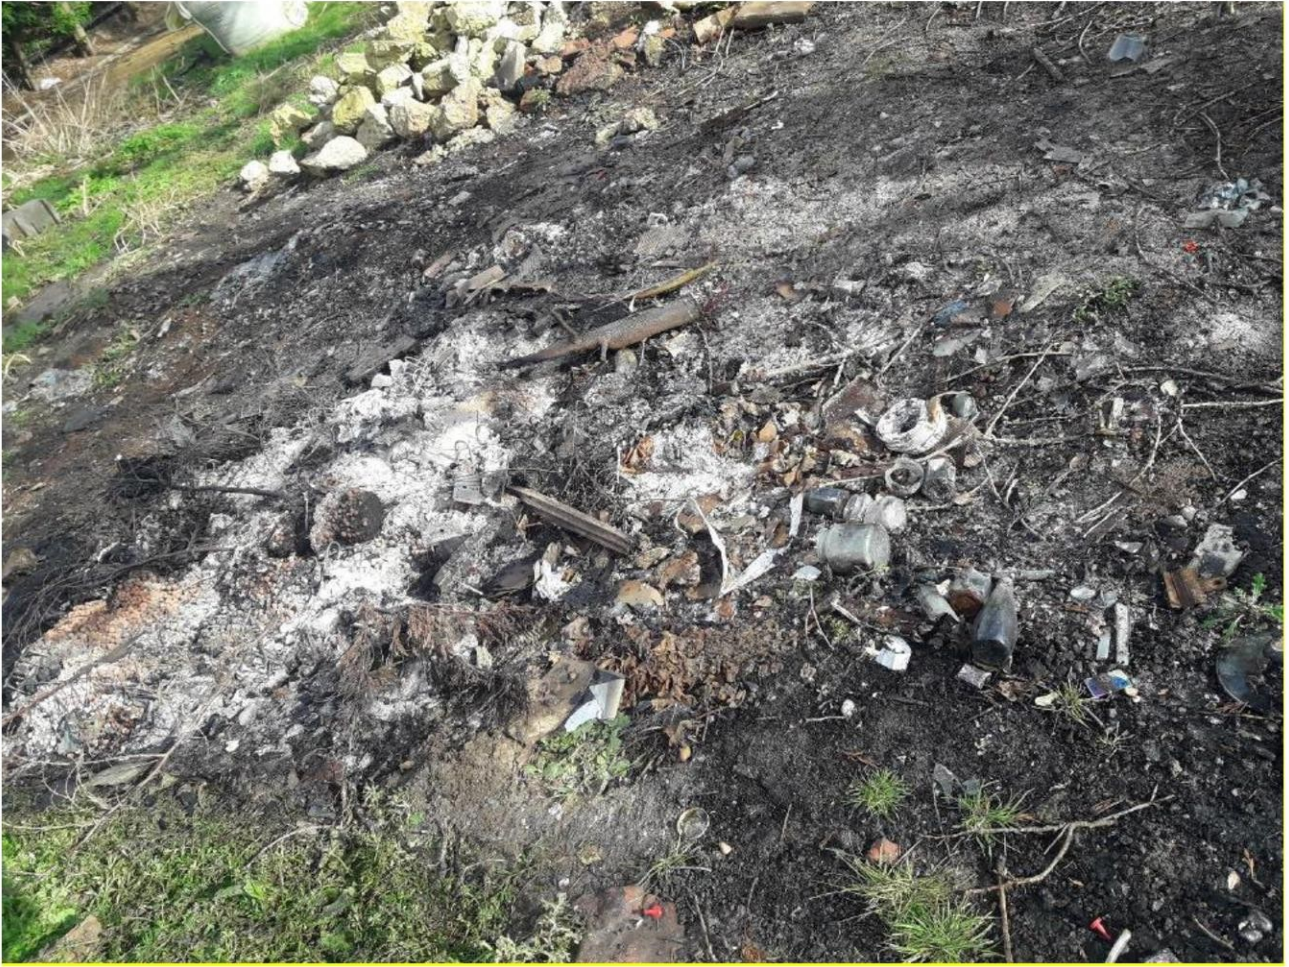
Plate 5: Area used for refuse fire

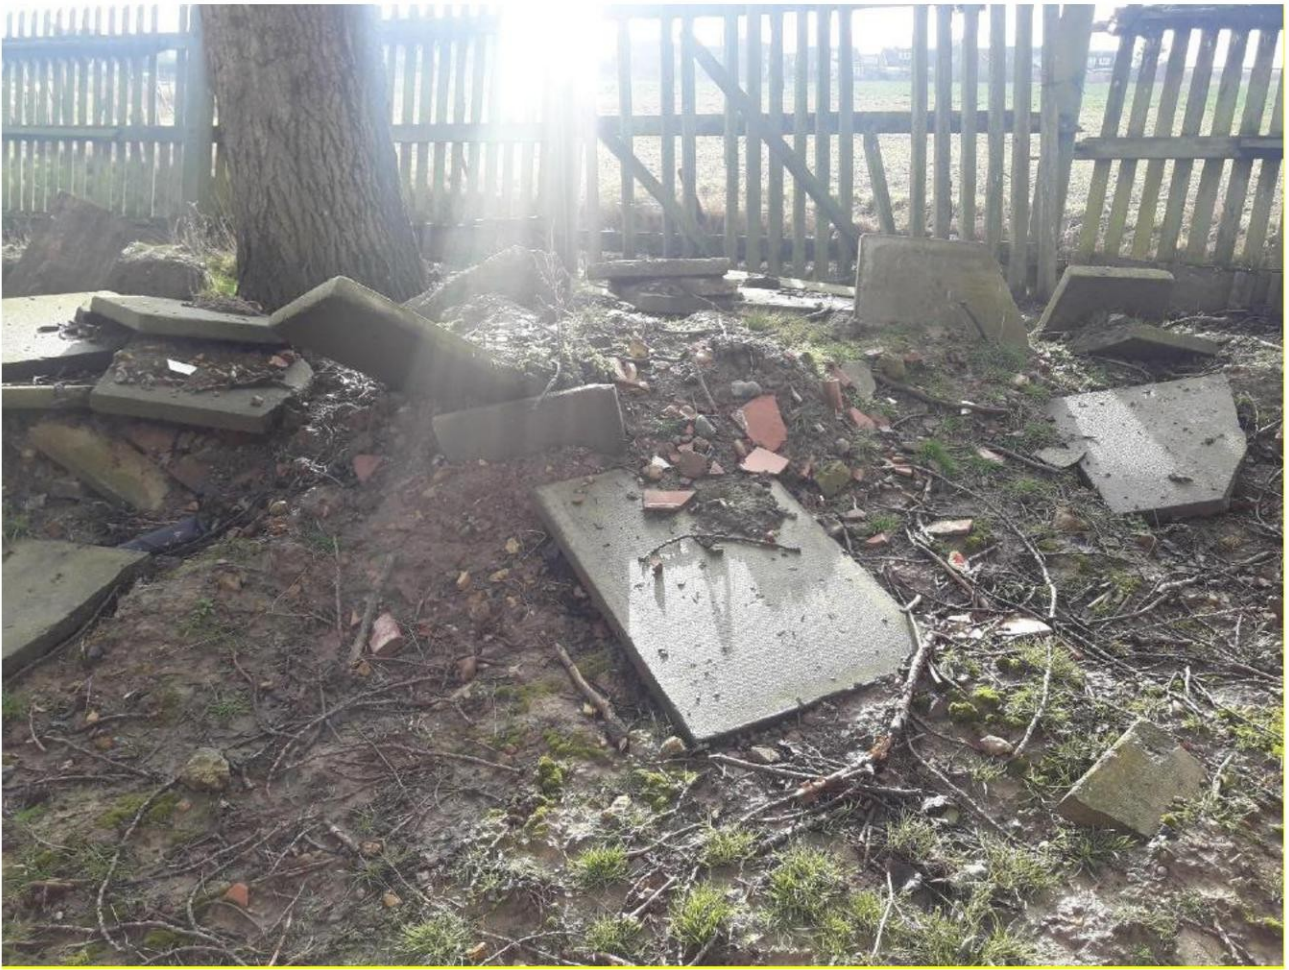
East of the building is an area of rough ground with concrete slabs, tiles and piping piled with the clay and gravel natural ground excavated from renovating services on the side of the building (Plate 6). Large flint gravel and cobbles are also evident throughout. A row of mature trees stand inside the fence line (Plate 7).

Plate 6: Rubble piles including concrete and brick

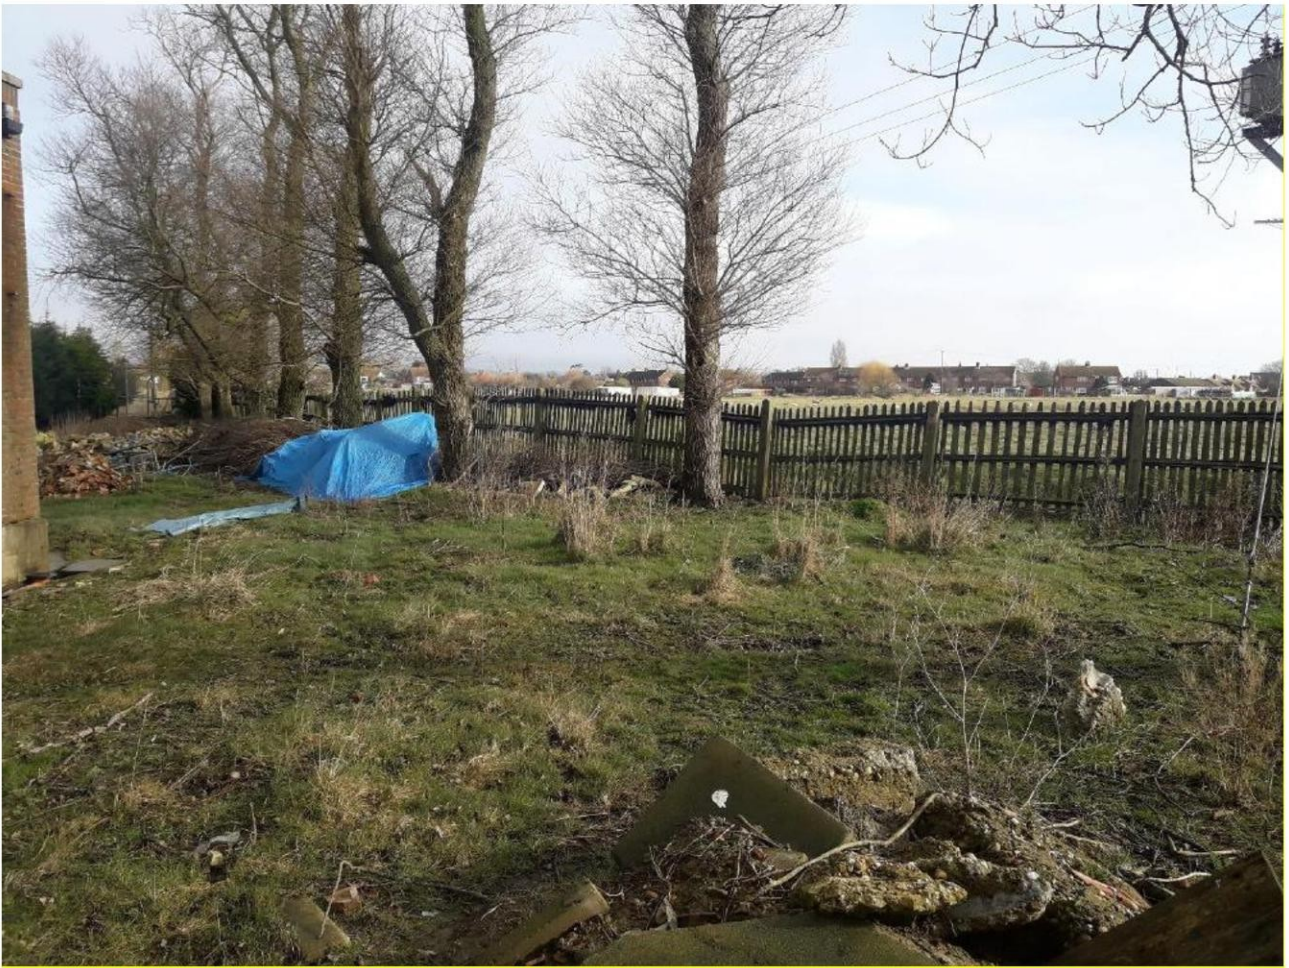
Plate 7: Mature trees along the fence line, plus concrete rubble and stockpiles of various materials

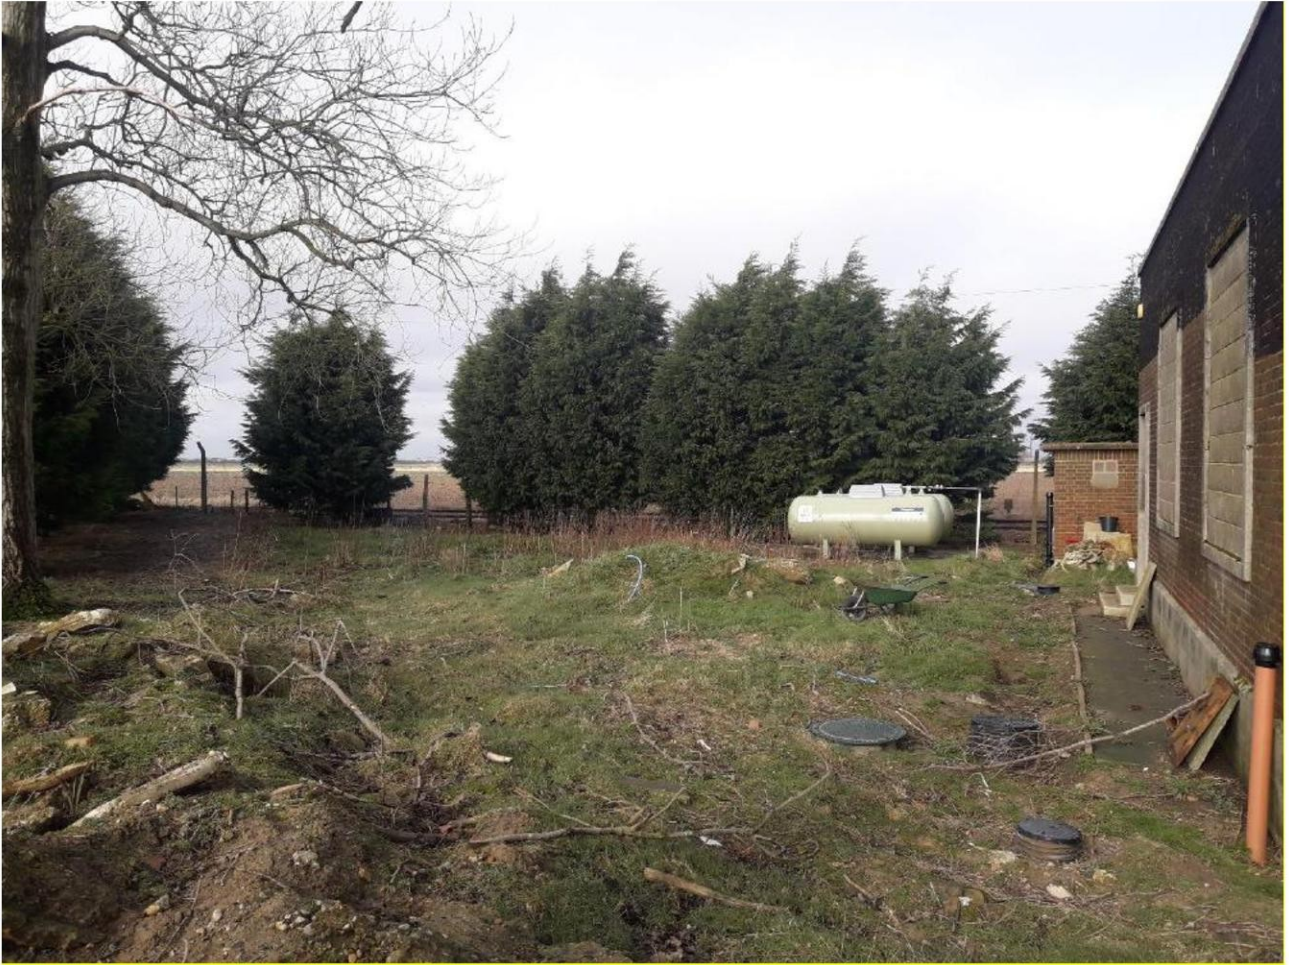
To the south of the building, a number of manhole covers were evident (Plate 8), one identified by the owner as covering the septic tank. Piles of concrete and excavated ground were again observed towards the fence line of the property (Plate 8). A strong sewage odour was noted in this area. The superficial ground was noted to be gravelly cobbly CLAY, with gravel of fine to coarse brown and rinded flint, ceramics and concrete fragments. Two gas tanks were situated to the south west of the building and looked to be in reasonable condition. To the south west boundary with the railway track, a small well cover is labelled "S V".

Plate 8: Proposed private garden area with visible services including septic tank. Railway track visible adjacent, propane gas tanks and additional rubble piles.

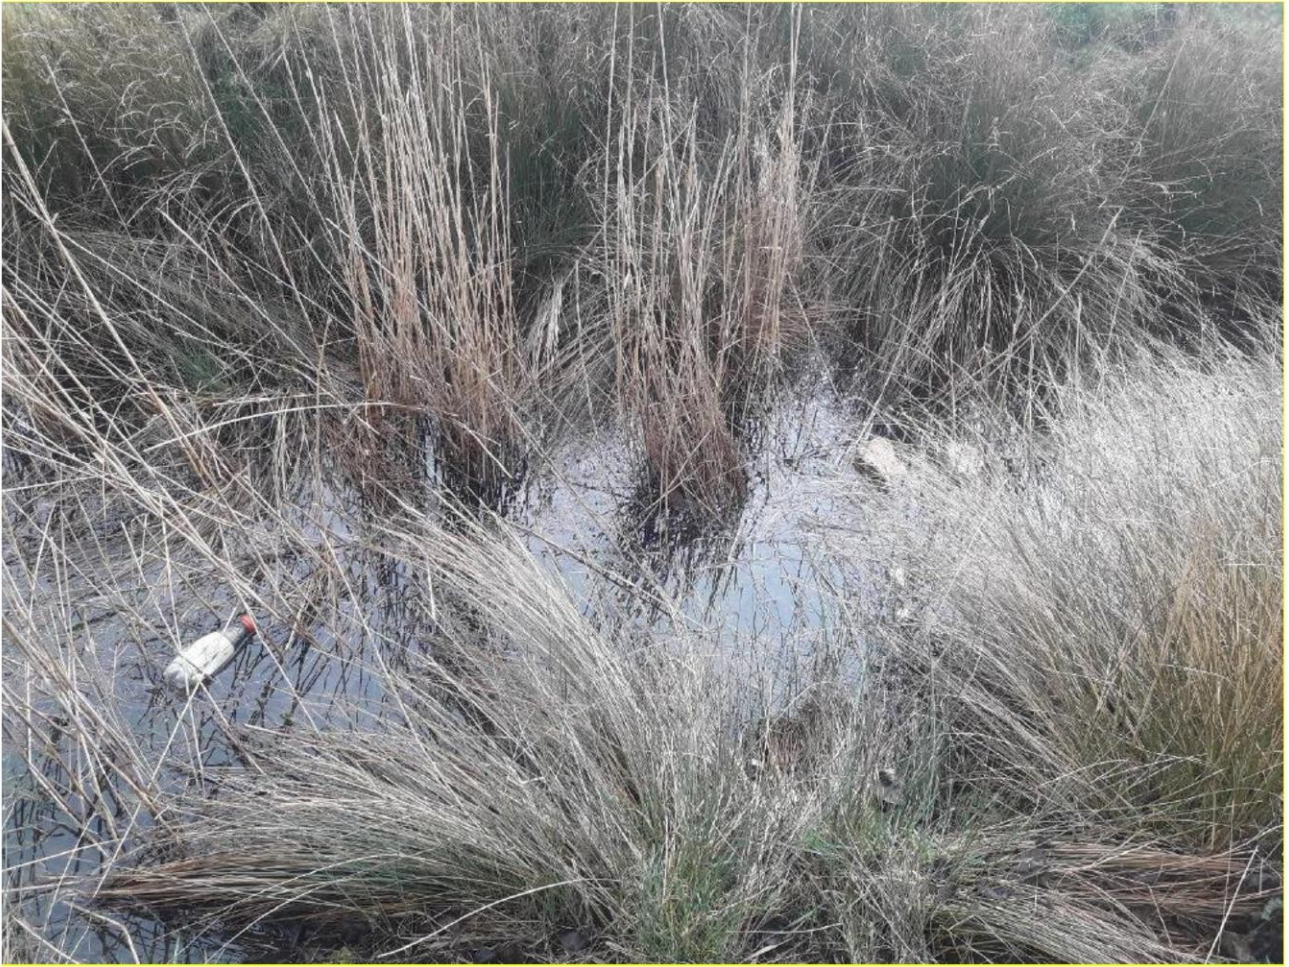
The drainage channels to the east were visually clean except for some minor plastic waste (Plate 9), the channel was vegetated within the channel and along the margins of the water, with algae also observed. Towards the confluence, both algae and aquatic plant density increased (Plate 10). The drainage channel to the south of the site was observed to host a higher density of algal rafts, up to half way along the length, where there was clear olfactory and visual evidence of sewage discharge into the drainage channel resulting in discoloured water, die back of aquatic vegetation and strong odour (Plate 11). The discharge appears to be sourced from the site, as the water discolouration was greatest at the nearside bank, and was accompanied by, foam, bubbles and disturbance of water. At the nearest fence line, there was a signage indicating the presence of an underground water pipe (Plate 12).

Plate 9: Drainage channel at eastern boundary of site.

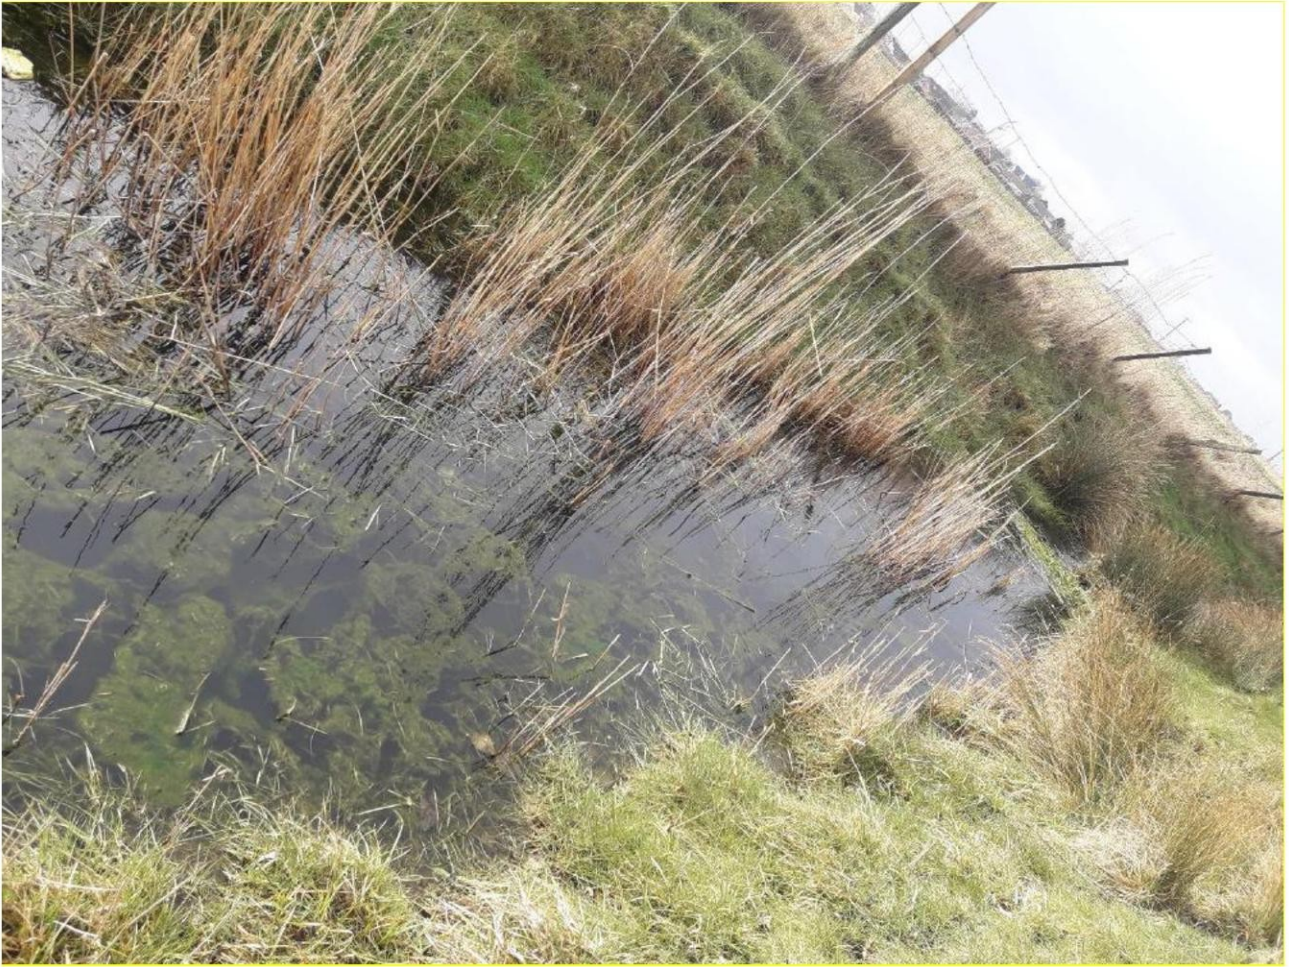
Plate 10: Algal blooms in drainage channel

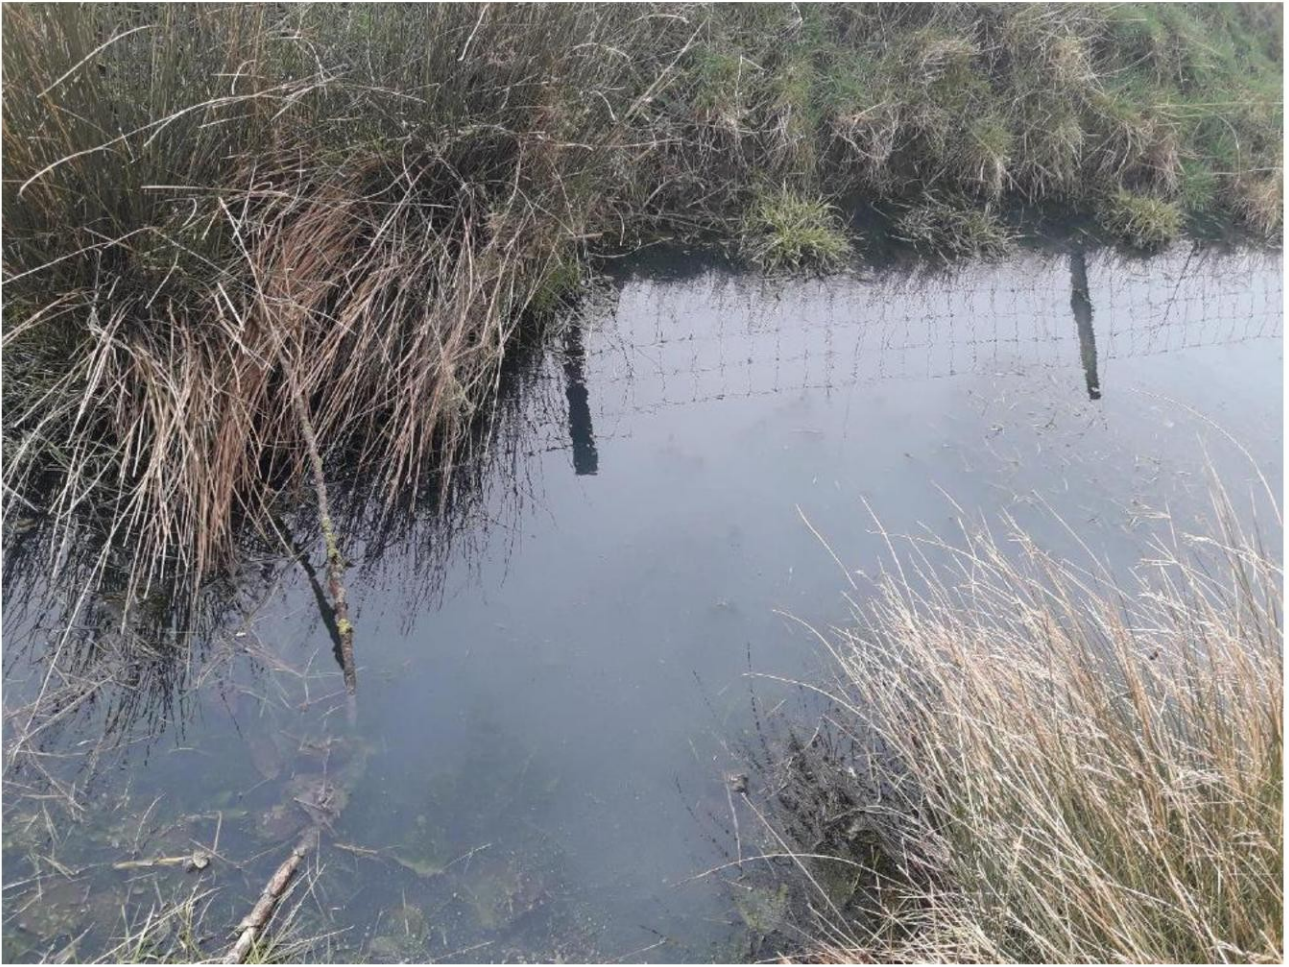
Plate 11: Visible discharge from site into drainage channel on southern boundary.

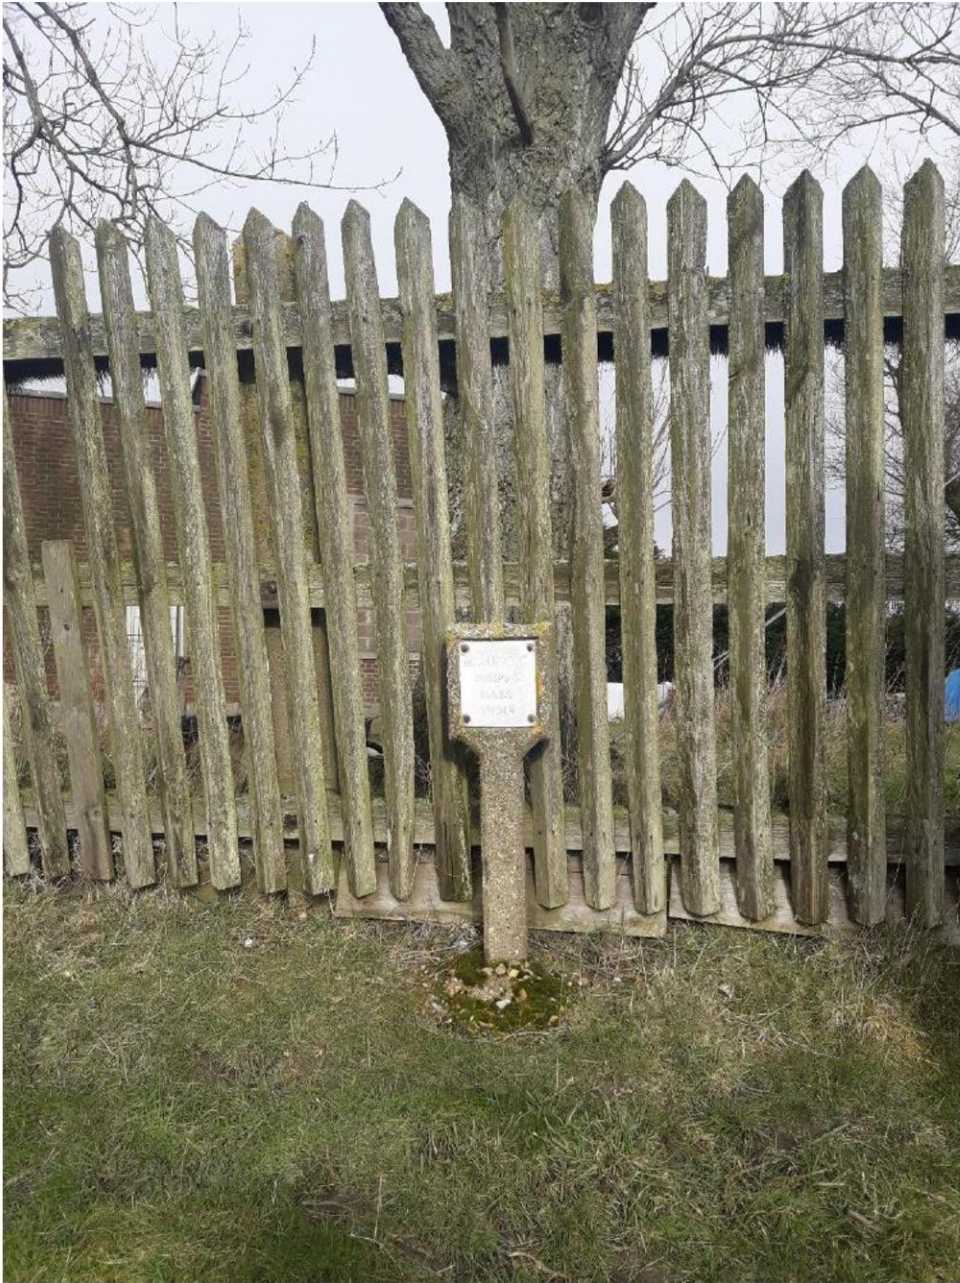
Plate 12: Water pumping mains marked near discharge point into drainage channel

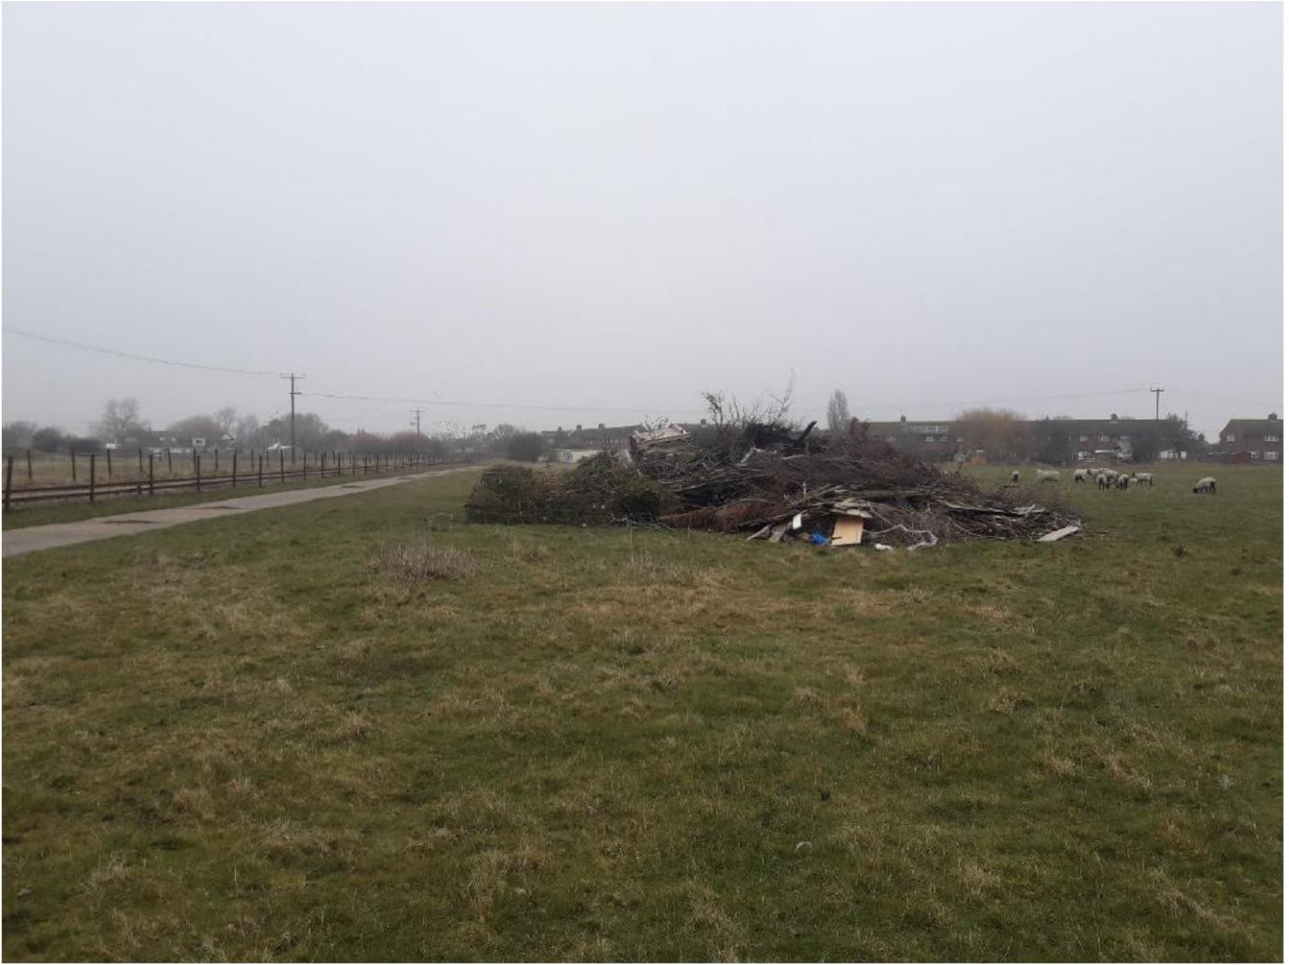
Zone 2 consists of the driveway leading from the gate to Zone 1, adjacent to the railway track, to the access gate leading to "Marshlands" residential road. It includes a one metre margin either side of the hardstanding access road, and a narrow strip of grassed area between the drainage channel to the north and the access road. A large pile of wood and wood-based materials, with other minor refuse, was noted adjacent to the boundary of Zone 2, outside the site (Plate 13) anecdotally described as a bonfire belonging to the neighbouring

Plate 13: Refuse intended for burning on neighbouring land.

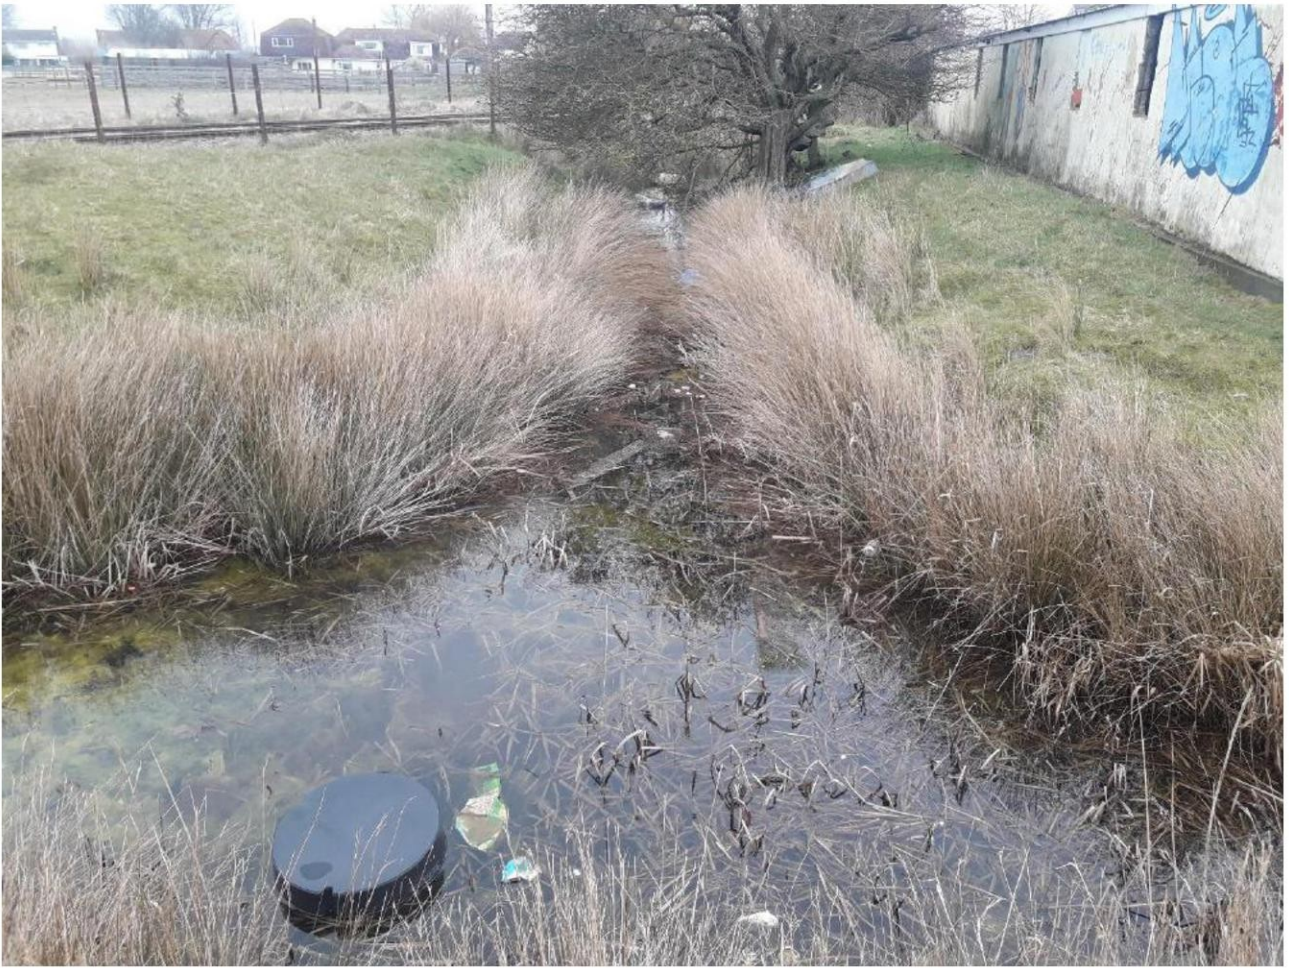
landowner. The access road was in good repair, with no evidence of hydrocarbon spills or residues, and there is no boundary fence separating the road from the pastoral land, allowing livestock to roam freely. The adjacent railway was devoid of vegetation and the boundary fence was observed to be in good repair. The drainage channel to the north of the access road had much aquatic vegetation and some algal floats visible. An unlabelled pipe traversed the channel (Plate 14) and plastic refuse was observed.

Plate 14: Drainage channel to the north of the site.
