# HORTON PRIORY GRANARY RESTORATION [REV A]

February 2016

HERITAGE STATEMENT & DESIGN AND ACCESS STATEMENT

Monks Horton

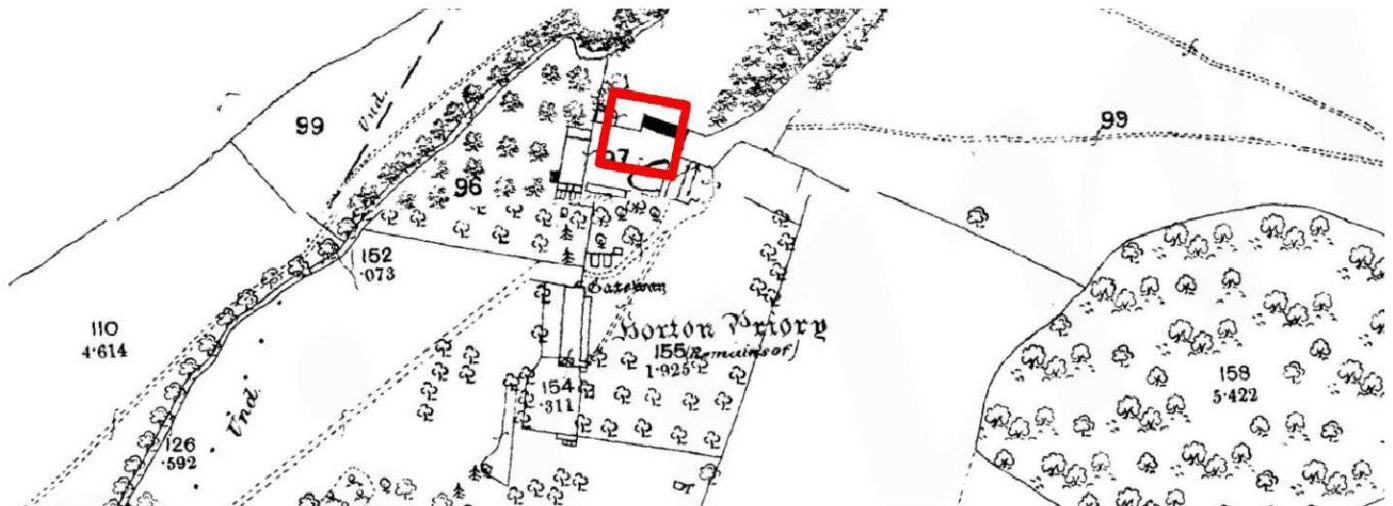
Fig.1: Site plan dating from 1870: Granary outline in red: Source EDINA maps

Information gathered from historic maps has shown that the granary building has existed on the site of Horton Priory since the late nineteenth century, erected sometime between 1870 and 1890 (see *fig.1* on opposite page).

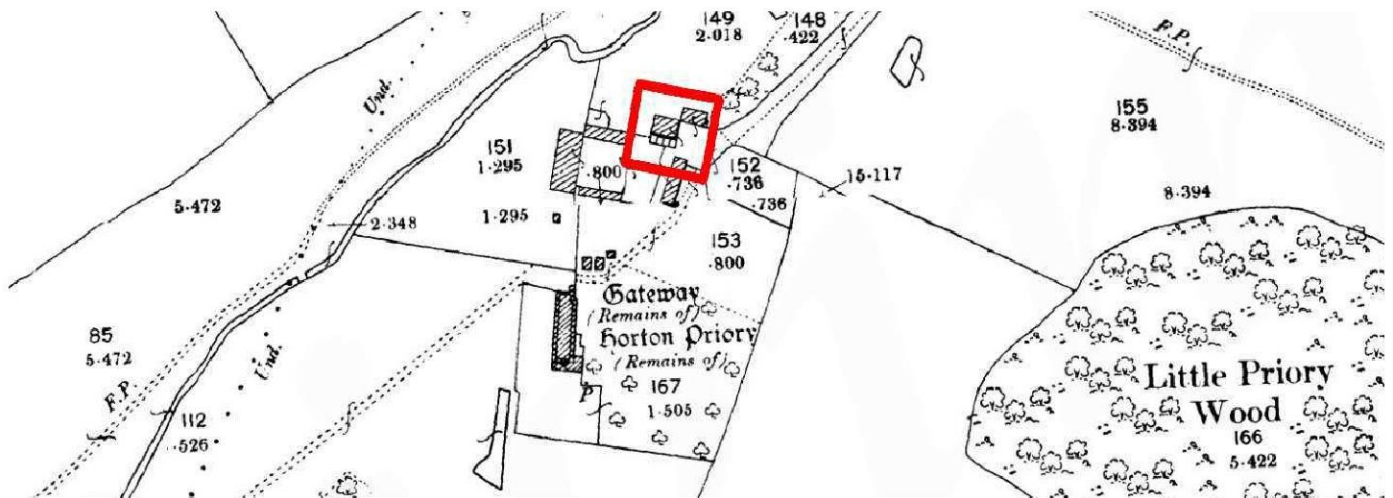
Fig.2: Site plan dating from 1890: Granary outline in red: Source EDINA maps

The building was part of a cluster of outbuildings to the north of the main property (see *fig.2*) used for farming purposes, as described in the Conservation Statement (see *appendix A*). The fields here were permanent pasture lands, providing ideal grazing for farm animals. The outbuildings are no longer present on the site plan from 1930 (see *fig.3*) which would suggest that they were removed from the estate sometime during the early twentieth century.

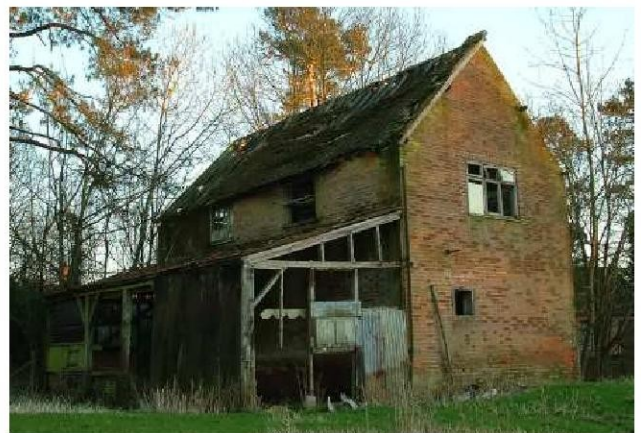
Archive photo of original granary, with adjoining timber outbuilding (2008)

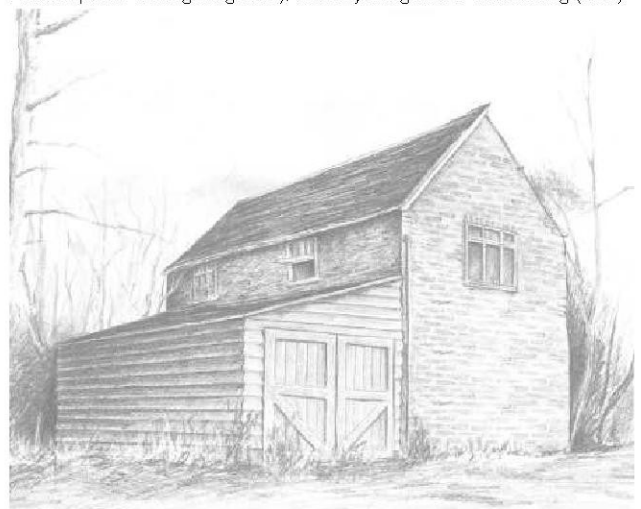
Sketch showing proposal based on original design

Outside, the timber framed, timber clad structure abutting the granary is to be rebuilt to provide external storage space. This space is to be used primarily for the storage of fertiliser and manure, used as part of the general upkeep. The space will be enclosed to protect the contents from the weather using timber cladding over a timber structural frame to match that on the south elevation of the building, as per the original design.

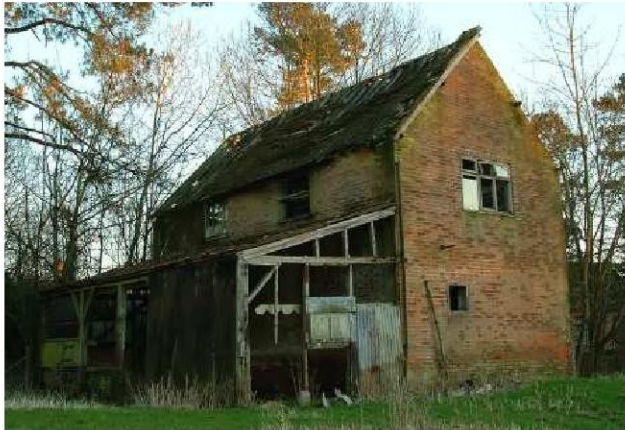
Showing original granary, with adjoining timber outbuilding

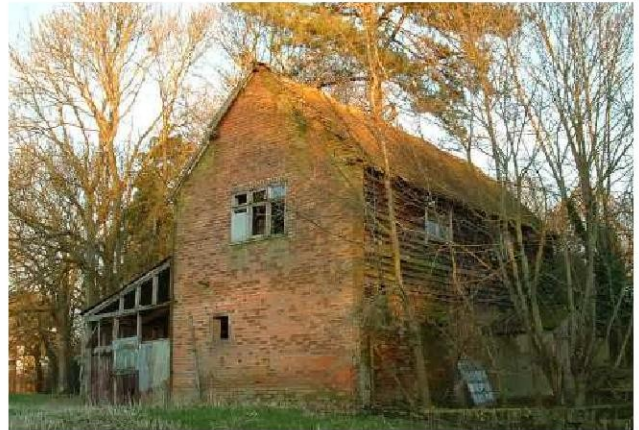
Showing timber cladding to granary's south elevation

All materials and finishes used in the reconstruction would match those present in the original building, typically a brick structure with timber cladding to the south facing facade.

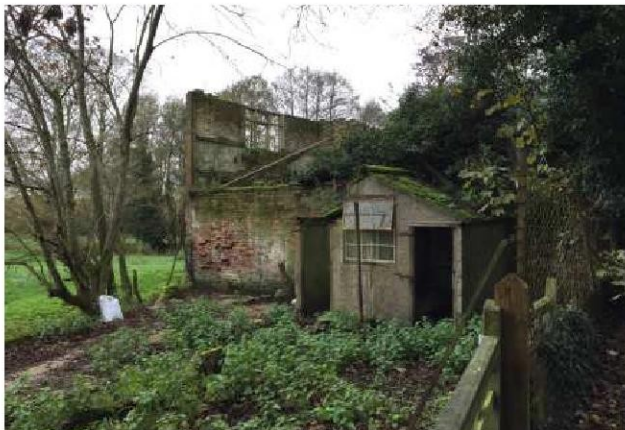
Front view showing current state of granary

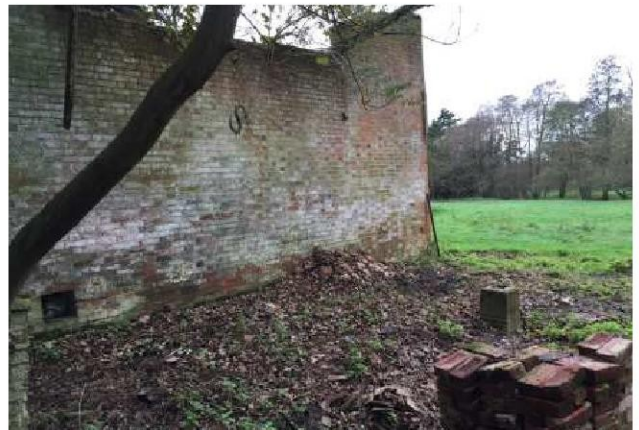
Rear view where timber framed structure used to sit

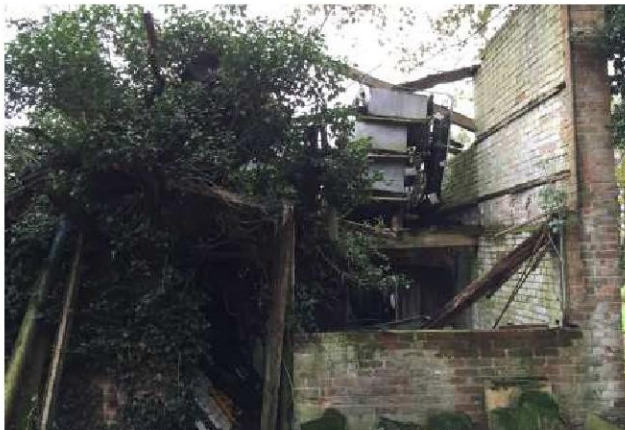
View showing collapsed roof

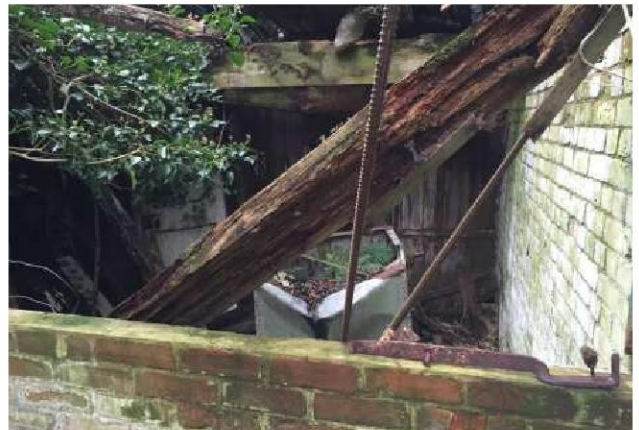
Debris resulting from collapsed roof
