**SITE AT ENCOMBE GARDENS, SANDGATE CT20 1DG**

**SITE INVESTIGATION AND SLOPE STABILITY REPORT**

**Reference: 1099/SI**

**18<sup>th</sup> May 2018**

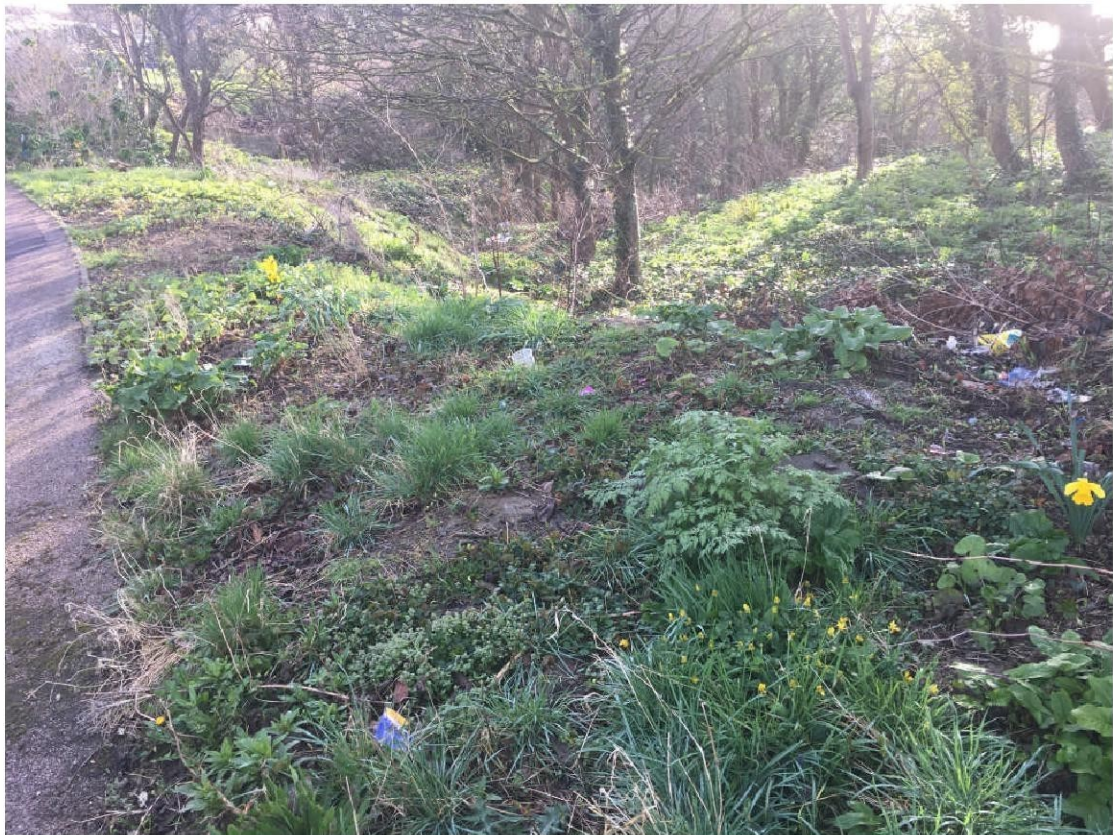
**Photo 2 Site from Encombe Gardens showing bent trees on slope**

3.2.4 Some trees were observed to be inclined or bent with an inclined lower trunk and vertical upper trunk, suggesting that the soils beneath the trees had slipped during the lifetime of the trees, estimated as 10 to 40 years. No signs of recent slips were observed but the Site was overgrown with low vegetation, making such observations difficult.

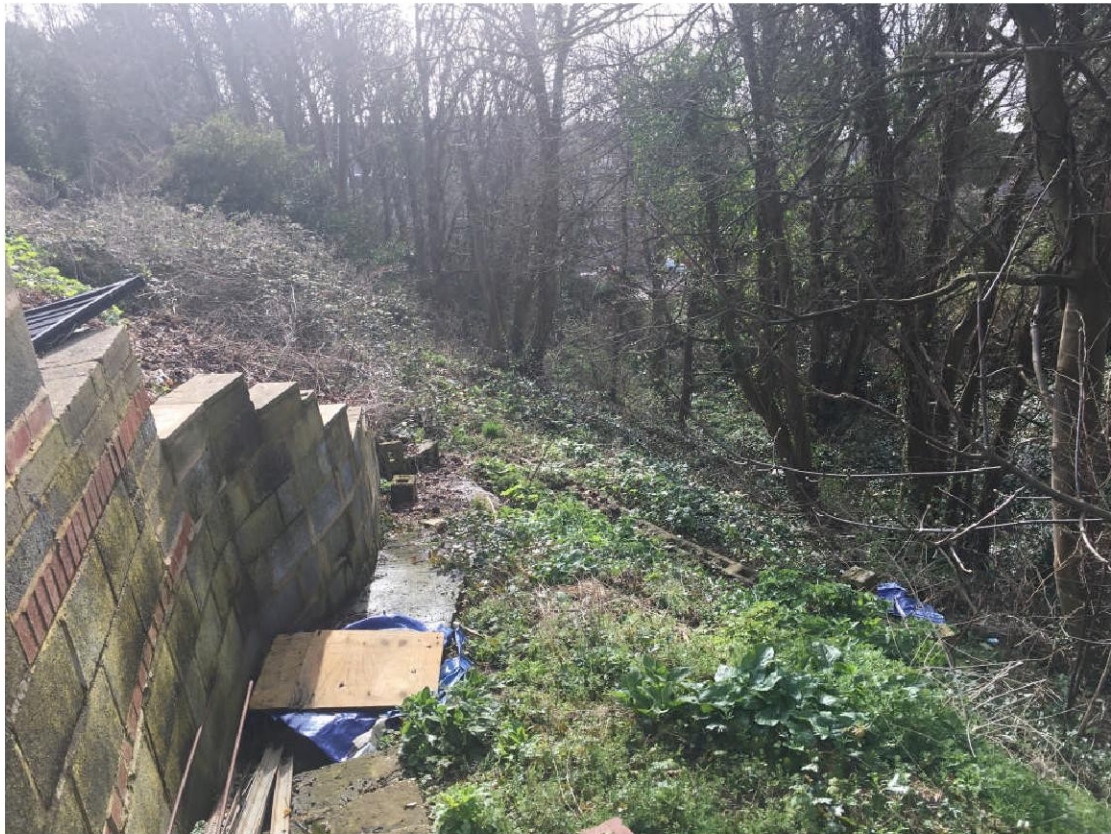
**Photo 3 Site from Encombe Gardens showing bent trees on slope**

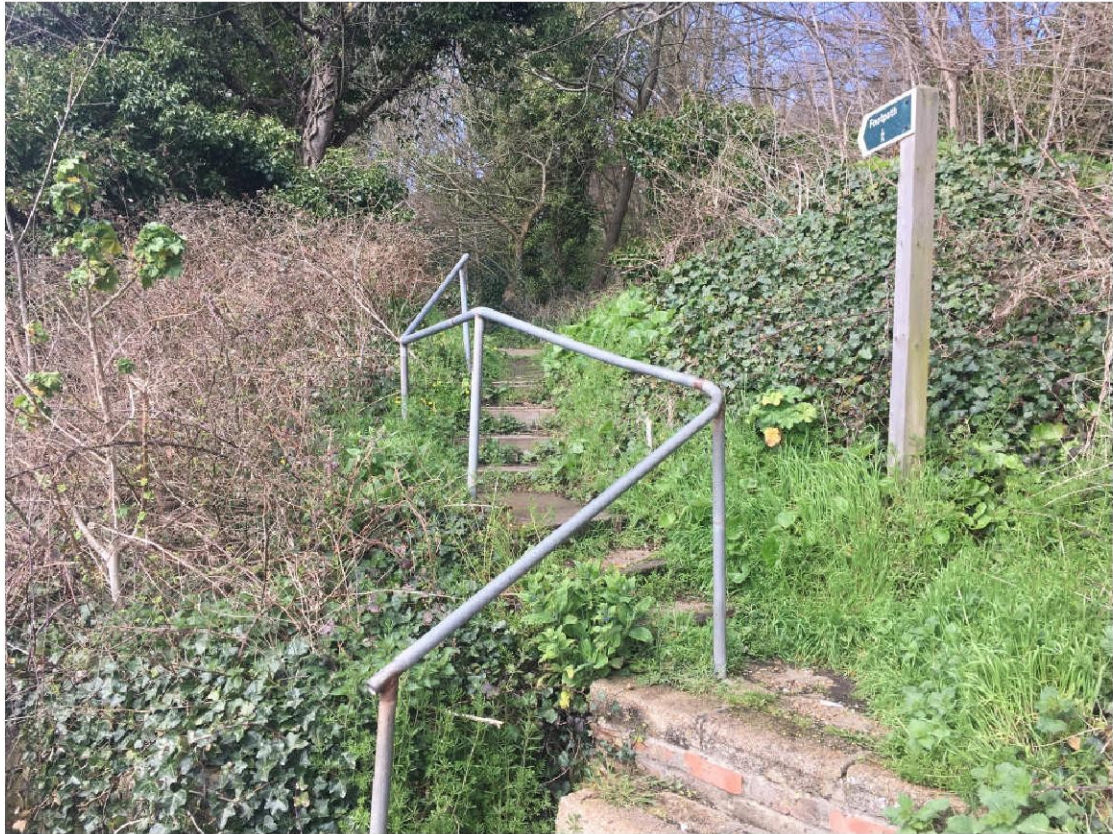
**Photo 5 Site from footpath illustrating level differences**

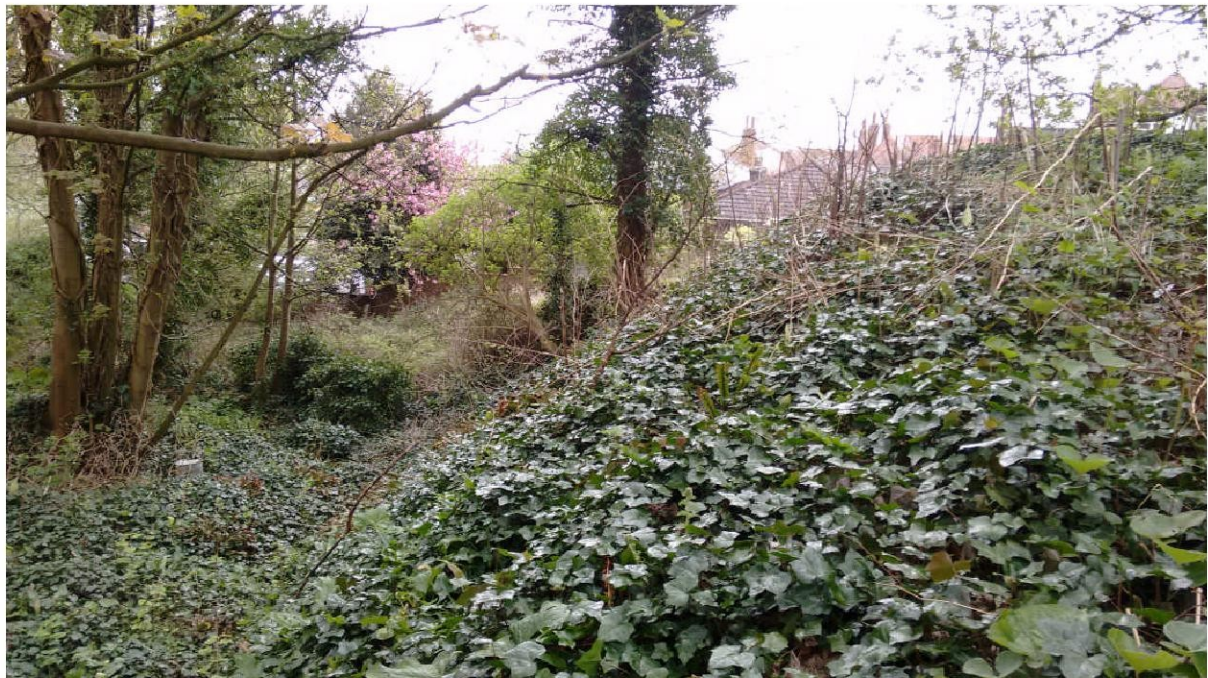
**Photo 6 Site showing 1 in 1.8 analysed slope**

- 5.1.3 These values were checked by incorporation in a slope analysis with a 4.5m high 1 in 1.8 slope, which from inspection of the survey presented in Appendix F, was a typical slope of the bank between the upper and lower levels of the Site. This bank was assumed to be close to failure, with a factor of safety of 1.0. The analysis gave a factor of safety of 1.04, which is considered to verify the strength parameters adopted for the slipped material.

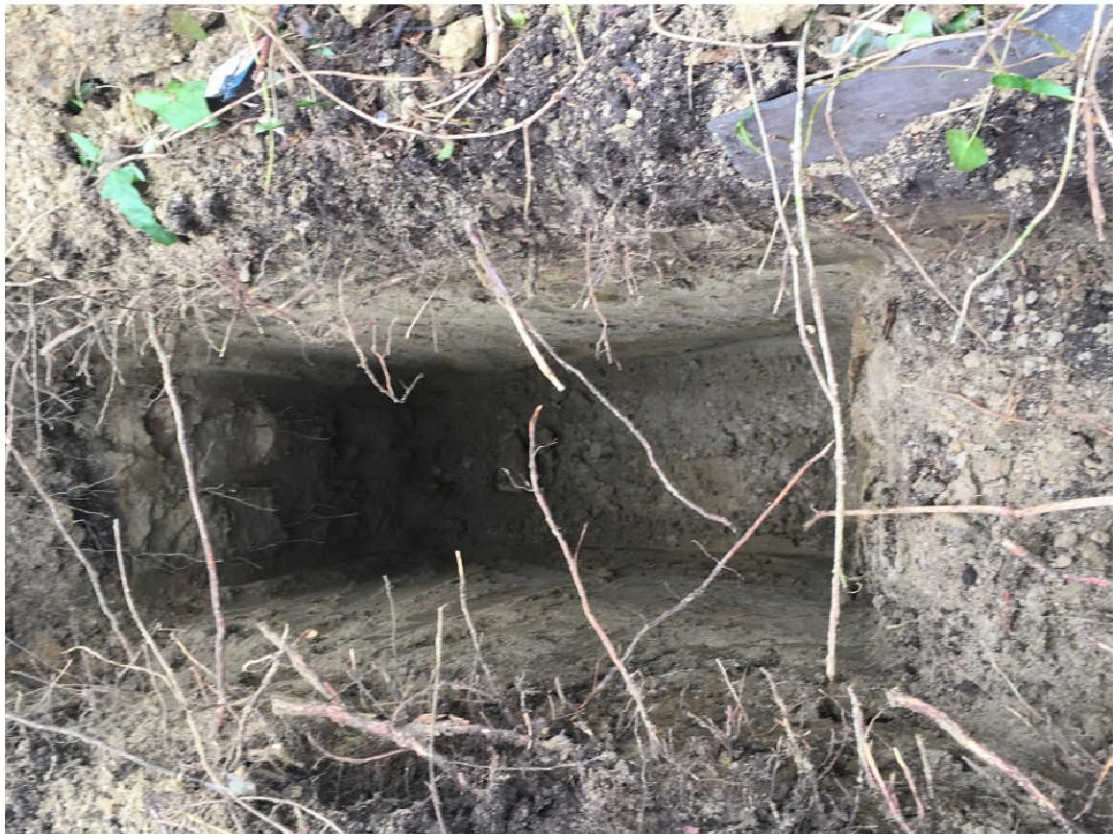
**Typical trial pit**
