# Preliminary Factual Geotechnical Site Investigation Report - Draft

Land Adjacent to Brandet House  
Brenzett  
Romney Marsh  
TN29 9UG

Ref: 3410 19 11 08 Rpt 01 Rev A NA GS

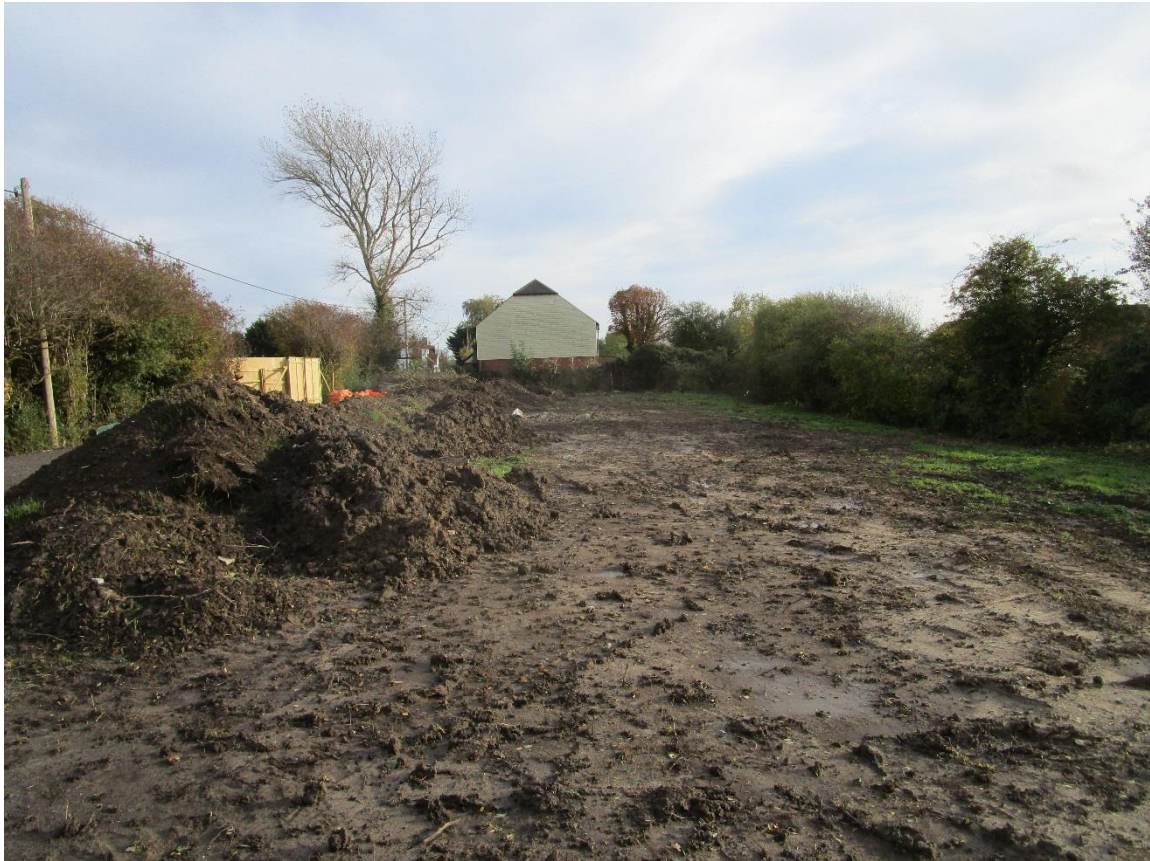
Photo 1 – View of site looking south

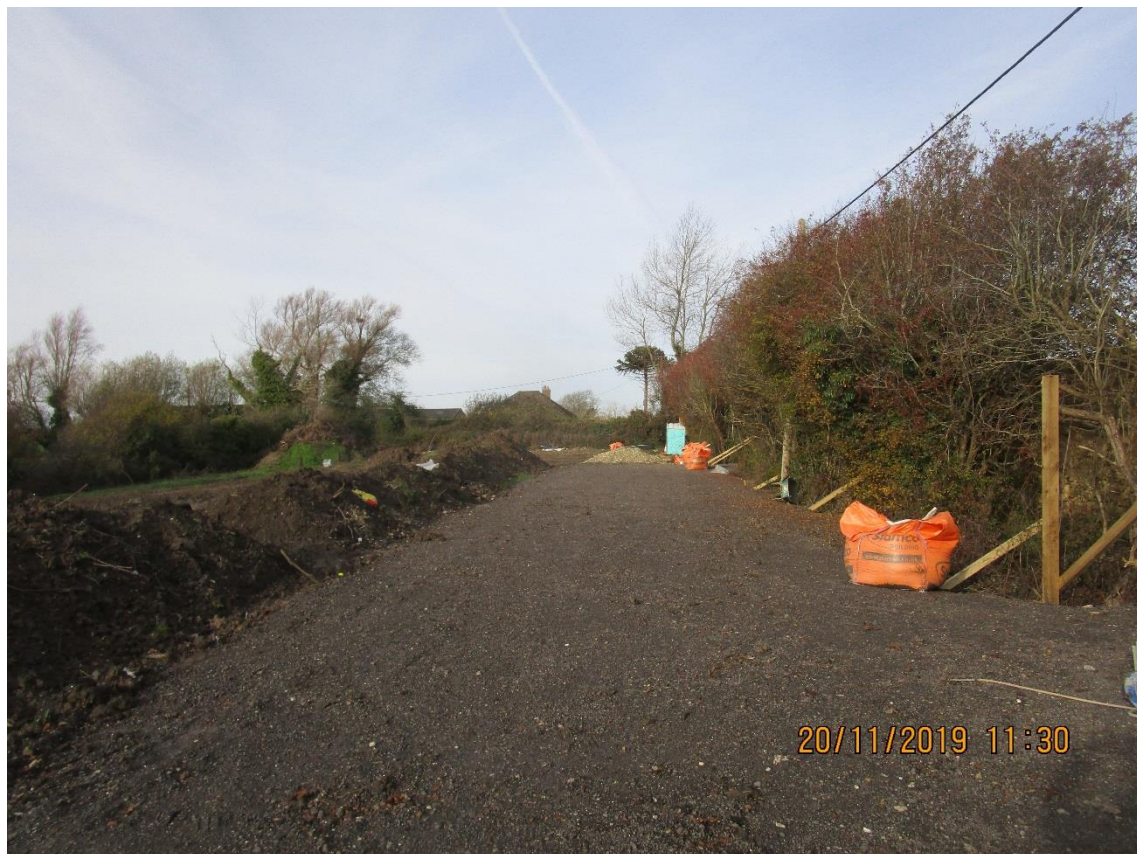
Photo 2 – View of the temporary access road looking north

- 1.4 The site comprised a vacant plot of land which formed a rectangular shaped plot see Appendix A Figure 2 for Existing Site Layout Plan). At the time of our investigation vegetation which previously covered the site had been removed. A temporary access road had also been constructed along the north eastern boundary of the site. The proposed development is understood to involve the construction of 6 no. residential properties with associated gardens and parking (see Appendix A Figure 3 for Proposed Site Layout Plan).

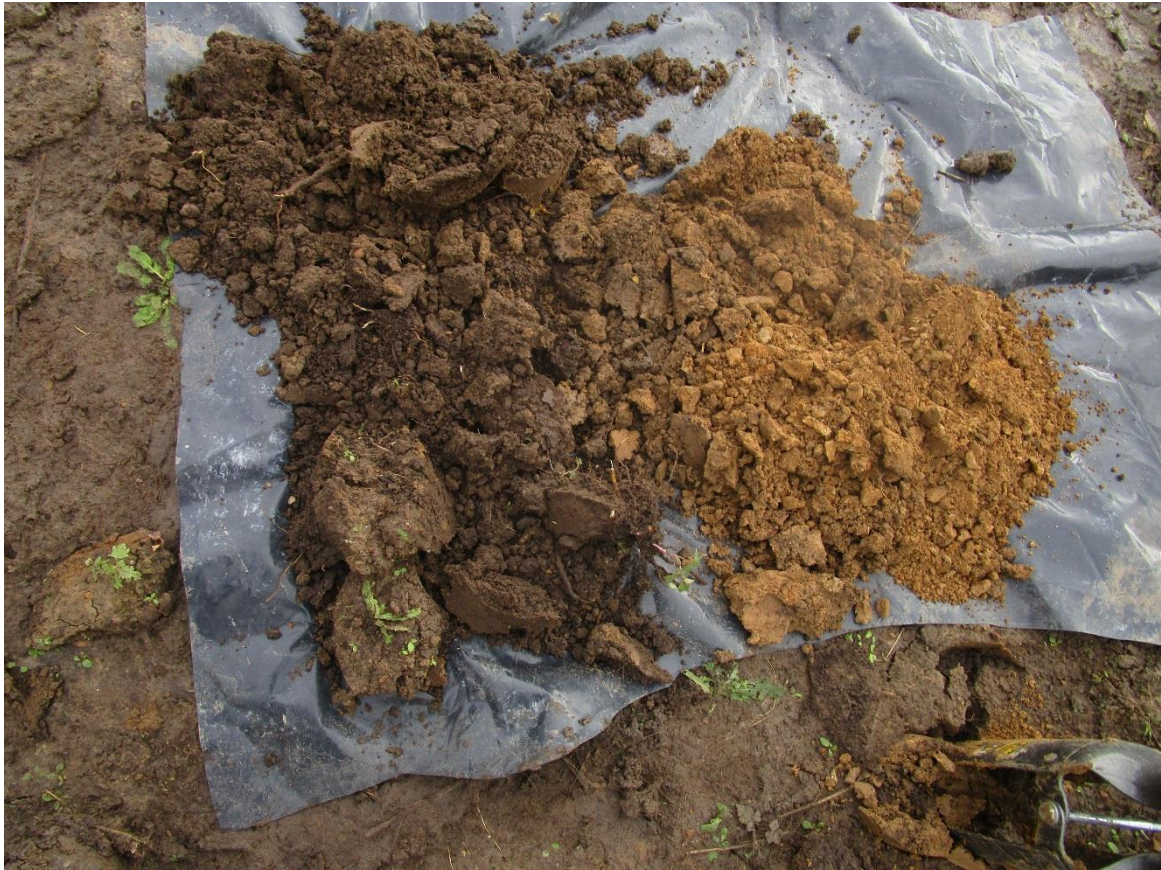
Photo 3 – Soil arising from HP01 between 0 – 5m bgl

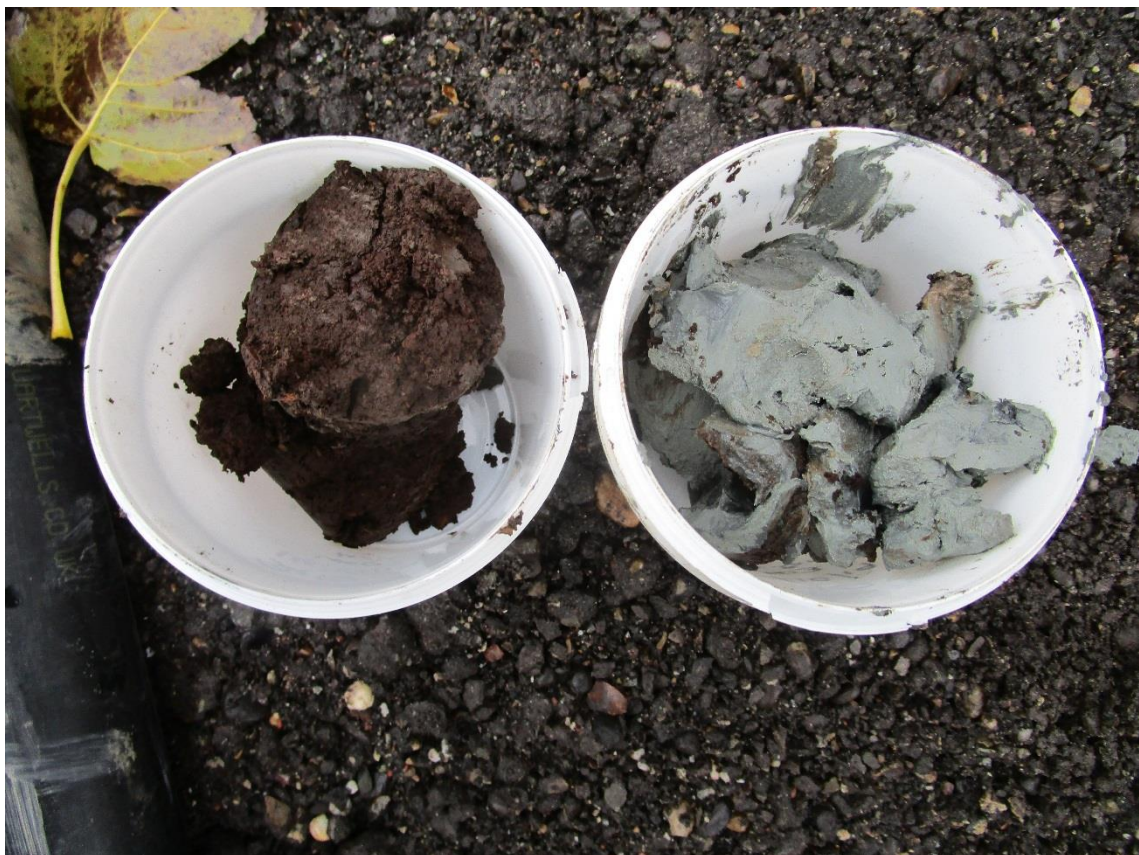
Photo 4 – Disturbed samples from WS03

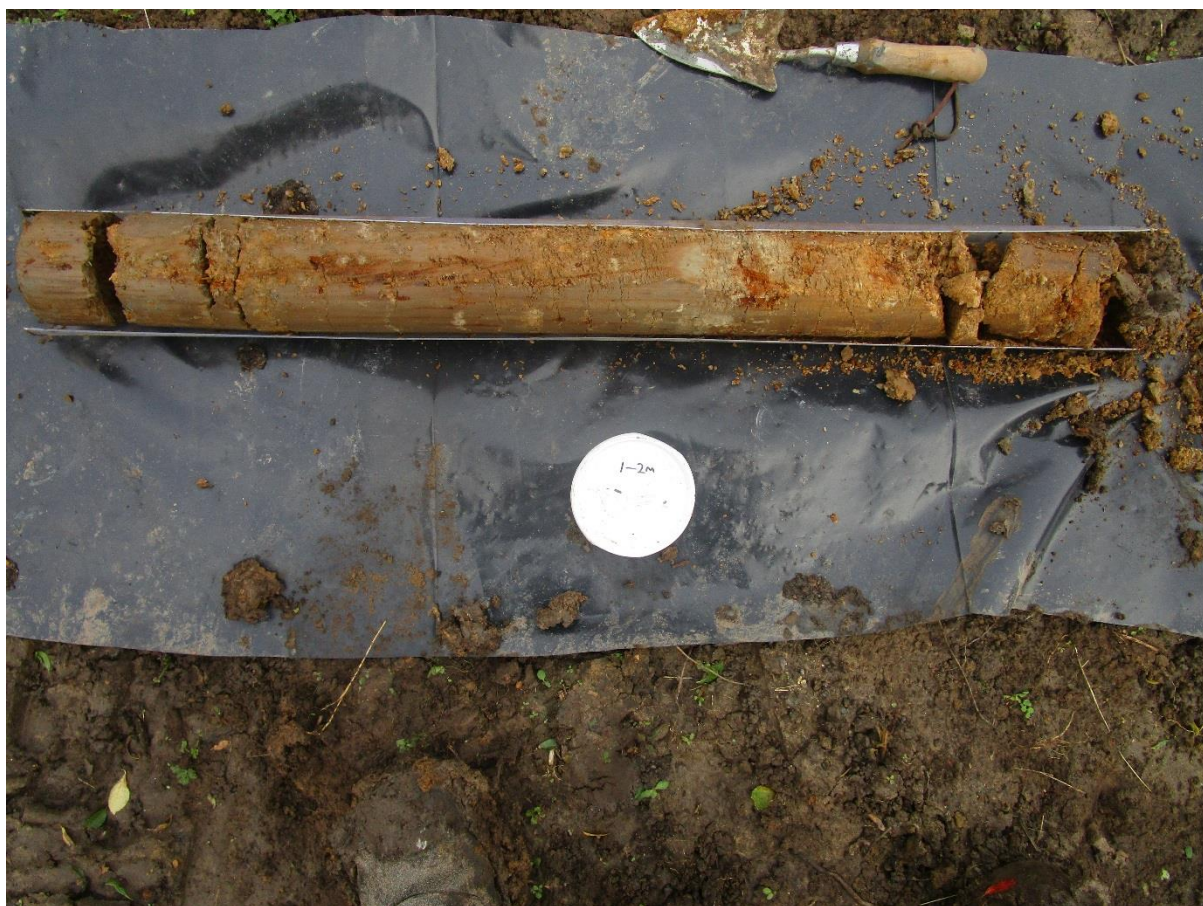
Photo 5 – Soil core sample from WS02 between 1.0m and 2.0m bgl
