# **19 Naildown Road, Hythe**

Material to Discharge Conditions 12, 18 & 19

Bioscan report ref: E2094r1

Planning consent ref: 20/1784/FH

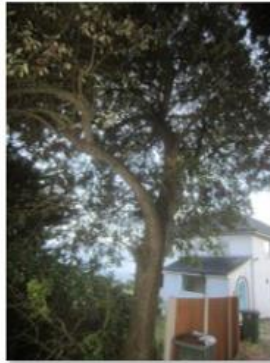
IMG\_0538 Tree 2

- Oak tree 1 had a number of wounds low down, but, on closer inspection, it was seen that none led to any cavity. A bird box was present on this tree.
- Oak tree 2 had a limb tear-out wound low down, but, on closer inspection, it was seen that it didn't lead to any cavity.

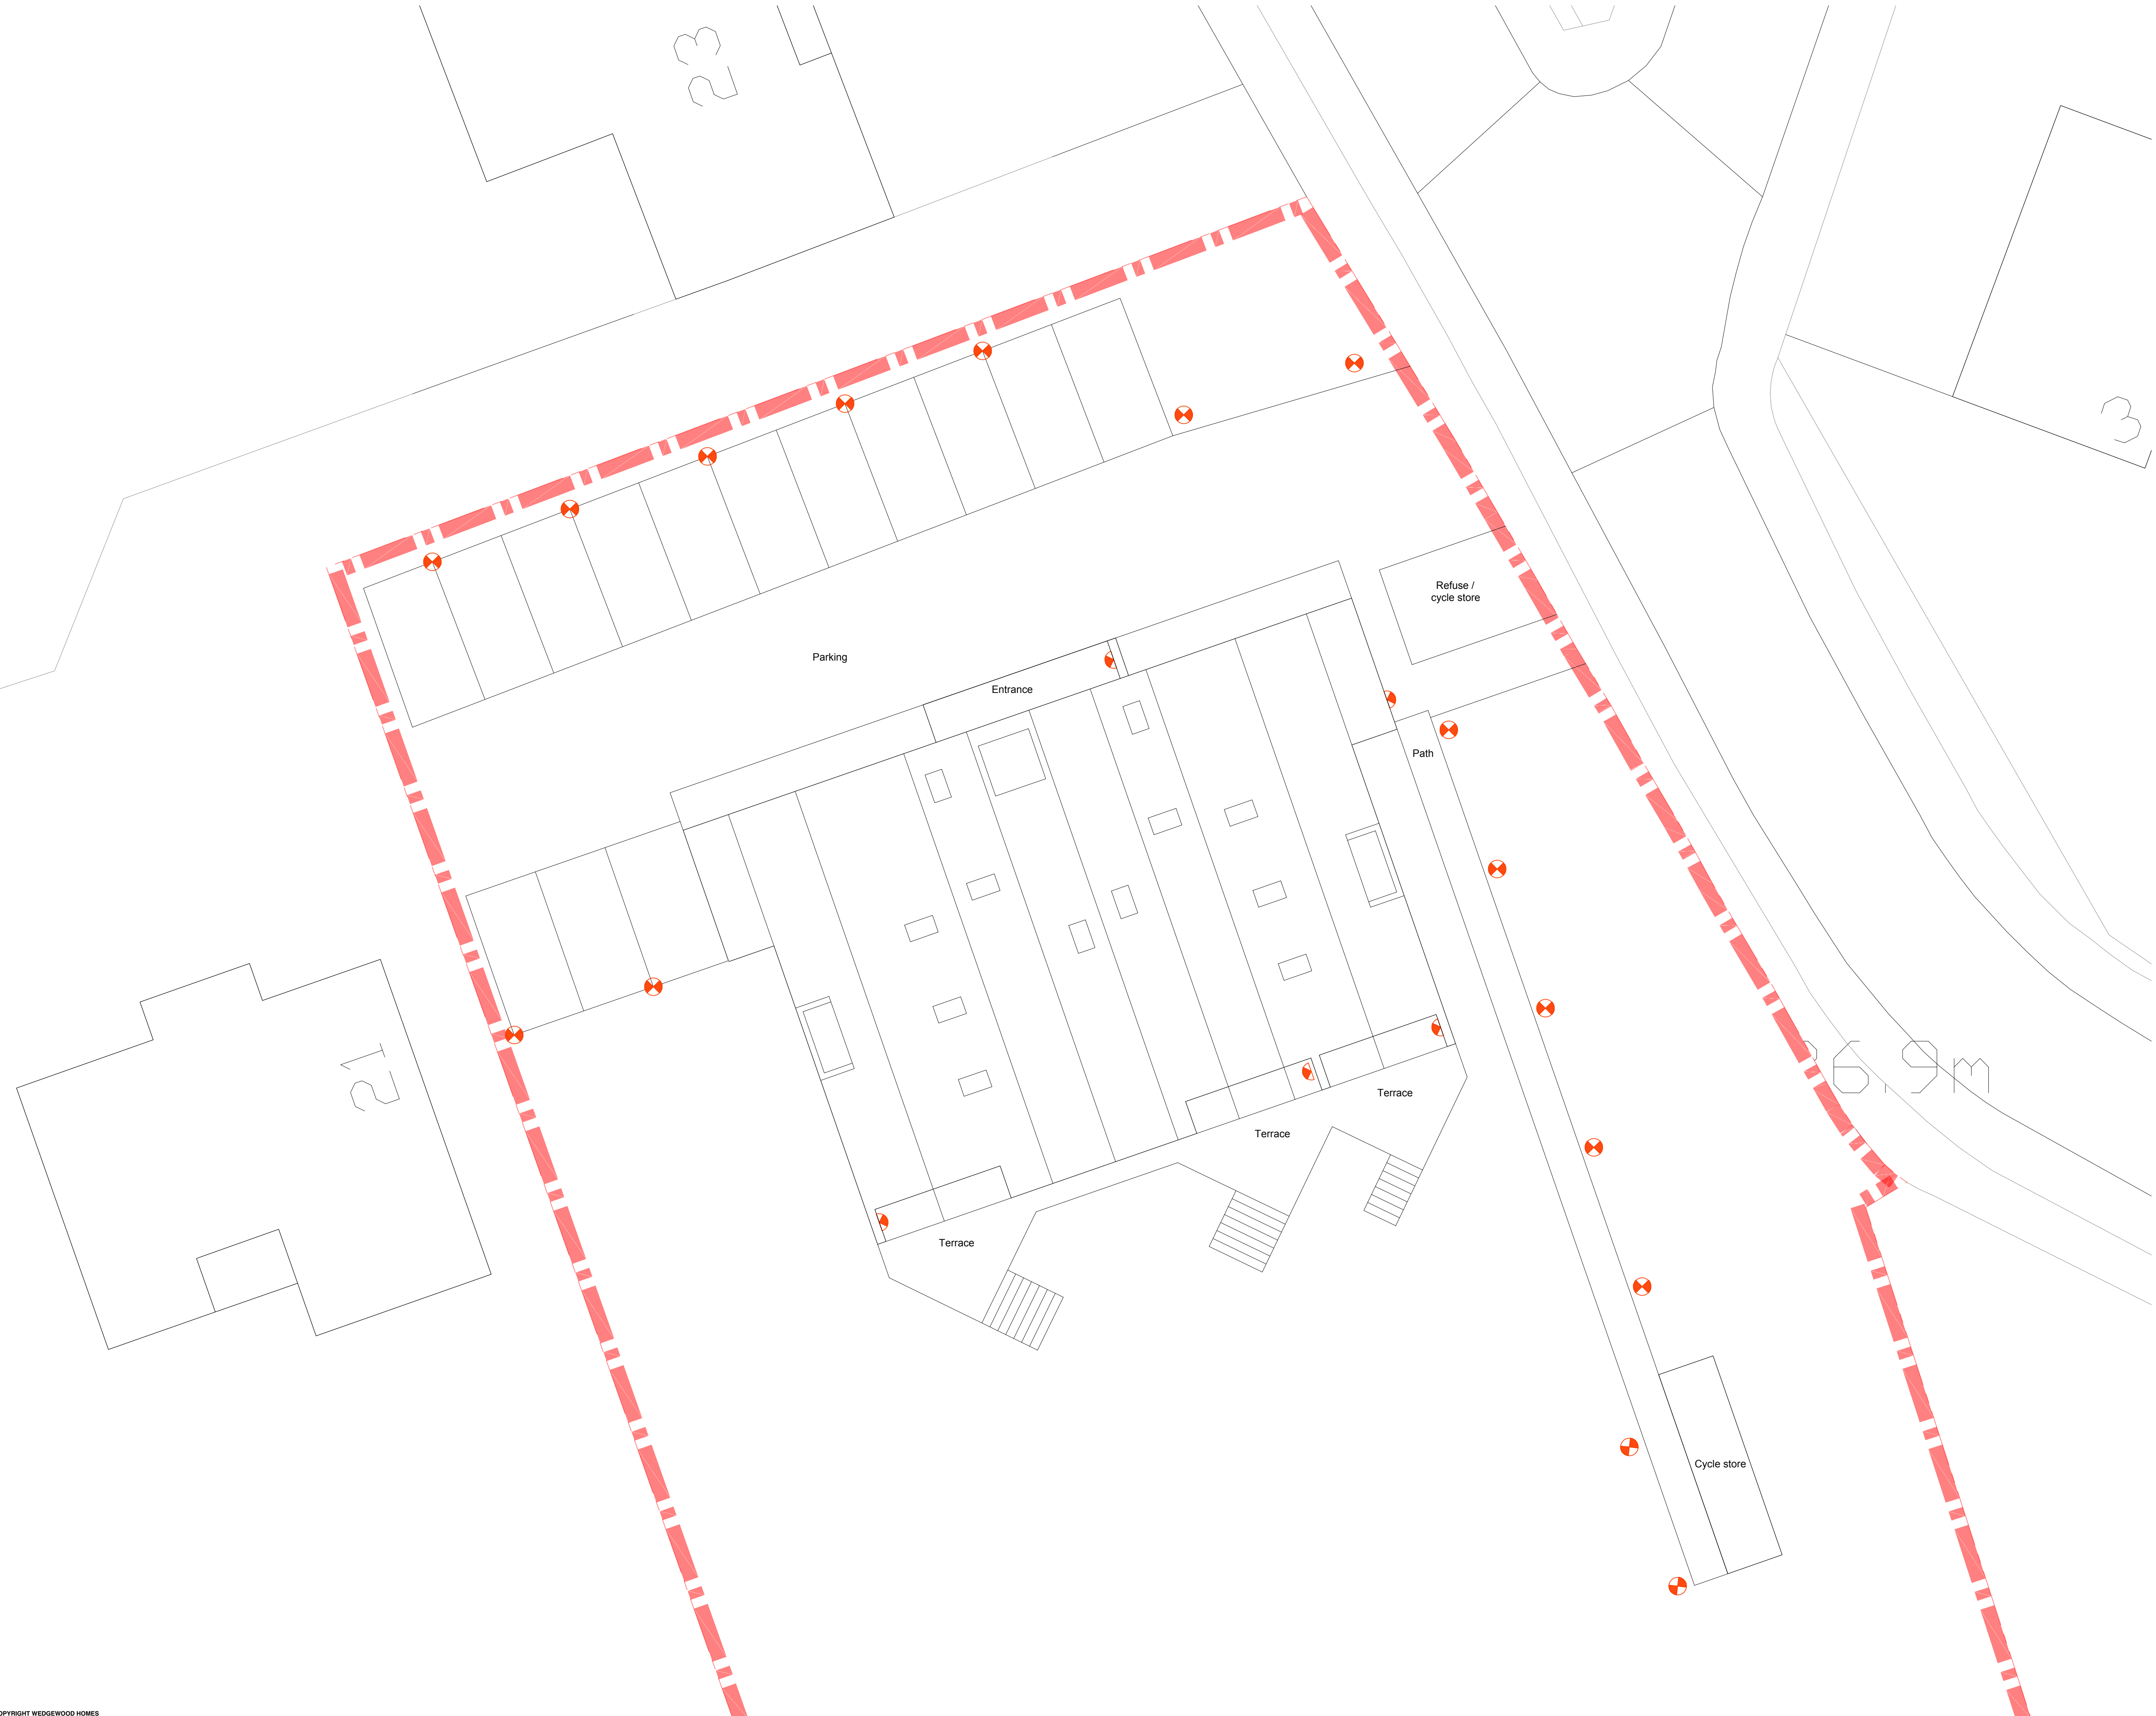
| Rev. | Desc. | By | Date |
|---|---|---|---|
| <b>SCALE</b><br>1:100 @A1 | | <b>DRAWING NO.</b><br>AA / 000 / 0103 | |

| Rev. | Desc. | By | Date |
|---|---|---|---|
| <b>PROJECT</b><br>19 Naildown Road<br>Hythe | | <b>DRAWING TITLE</b><br>Site Plan<br>Proposed External Lighting | |

- 4.2.1** The proposed lighting strategy is included at Appendix 2. Two types of external lighting are proposed: Wall lights (see Appendix 3) and bollard lights (see Appendix 4). In both instances their design means that they direct light downwards towards the ground where it is needed. They also have a relatively low colour temperature. This has been shown to have less of an effect on bats compared to higher colour temperatures.
- 4.2.2** Given these factors, the proposed lighting it is considered unlikely to have a significant impact on bat activity.

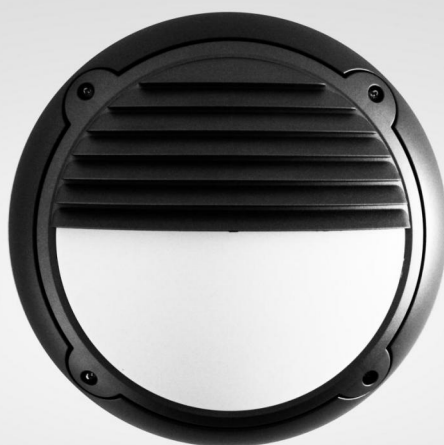
ASD Lighting Horizon Round Louvre 353mm, Black, Premium Opal, IP65/IK10, 3000K. 353mm Diameter, 122mm Depth, Body: 283mm vandal resistant polycarbonate with self-extinguishing fire properties, Diffuser / Fascia ring: Vandal resistant polycarbonate in opal with self-extinguishing fire properties.

| Colour | Black |
| Diffuser | Premium Opal |
| CCT | 3000K |
| System Power | 15.7W |
| Delivered Lumens | 806lm |

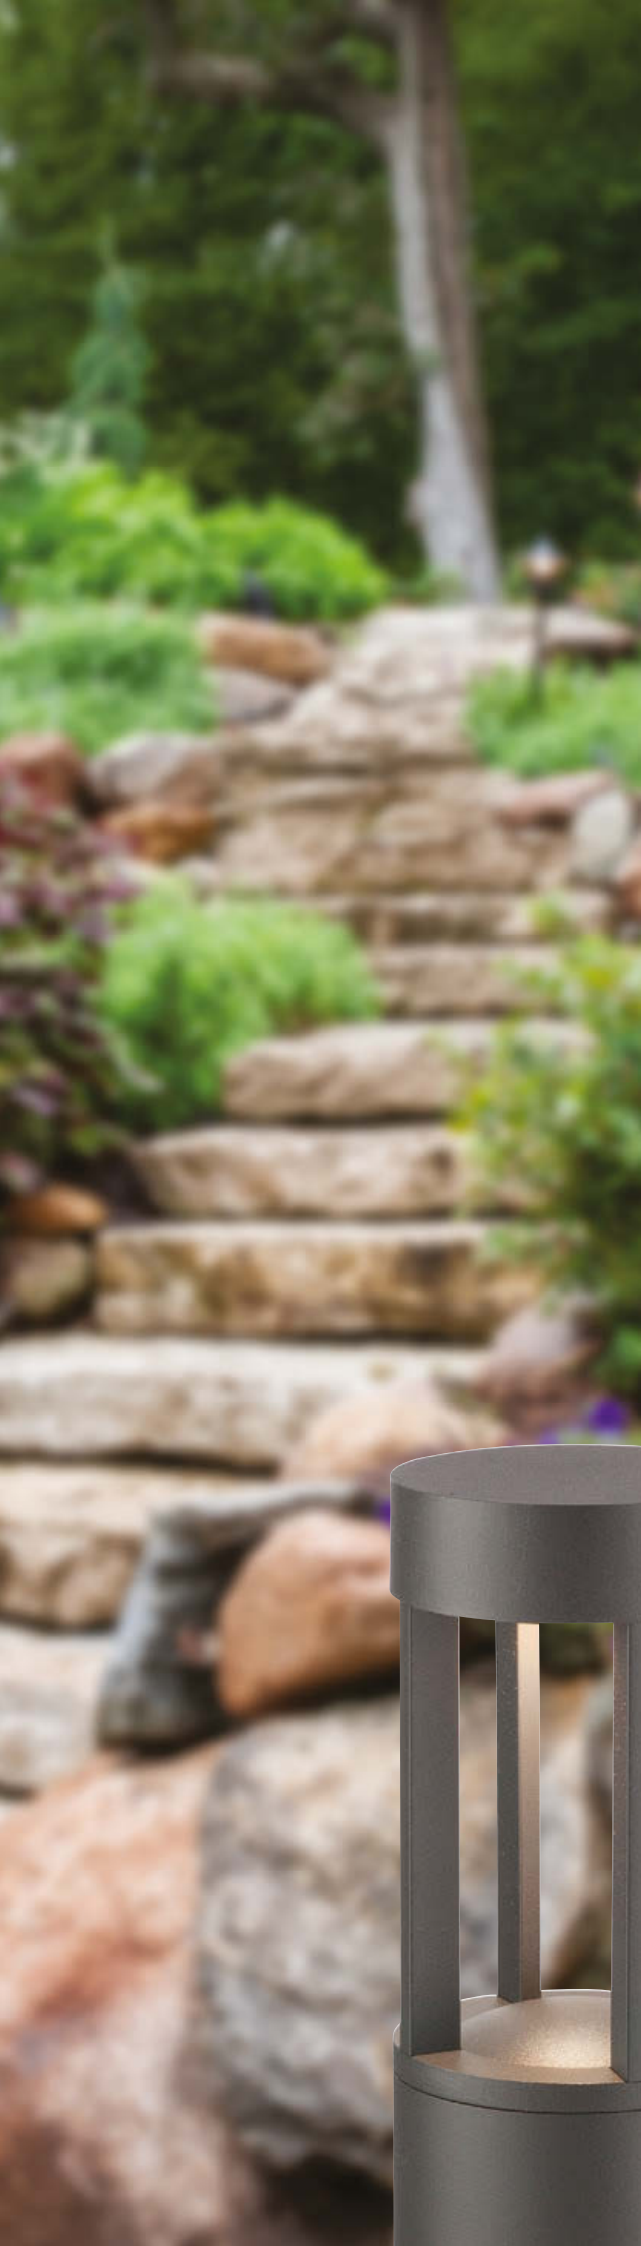
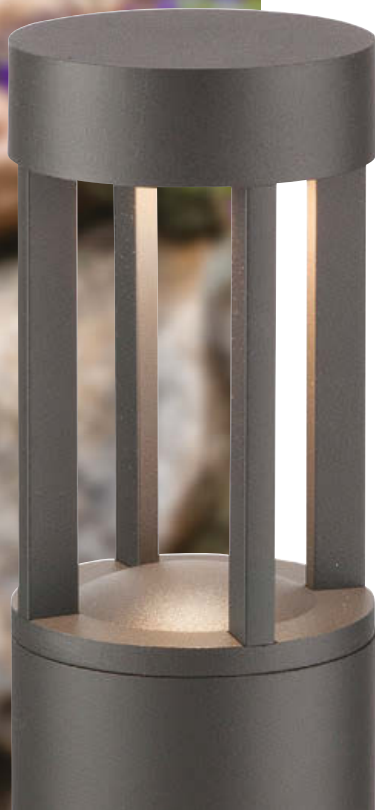
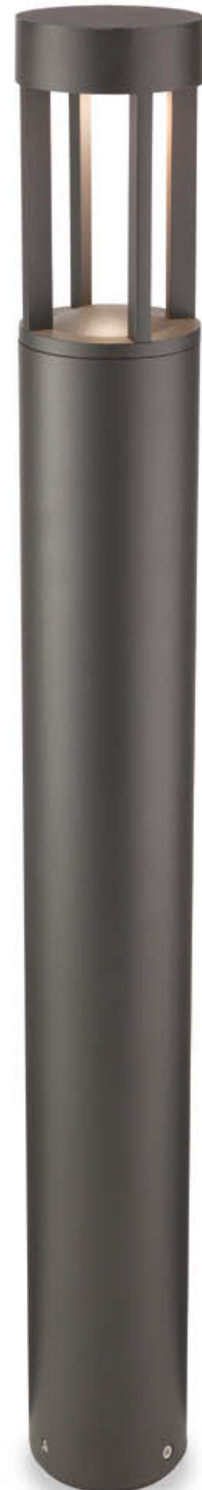
### Delta LED Bollards – Die Cast Aluminium

| Code | Max Wattage | Diam (mm) | Height (mm) |
|---|---|---|---|
| 8667 | 7w CREE LED 398lm 3000K | 90 | 455 |
| 8668 | 7w CREE LED 398lm 3000K | 90 | 805 |

IP54 rated
