## SUMMARY DESK TOP STUDY

MULBERRY COTTAGE,  
HIGH STREET,  
ROMNEY MARSH,  
Lydd  
TN29 9BB

APPLICATION NUMBER 20/1936/FH  
FOR THE ERECTION OF SEVEN DWELLINGS, TOGETHER WITH PARKING AND  
LANDSCAPING, FOLLOWING THE DEMOLITION OF THE EXISTING OUTBUILDINGS

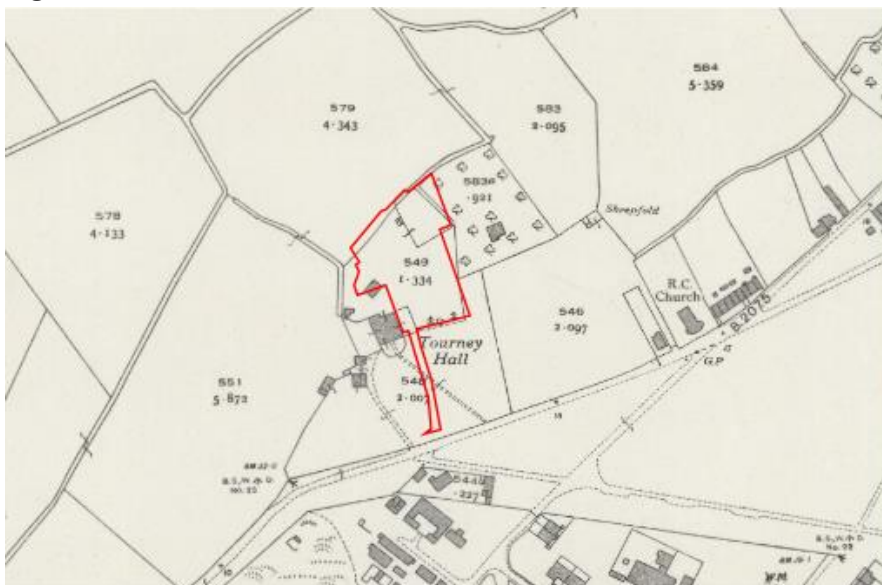
Fig 3 1940

In 1907 a series of outbuildings located North of the house appear, as well as two more structures to the East and North East. Boundary planting running East to West dividing the Southern meadow and then Northern garden is also depicted. Fig 3

By 1940 the separate buildings to the South West were demolished. Presumed farm buildings. This left just two outbuildings to the North of the house.
