Elm Tree Farm, Sellindge

22-029-005 Rev -

Transport Assessment Addendum

December 2024

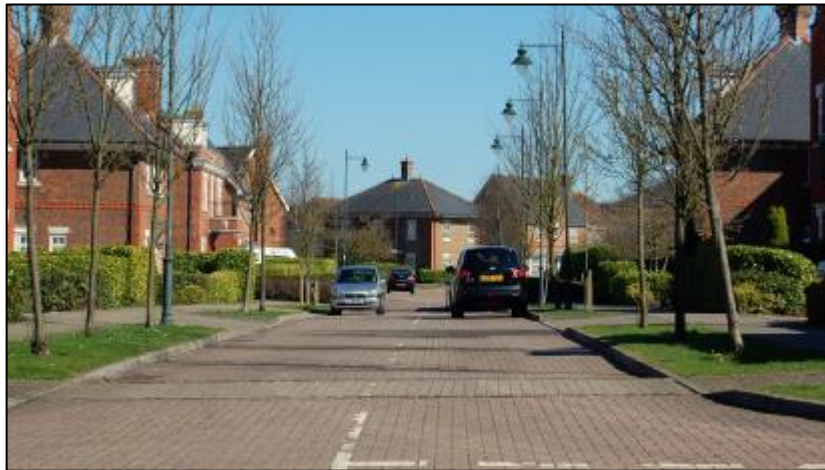
**Figure 2.1: Illustration of Primary Street**

- 2.2.1 This would be the principle all-modes access to the site from Ashford Road, initially running alongside the local centre and then through the residential component to the eastern edge of the site.
- 2.2.2 This street would serve the entire site of 105 dwellings, including direct frontage access to some of the dwellings, so it accords with the KDG 'Major Access Road' which is appropriate to serve 50 - 300 dwellings. The street would have a carriageway width of 5.5m and a footway width of 1.8m.

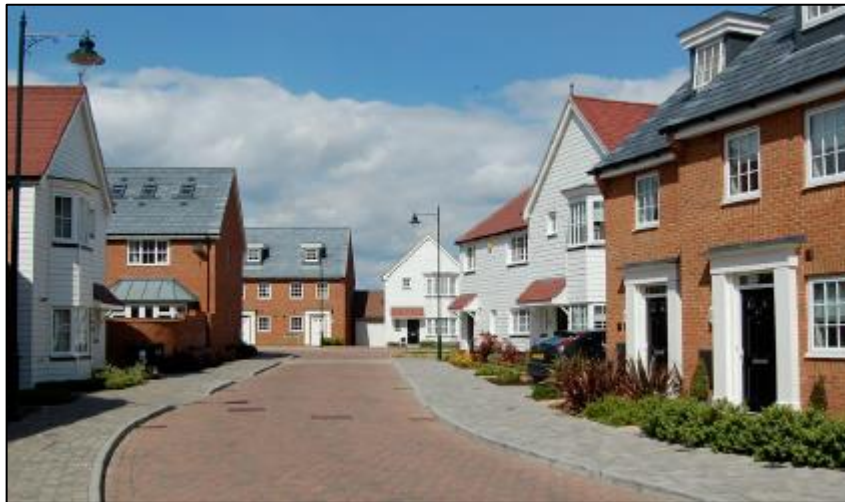
Figure 2.2: Illustration of Primary Street

- 2.3.1 There would be around five secondary streets connecting with the primary street, each serving no more than 25 dwellings. These streets would have a shared surface of 4.8m width and incorporate visitor parking bays, according with the KDG 'Minor Access Way' road type which is appropriate to serve up to 25 dwellings in a cul-de-sac.

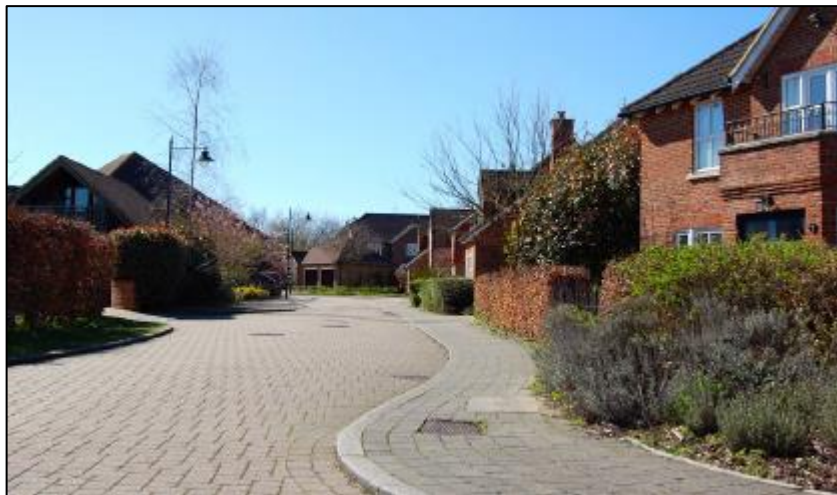
Figure 2.3: Illustration of Private Lanes

- 2.4.1 Finally a series of private lanes would connect with the other roads, typically providing direct access to around 5 dwellings each. These would have a shared surface of 3.6m and incorporate visitor parking, according with the KDG 'Shared Private Drive' type.

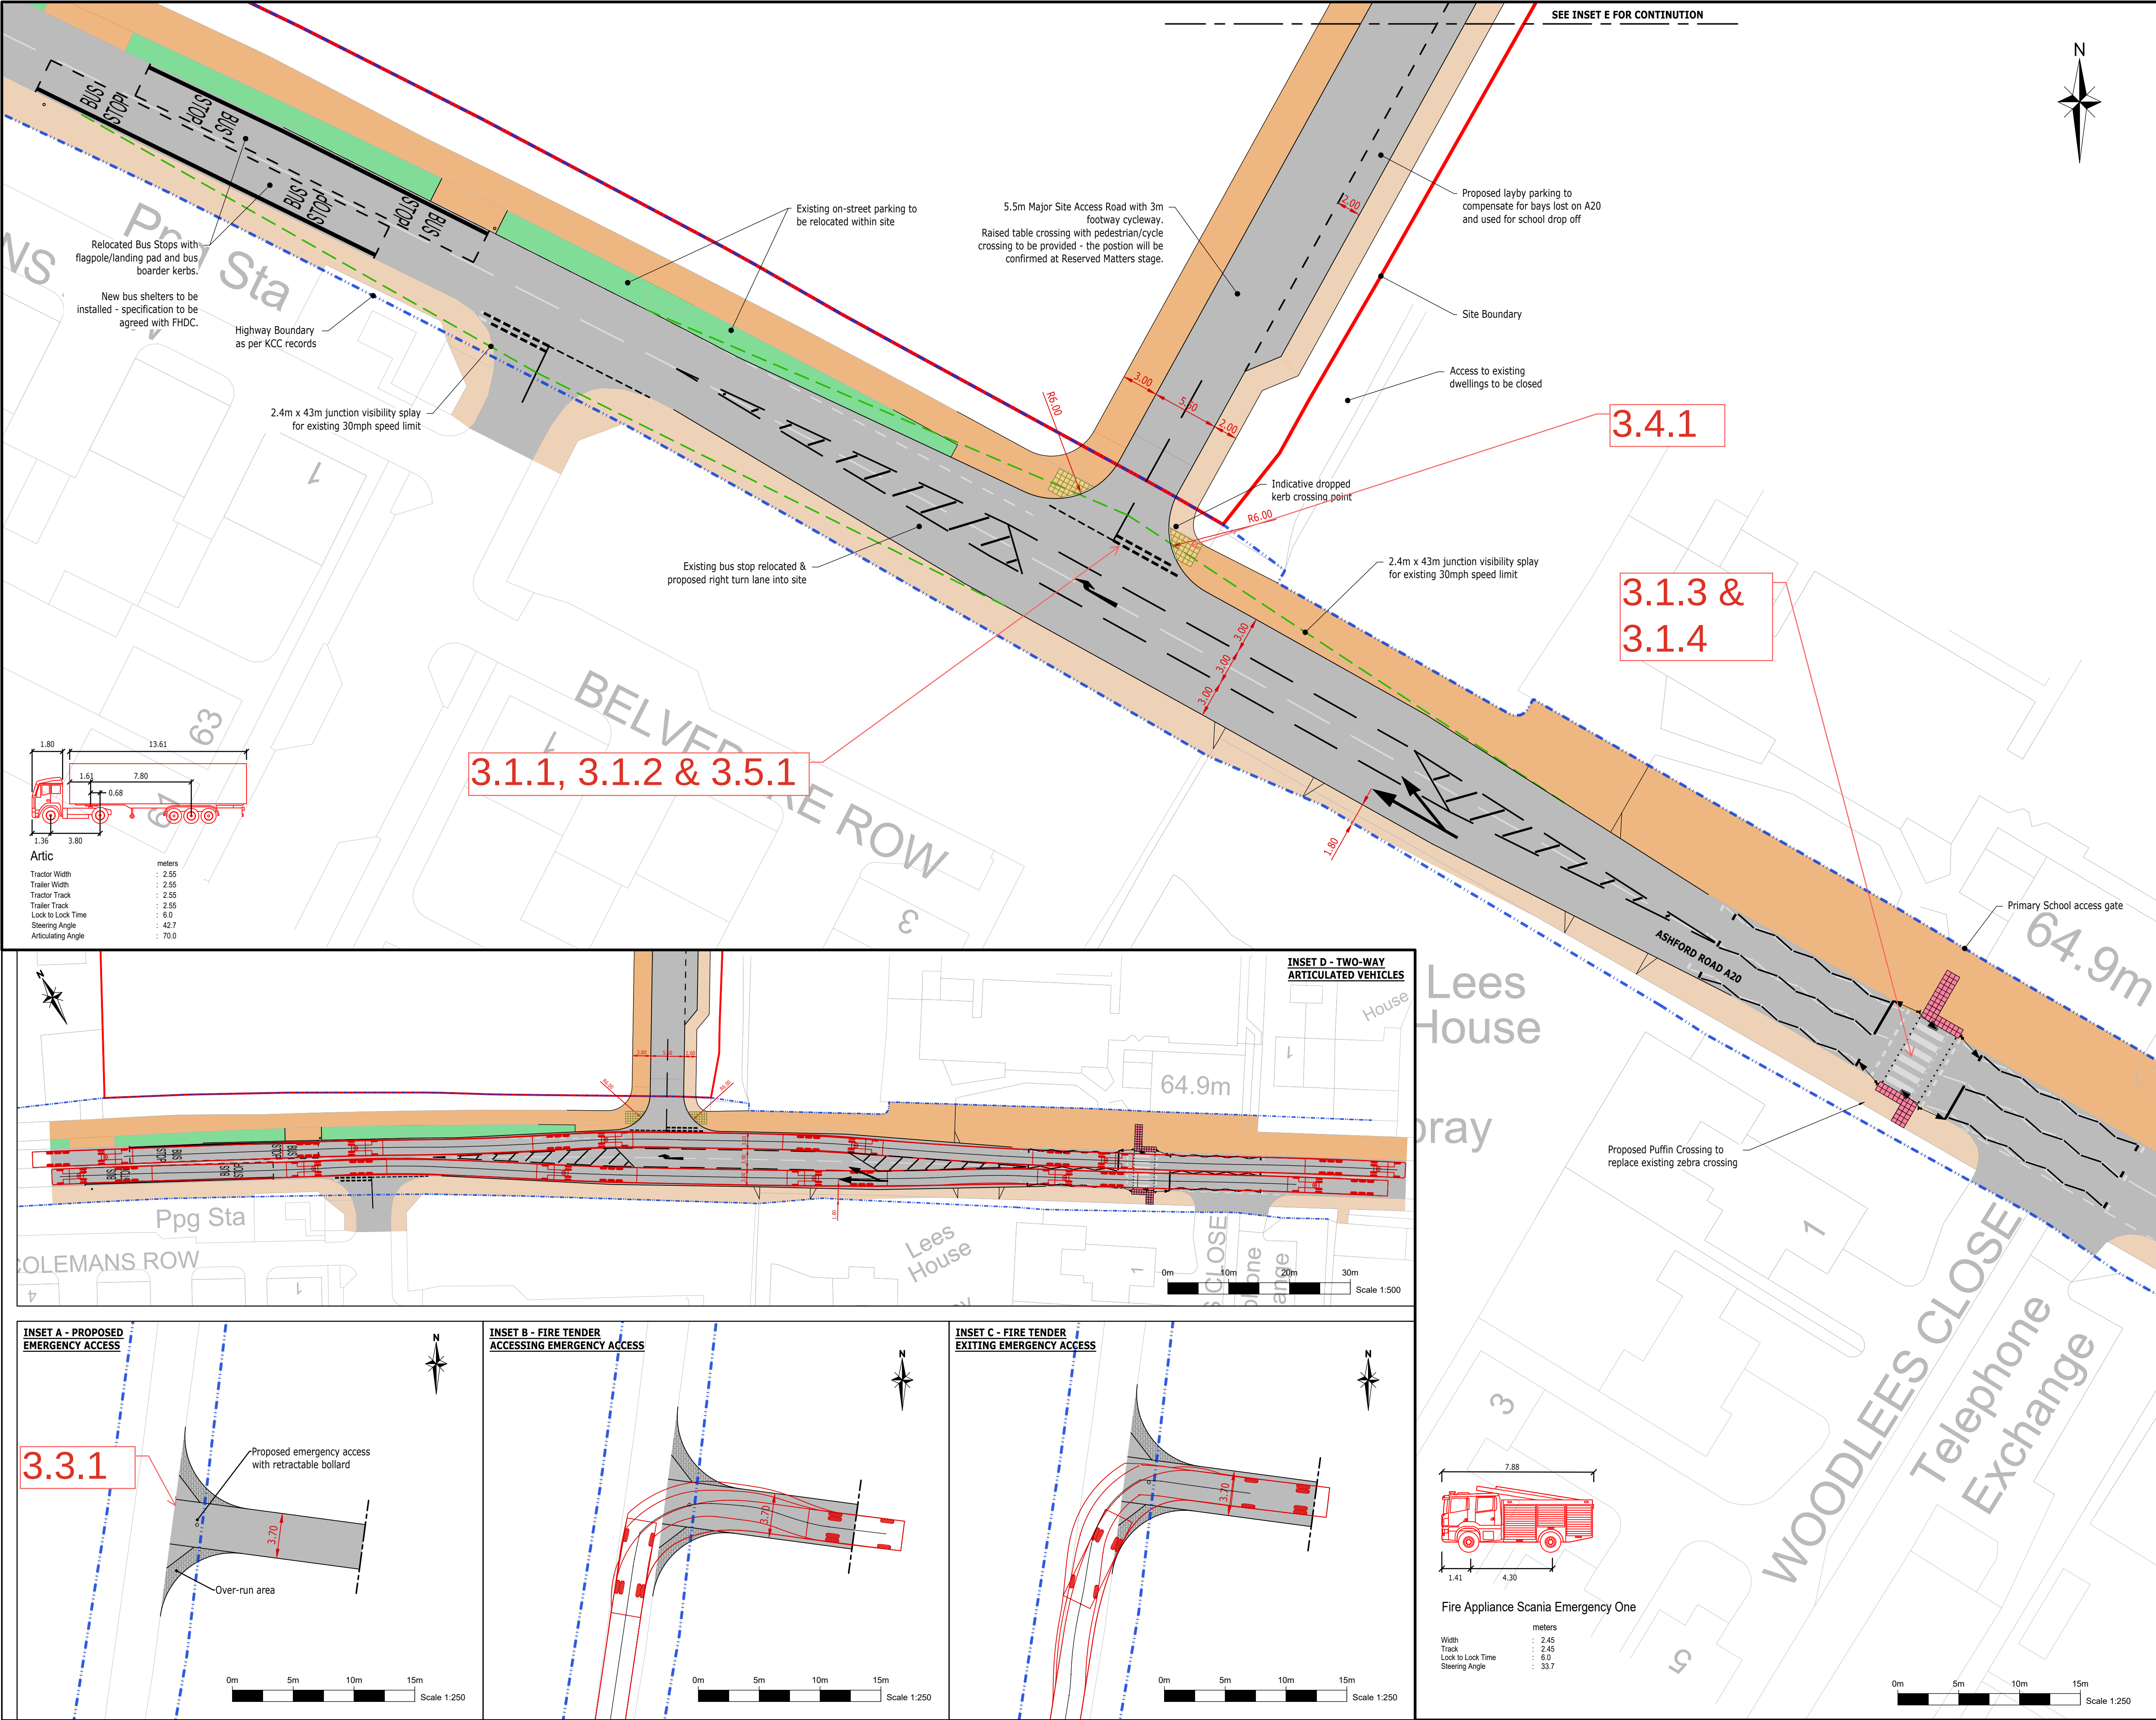
**Proposed Site Access**

**Location:** Proposed junction.

**Summary:** Inappropriate surfacing could lead to loss of control collisions.

It is also noted that is proposed to widen the carriageway to accommodate the proposed right turn lane at the access, where vehicles may be straddling two different surface types and may experience differential braking, which under sudden severe braking conditions could lead to loss of control collisions.

It is proposed to widen sections of the carriageway to accommodate the right turn lane junction, where no details have been provided regarding the carriageway drainage at this early stage. Inadequate drainage provision could cause possible ponding, which could lead to loss of control collisions.

No traffic survey information was provided for assessment and although this section of Ashford Road has a 30mph speed restriction the road has a straight alignment and observed free flow speeds were high. Excessive speeds on the approaches to the crossing may affect the safe

No vehicle maintenance bay has been shown on the plan provided, where a lack of provision may result in operatives parking in unsafe locations. This could lead to restricted intervisibility increasing the risk of vehicle to pedestrian collisions or rear end shunts, in the event of sudden braking.

No details relating to the visibility splays at the access have been provided for assessment. There is concern that hedgerows could restrict visibility where a lack of visibility could increase the risk of side impact collisions.

There is concern that the parking bays on the eastern side of carriageway of the access road may restrict pedestrian / traffic intervisibility at the eastern corner of the junction. A parked vehicle in the bay could mask a child pedestrian at the crossing, where restricted intervisibility could lead to vehicle to pedestrian collisions.

At the junction with Ashford Road only three warning lines to diagram 1004 are proposed on the approach to the junction. Insufficient warning of the junction approach could lead overshoot collisions.

Plan attached showing the locations of the problems identified as part of this audit (location numbers refer to paragraph numbers in the report).

It is recommended that materials used in the carriageway construction be of a consistent PSV to those used throughout the junction.

It is recommended that drainage details and carriageway profiles be such that surface water is shed to an appropriate surface water system, where details should be supplied for assessment at Stage 2 Road Safety Audit.

It is recommended that the 85<sup>th</sup> percentile speeds be checked to see if speed discrimination or speed assessment equipment is required.

It is recommended that a vehicle maintenance bay should be provided at a location, which does not interfere with the visibility splays.

It is recommended that there should be no physical obstruction of the visibility splays and additionally, that the splays should be periodically maintained to retain visibility.

It is recommended that parking bays should not impede upon the pedestrian / traffic intervisibility splays at the crossing point.

It is recommended that the additional longitudinal markings should be installed in accordance with Table 5-1 of Traffic Signs Manual, Chapter 5, Road Markings.
