## KENT COUNTY COUNCIL

Folkestone LUF2, Kent

Factual Ground Investigation Report

LN/C5608/13087

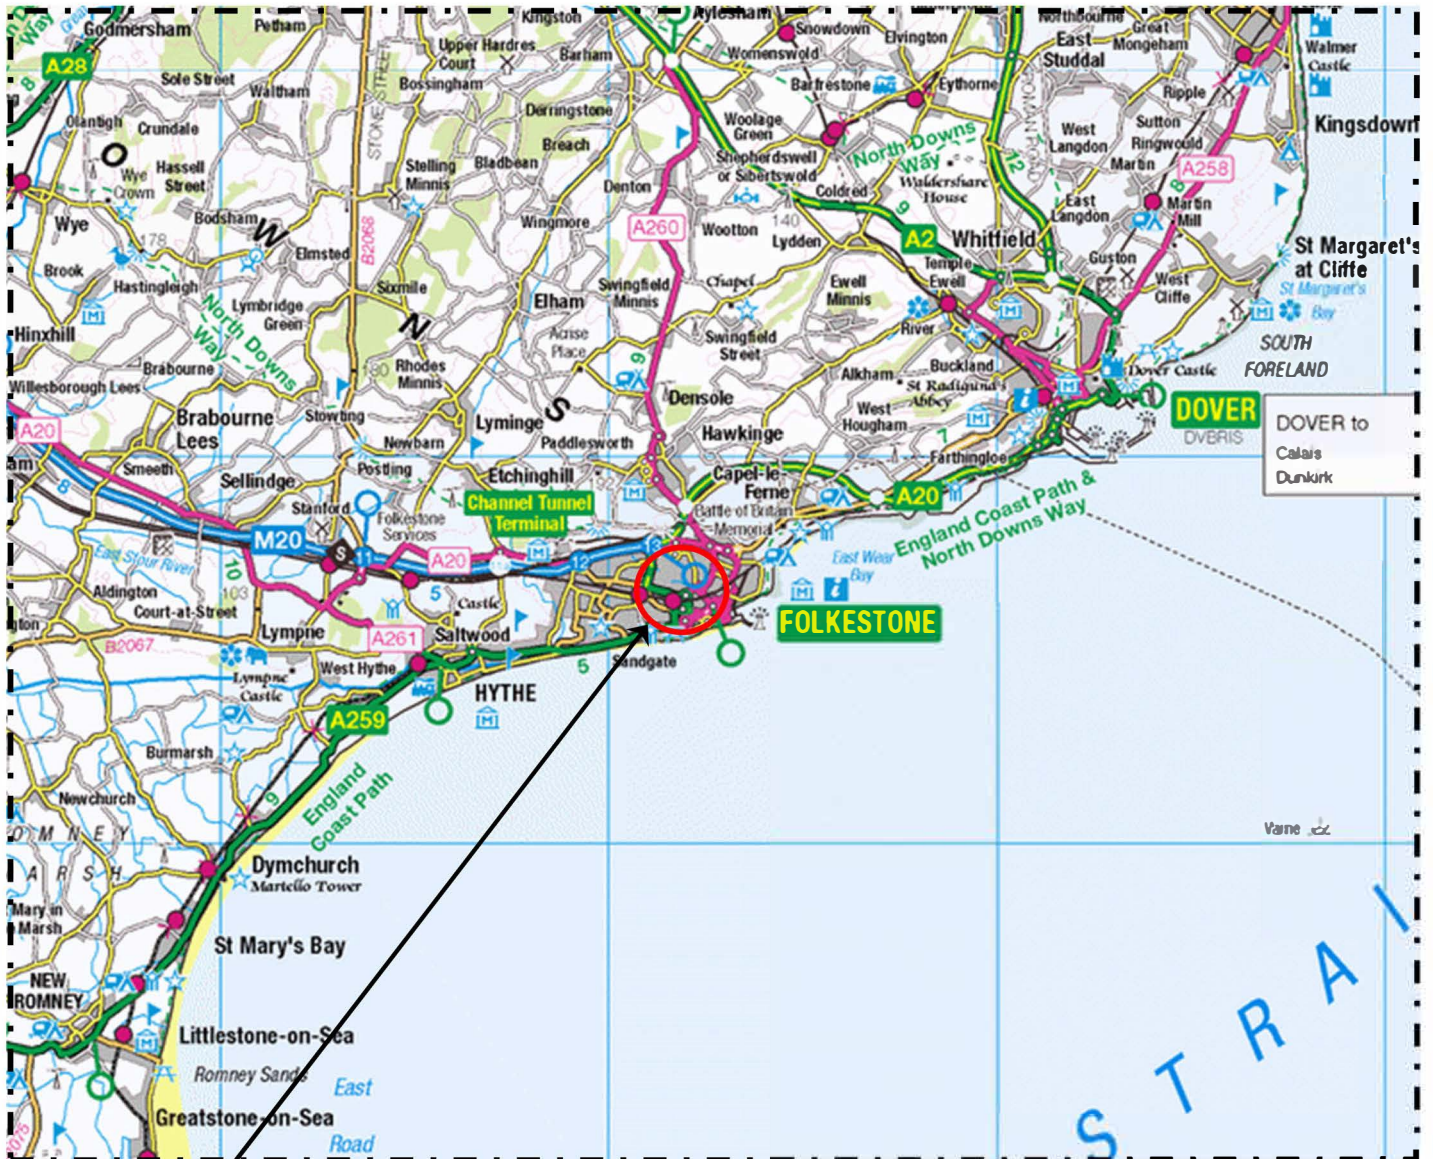
SITE LOCATION

The site is located along sections of several main roads in Folkestone, Kent, centred on National Grid Reference 622808, 136173 as shown on the Site Location Plan, Drawing No. C5608/01. The main areas / road that comprise the site are as follows:

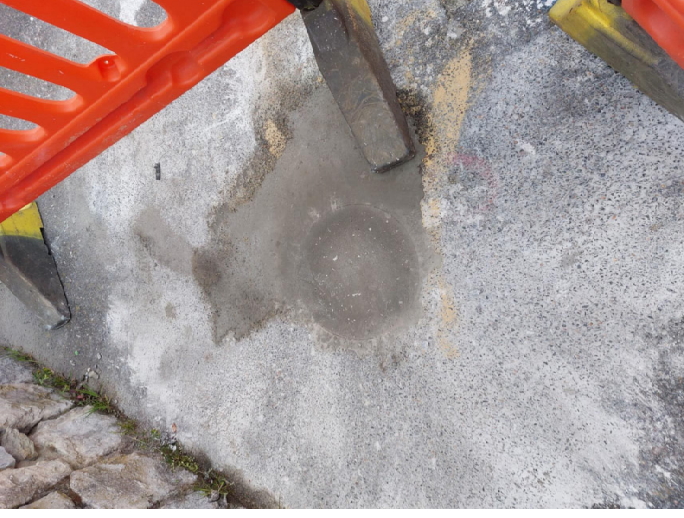
PHOTO 2

PHOTO NO.	DETAILS
1	Road surface before coring
2	Road surface after reinstatement
3	Inside the core hole
4	Extracted core

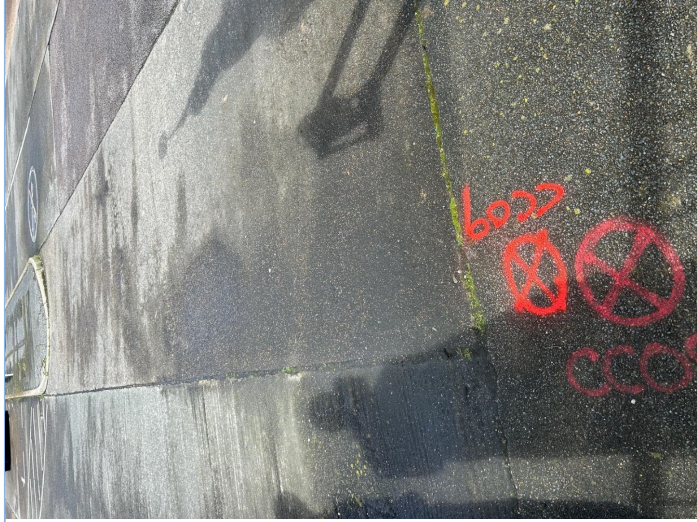
PHOTO 1

PHOTO NO.	DETAILS
1	Road surface before coring
2	Road surface after reinstatement
3	Inside the core hole
4	Extracted core

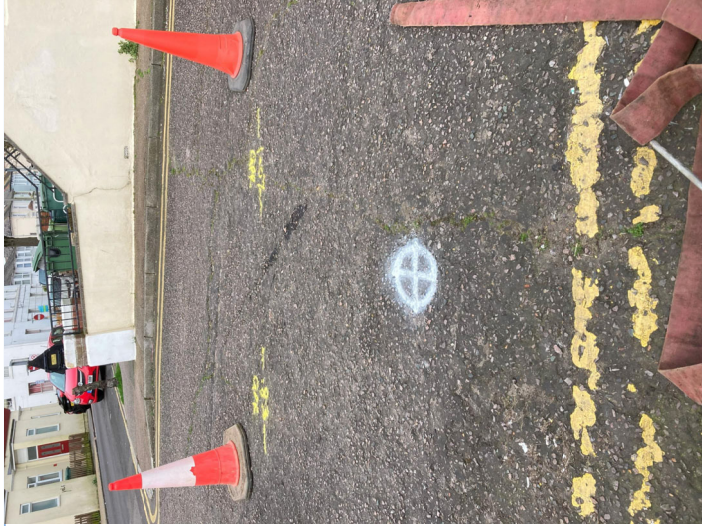
PHOTO 1

PHOTO NO.	DETAILS
1	BH03 – Precondition
2	BH03 - Postcondition
3	WS01 - Precondition
4	WS01 - Postcondition

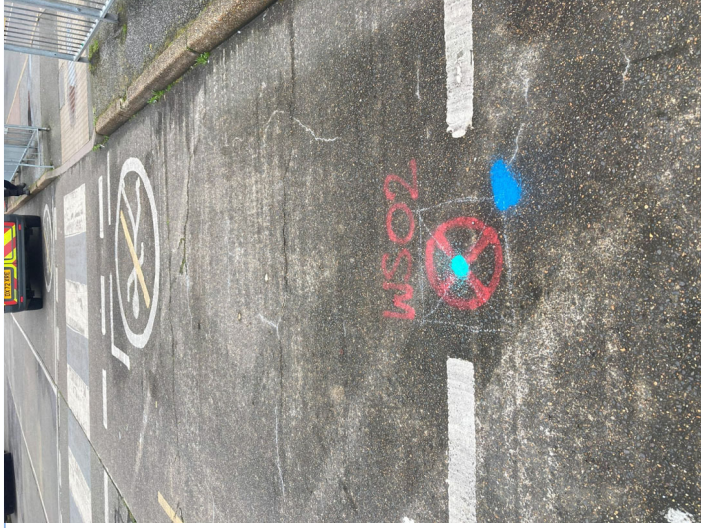
PHOTO 1

PHOTO NO.	DETAILS
1	WS02 – Precondition
2	WS02 – Postcondition
3	TP01 – Precondition
4	TP01 – Postcondition

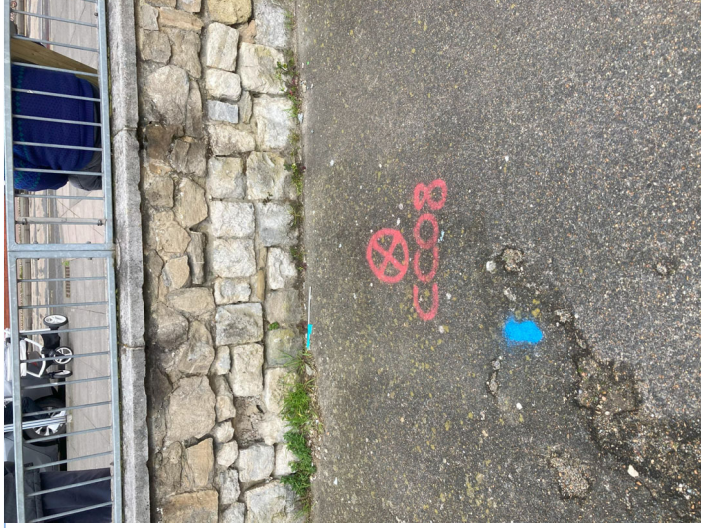
PHOTO 1

PHOTO NO.	DETAILS
1	CC08 – Precondition
2	CC08 - Postcondition
3	CC09 - Precondition
4	CC09 - Postcondition

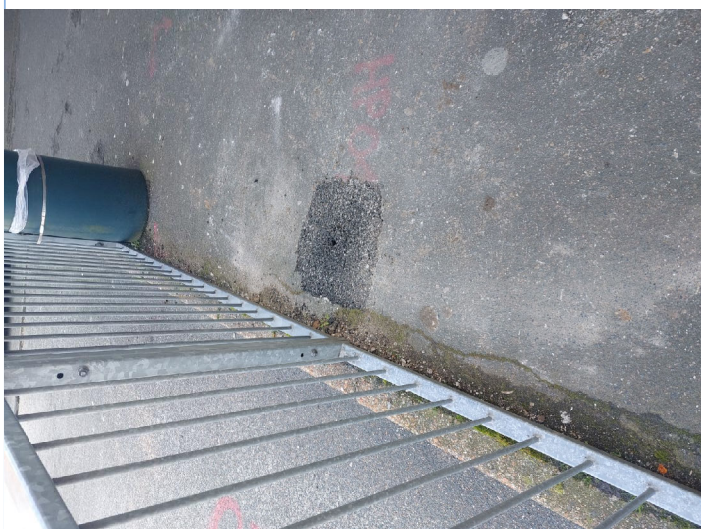
PHOTO 1

PHOTO NO.	DETAILS
1	HP04 – Precondition
2	HP04– Postcondition
3	HP05 – Precondition
4	HP05 – Postcondition
