**REMEDIATION METHOD STATEMENT**  
**ASHFORD ROAD**  
**NEW ROMNEY, KENT**  
**PENTLAND HOMES**  
**RMS-25093-25-276**  
**JULY 2025**

REMEDICATION METHOD STATEMENT  
ASHFORD ROAD  
NEW ROMNEY, KENT  
PENTLAND HOMES  
RMS-25093-25-276  
JULY 2025

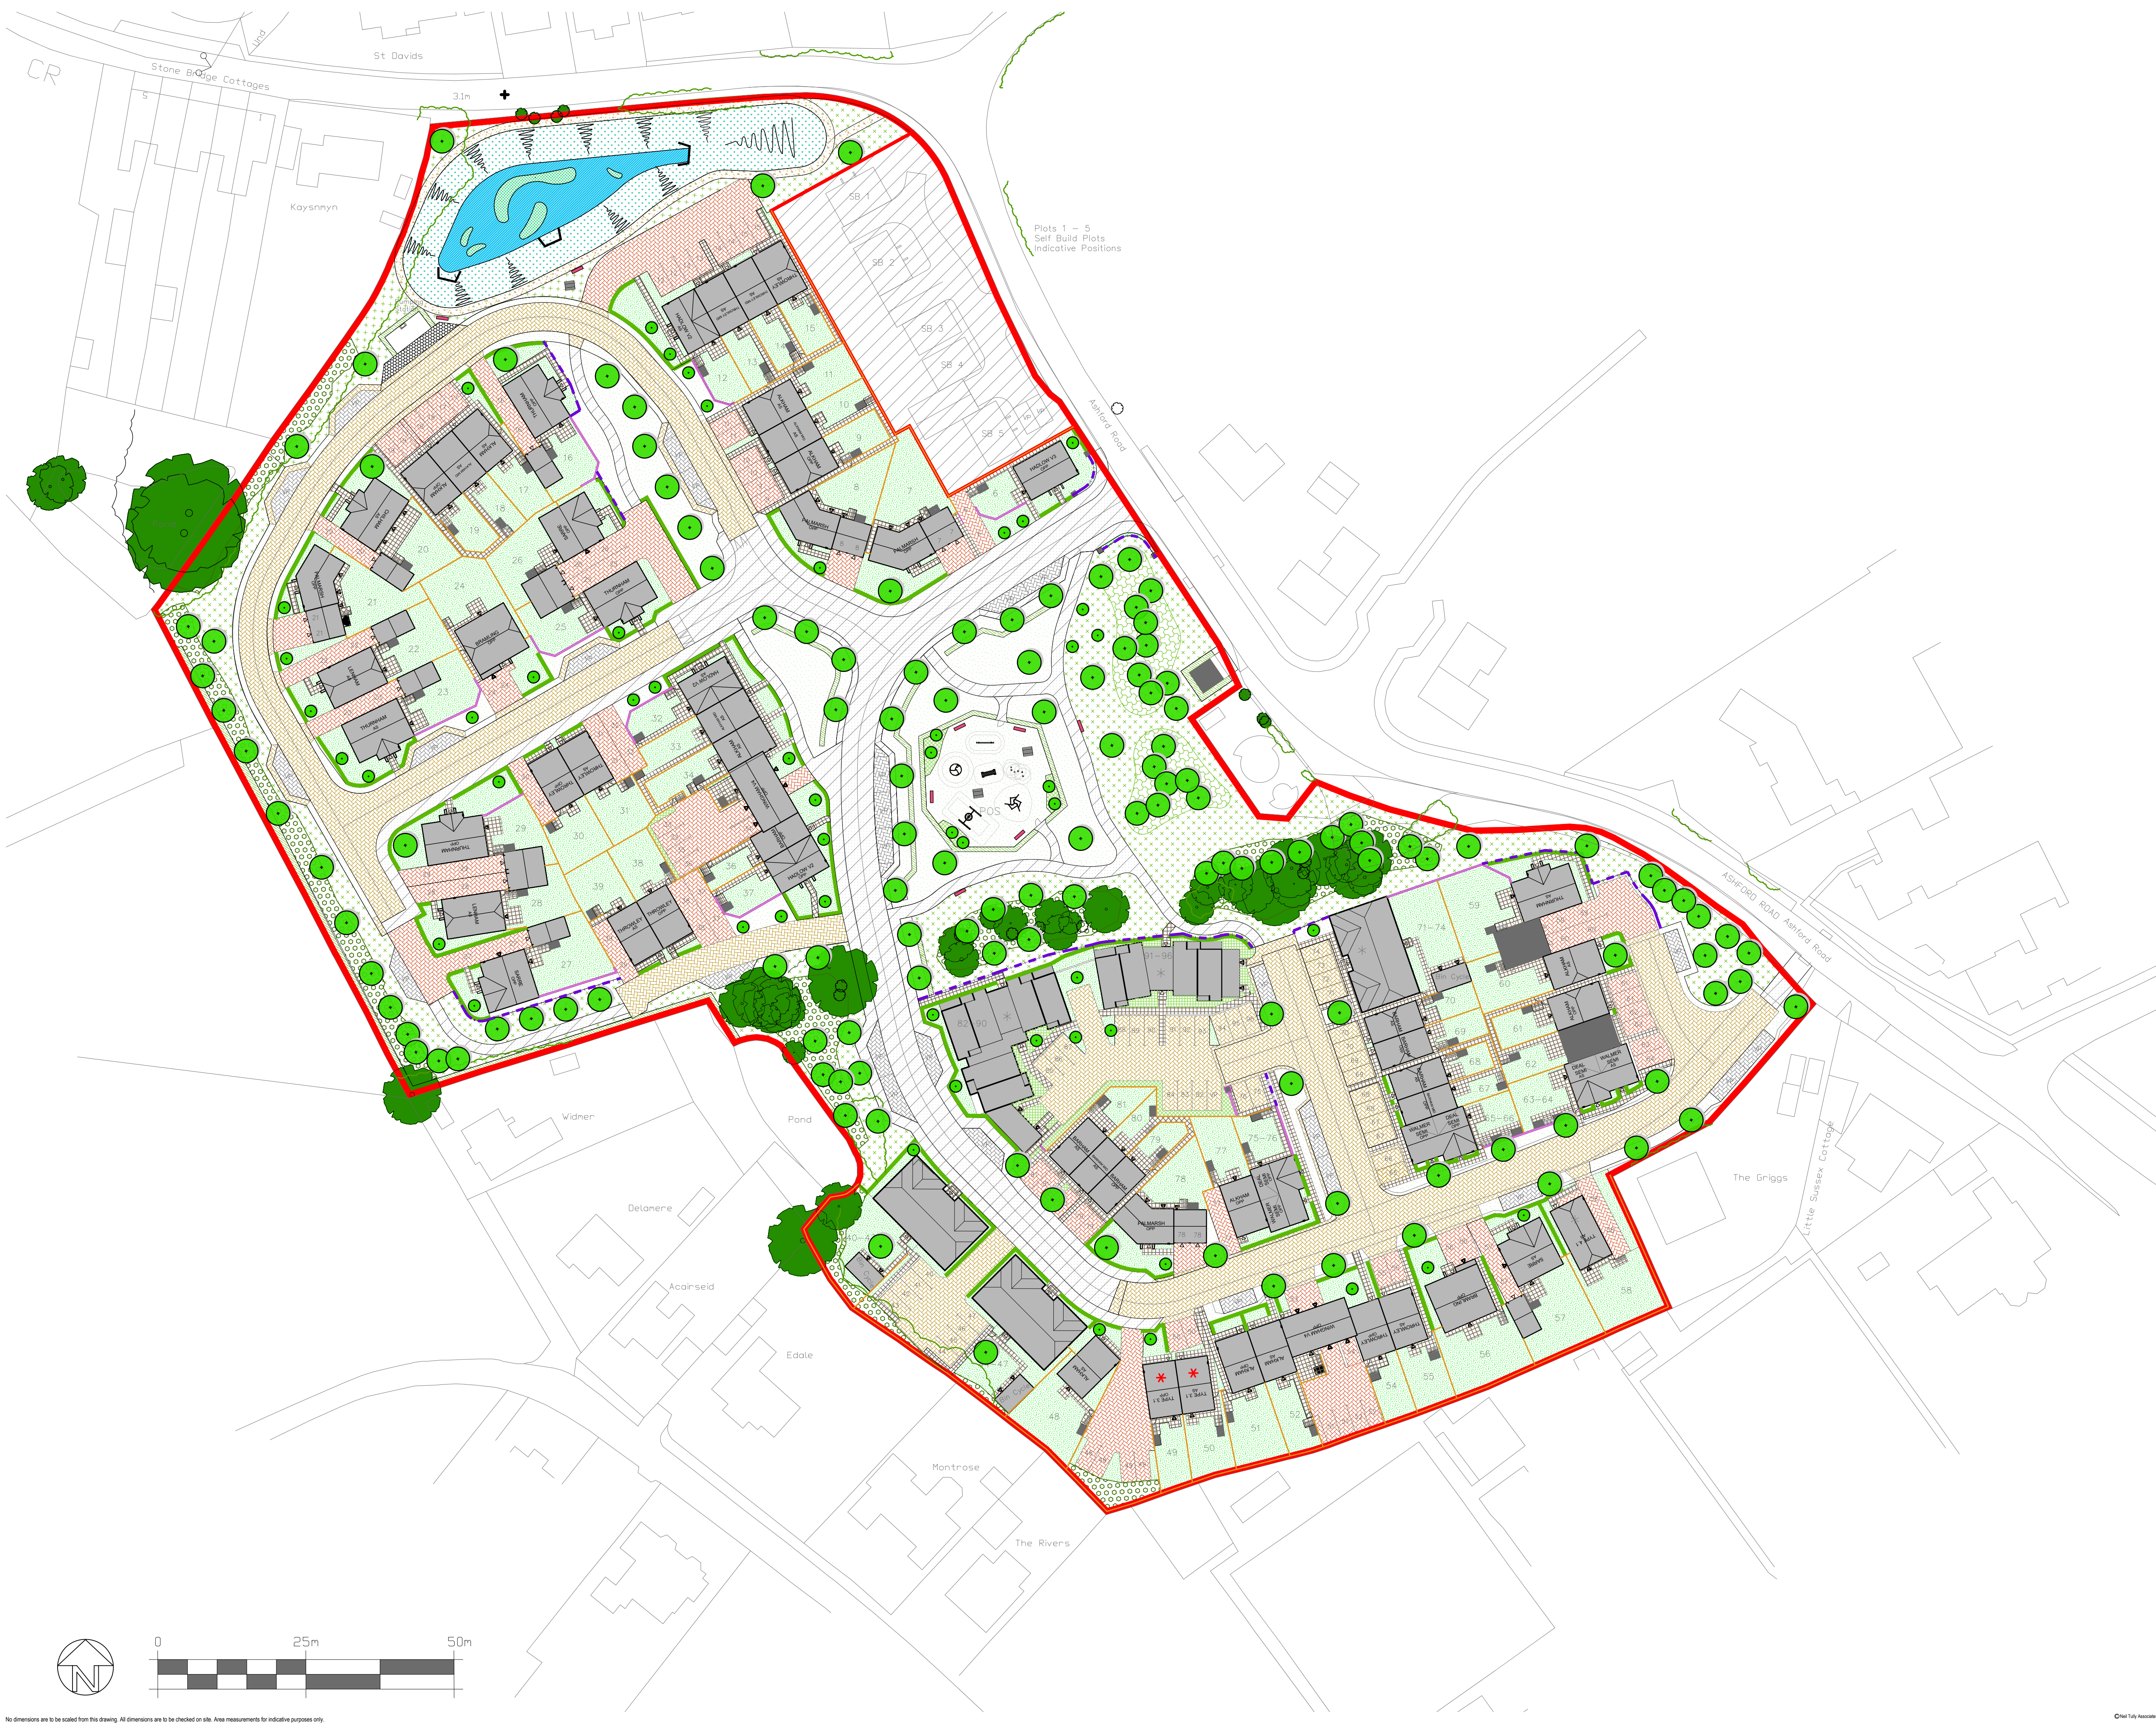
| PROJECT NO:<br><b>2247</b> | DRAWING NO:<br><b>2247.01</b> | REVISION:<br><b>AB</b> | |

- Legend
- KEY MASTERPLAN
- HARDWORKS
- Main routes/roads  
Standard black bitumastic macadam with standard BS kerb to CE/adoption requirements
  - Shared surface, raised tables  
Concrete block paving, one size, laid herringbone pattern with conservation kerb, exposed aggregate and trims

- Private driveway  
Concrete block paving, one size, laid herringbone pattern with conservation kerb, exposed aggregate and trims
  - Visitor parking  
Concrete block paving, one size, laid herringbone pattern with conservation kerb, exposed aggregate and trims

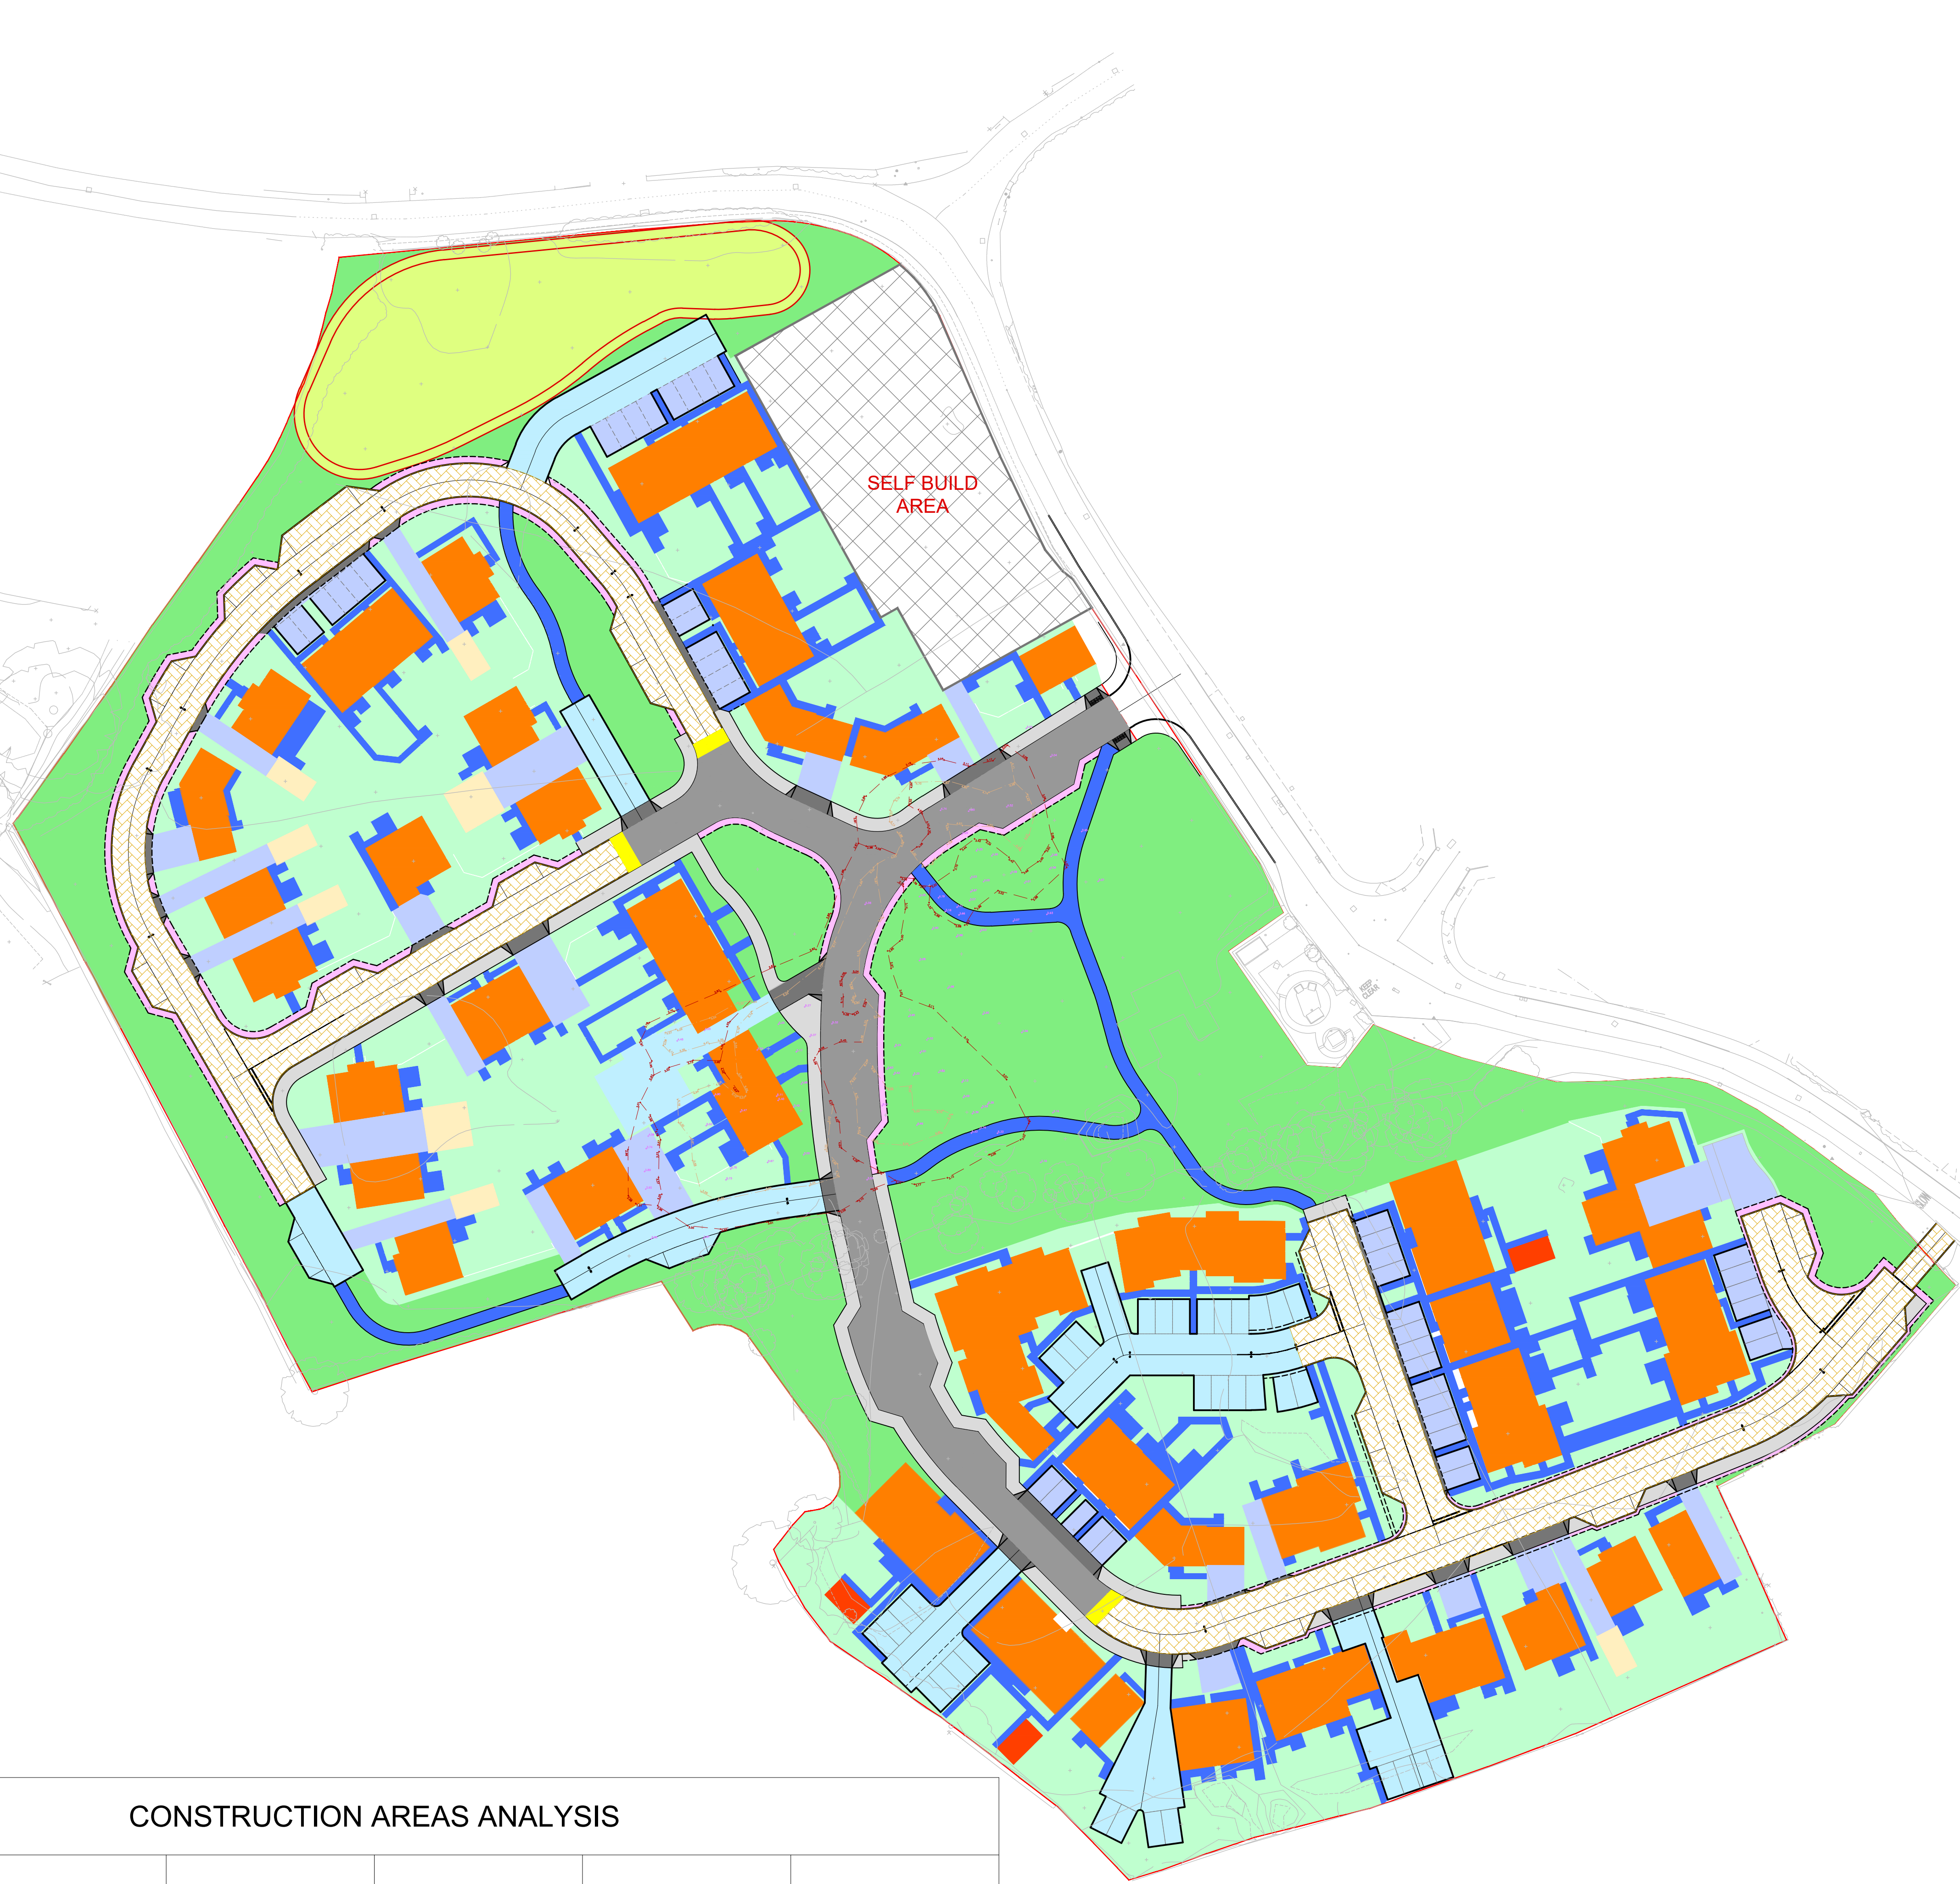
- 9.2.1 The general earthworks analysis, enclosed in Appendix 1, indicates that a significant volume of soils will need to be imported to facilitate the redevelopment of the site.
