# **Nissen Hut, Lympne, Newingreen, Hythe**

## **Built Heritage Assessment Report**

On behalf of **Otterpool Park LLP**

Report Title: Built Heritage Assessment Report

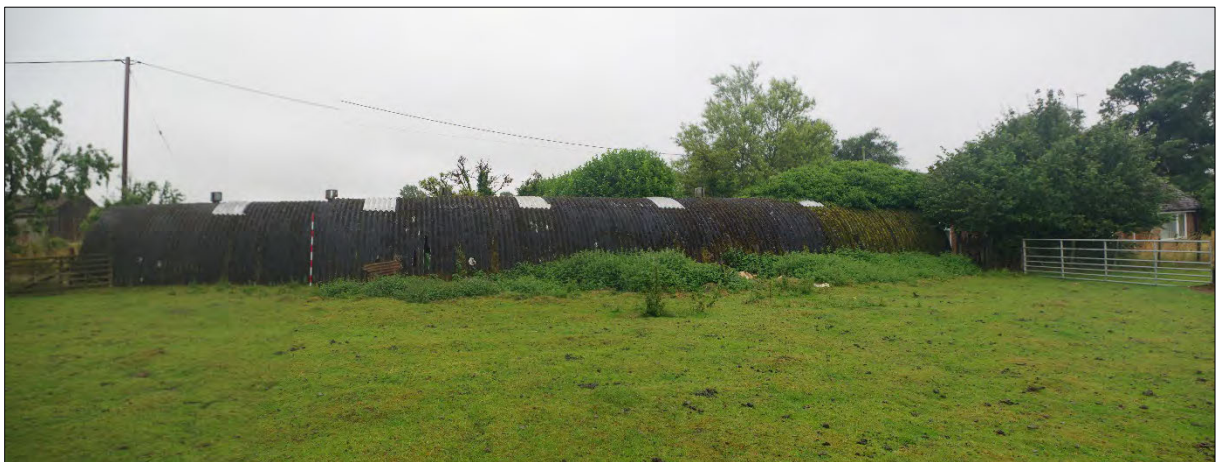
Plate 1: Nissen Hut facing south.

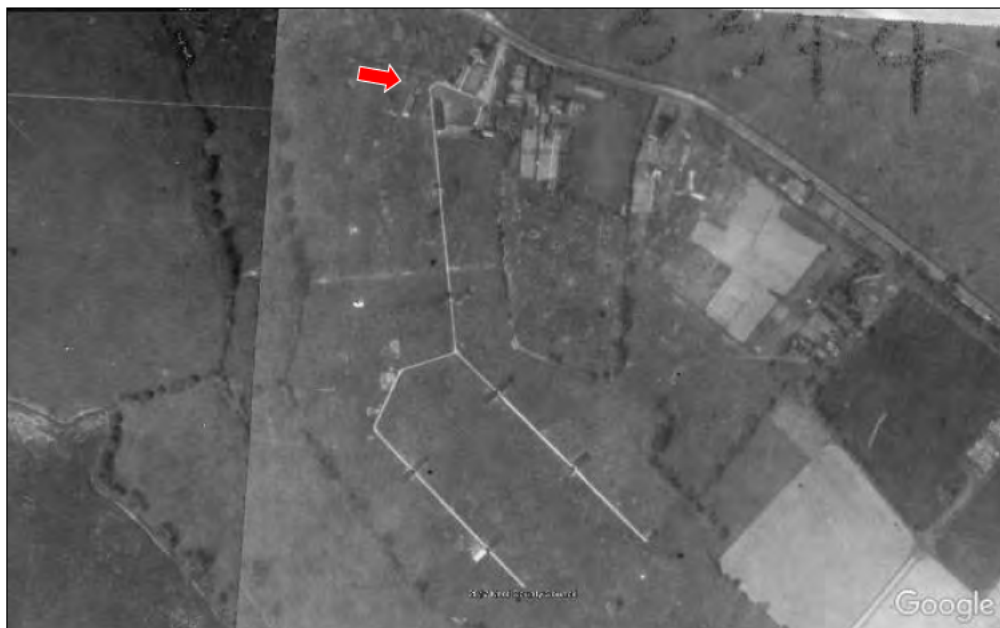
Plate 2: c.1940s aerial photograph of ammunition depot, with approximate position of Nissen hut shown by red arrow (reproduced from Arcadis 2019, Appendix 9.5, Plate 10).

- 2.4.2 The ammunition depot, as depicted on the aerial photograph from c.1940, is quite small (though no doubt developed through the War), with an access road turning south then west around Red House Farm, before heading directly south across the fields to a junction with a further C-shaped service road leading to (at least) four pairs of huts facing each other and spaced along the service road equally. Further buildings lie east of the access road (some of which have been suggested by Arcadis may still survive, including two workshop buildings on the Benham Business Park which are consistent in style and fabric with other military buildings of this period in the area).

- 2.4.9 The Nissen Hut does not appear on the aerial photograph (Plate 2) or mapping from that period. This was quite common for war-time establishments, which were deliberately left off mapping in case this should help the enemy, and, later, not included as they had either been decommissioned or were still serving a military role which required continued secrecy. The ammunition depot has been largely lost and the original layout was no longer extant, the main southerly access road and service road having been removed by the 1960s (from aerial photographic evidence). The Nissen Hut is therefore a suggested (possibly isolated) survival of the former complex.

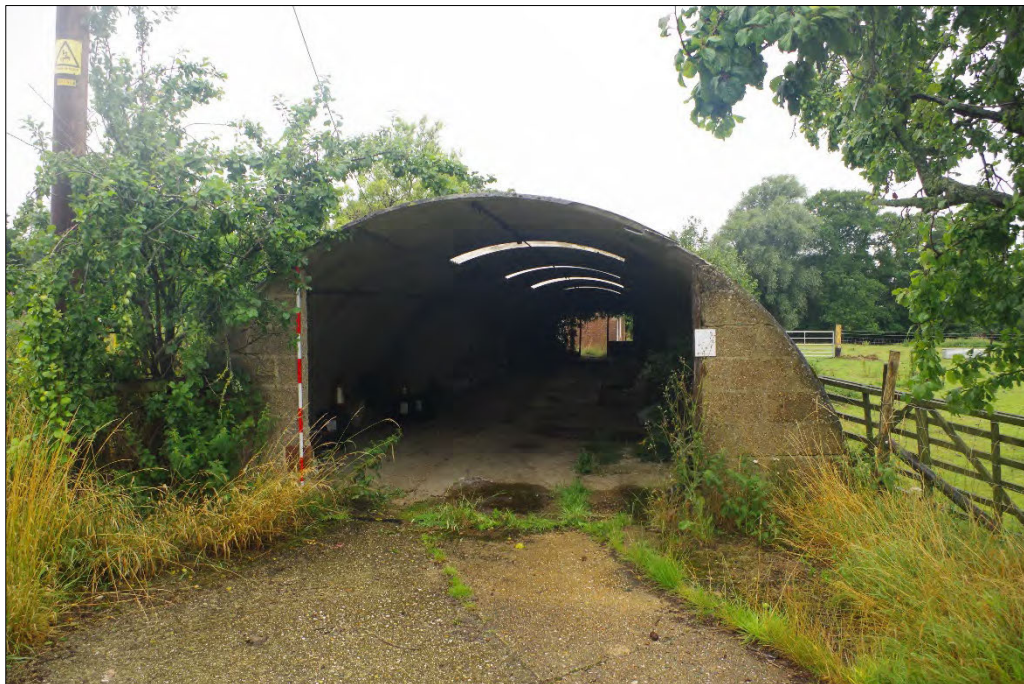
Plate 3: the Nissen Hut facing west.

- 3.1.1 The Nissen Hut is a single storey, one-celled structure measuring 26.8m (88') in length by 5.49m in width (18') and standing to 2.74m (9') in height. The building is aligned east west and has a semi-circular profile. The building appears to be built around a steel frame, but as the frame is clad internally and externally by corrugated asbestos sheeting, the frame was only visible as ferric staining on the internal sheeting. Traditionally, the frame would comprise ribs set at roughly 6' (1.84m) centres, which seems the case here. The total length of the building equates to approximately 15 ribs, forming 14 bays. No purlins were evident, but it must be assumed these exist between the sheets to provide bracing between the ribs.

- 3.1.2 The asbestos sheeting is laid with three sheets covering the arc of the hut. The upper sheet overlaps the side sheets by at least 0.15m, with each sheet overlapping the next by at least two corrugations. Every fifth upper sheet has been replaced by a modern corrugated see-through plastic sheet, to allow light into the interior. Every fourth sheet has a circular hole, 0.35m in diameter, pierced through it, which supports the pipe for an upstanding aluminium box ventilator, which also appears to be modern. At least two of these have now been removed or have fallen off, leaving a hole only. The whole structure sits on, and is embedded into, a concrete pad on the north and south sides which provides the foundation.

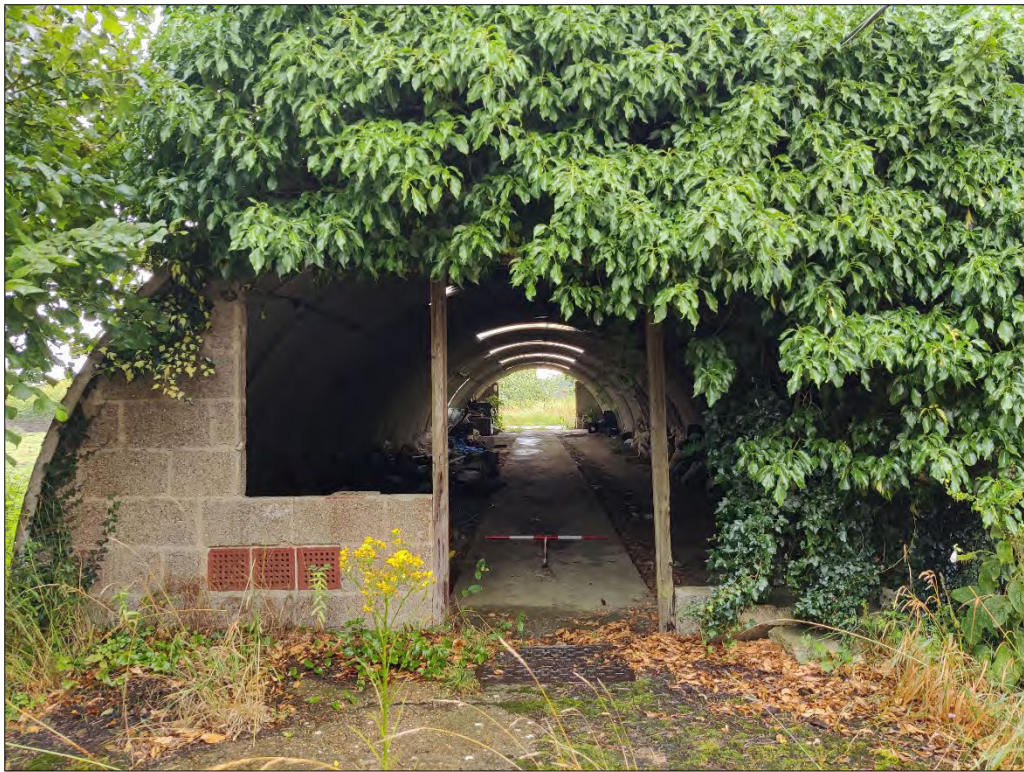
Plate 4: the Nissen Hut facing east.

- 3.1.3 Both the eastern and western ends were originally enclosed, but only the western end now survives largely intact (Plate 4), the eastern end having been opened out to allow vehicle access (Plate 3). The western end has a large central doorway, 1.96m in height by 1.06m in width, now only surviving as a timber frame, but with evidence of the location of hinges and strike plate for the door latch still surviving. The doorway is flanked by windows, both now only surviving as openings, measuring 0.96m in width by 1.18m in height. The wall infill comprises large concrete breeze blocks, mortared with cement, between the edge of the asbestos roof structure, which overlaps the wall slightly, and the former windows and door. The northern wall in the western elevation includes a row of three ceramic ventilation grilles. The eastern end is likely to have

mirrored the western end to a certain extent, evident by some remaining sections of timber frame, possibly formerly part of the window, in the north wall, and the truncated remains of a ceramic ventilation grille in the south wall. It appears the breeze blocks were cut through with a circular saw.

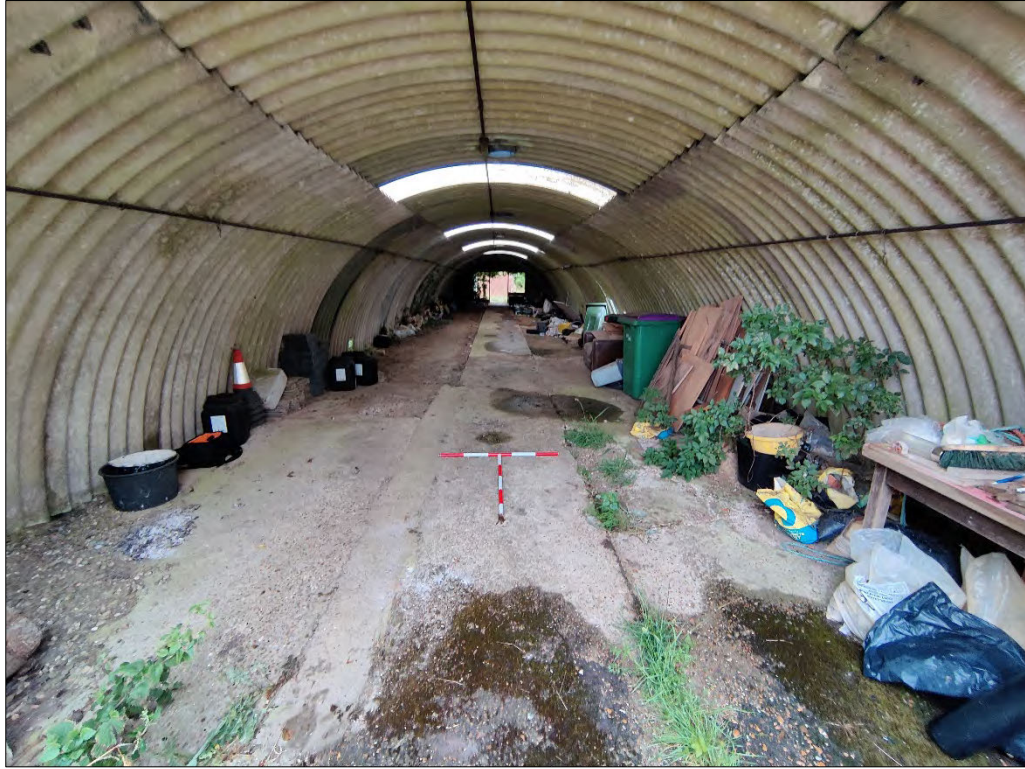
Plate 5: internal view of Nissen Hut, facing west.

- 3.2.1 There is no evidence of any internal flooring within the building, though it may originally have had a timber floor resting on lateral floor joists. The floor now comprises bare earth, with a modern concrete pathway 1.30m in width extending the full length of the building and providing a walkway through to the modern cottage to the west, which appears to have made use of the buildings as a garage and store. There are further concrete pads on the north and south sides of the walkway, c.5m in length, to support a parked vehicle in the eastern end of the building (Plate 5).

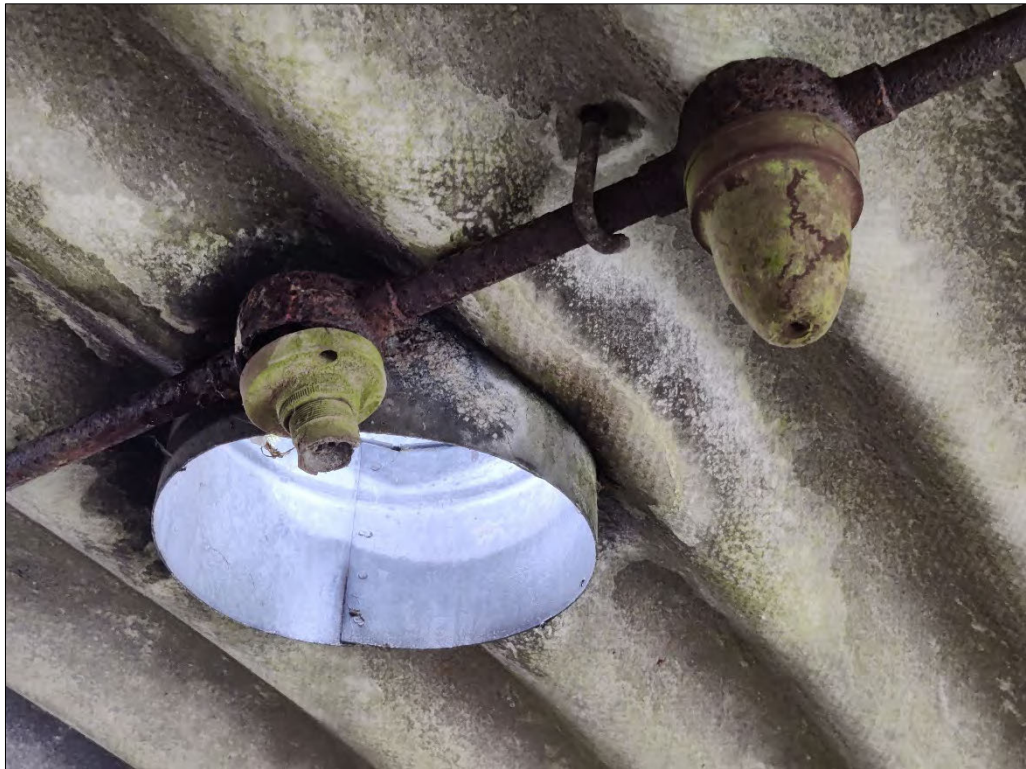
- 3.2.2 Prior to its current use, the building appears to have been repurposed as a chicken house, probably sometime in the 1950s. There were a series of openings cut into the walls on the north and south sides of the building, at ground level, with evidence of concrete supports for probable timber and chicken-wire stalls inbetween, which would have formed a series of pens for the birds, at roughly 2m spacings. The openings would have allowed the access/egress of the birds from the pens to the outdoors. Cable ducts for electric lighting and sockets extend down each side of the building, with pairs of fittings for a socket and pull-switch spaced above each pen. A further duct extends down the centre of the building, with a pair of light fittings and pull-switches, lining up with the wall switches on each side. All the fittings are Bakelite and include black and red coloured wiring. The fittings appear to relate directly to the use of the building as a chicken house, and there is no evidence this lighting was used for any other (military) purpose before this. Within the southern concrete pad, a line had been cut in for a modern water-pipe (then covered with concrete again) with a tap at the western end, presumably for providing the birds with water.

Plate 6: detail of Bakelite fittings

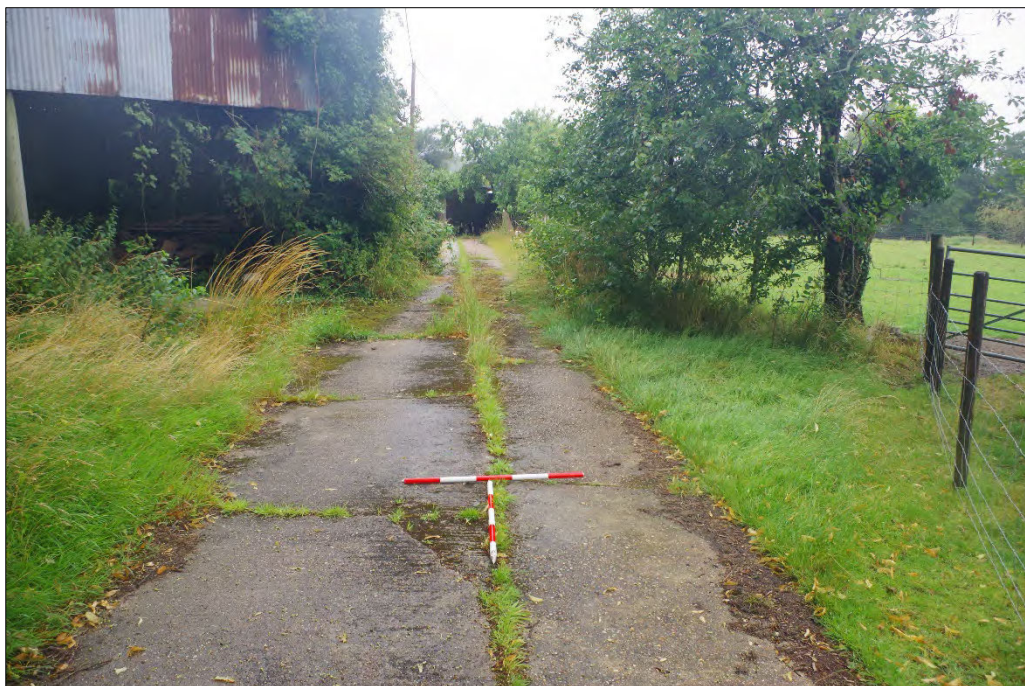
Plate 7: the access road leading west to the Nissen Hut

- 3.3.1 The road which leads down to the Nissen Hut is part of the original infrastructure associated with the ammunition depot and is shown on the 1940s aerial photograph (Section 2.4.2). The access road is typical of military roads, which were laid as heavy duty paved sections of concrete often at least 6" (15cm) thick and designed to be able to withstand heavy loads without breaking up (Francis, Flagg and Crisp 2016, 6). The position of the road in association with the Nissen

Hut provides some context to its origin and does provide some evidence that the position of the hut may be original, though this is hard to be certain in view of its general absence of interior features which would confirm its wartime use.
