# HERITAGE DESIGN AND ACCESS STATEMENT FOR PROPOSED REPAIR WORKS TO THE MANOR, POSTLING

30th April 2019

### Document Reference – SC19-022

This heritage, design and access statement has been prepared in support of an application for listed building consent to underpin using traditional methods a Bay window and repair associated cracking. It is Grade II listed and lies within the Postling Conservation Area and Kent Down Area of Outstanding Natural Beauty (AONB).

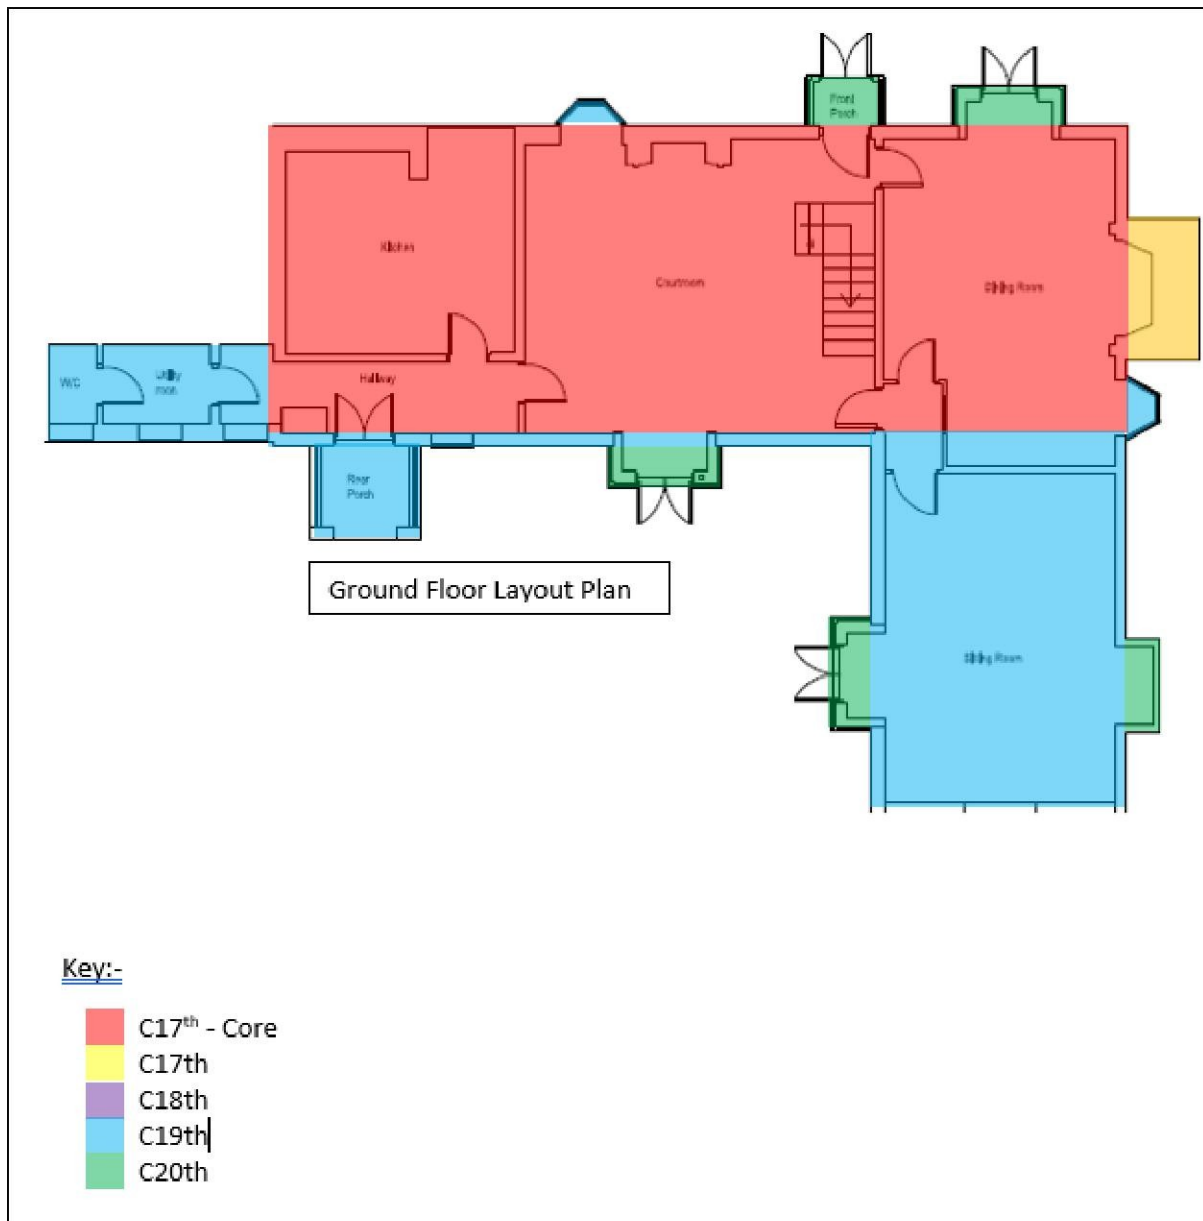
**FIGURE 2 - PHASES OF CONSTRUCTION**

The listing description (Grade II) is a clear reflection of the structure as it can be seen externally although the bay extensions would appear to be of a later date and are more likely to be of 20<sup>th</sup> Century origin. Internally, the position of timbers may suggest that a number of alterations have been made with the reuse of removed timbers, such as within the internal bay windows.

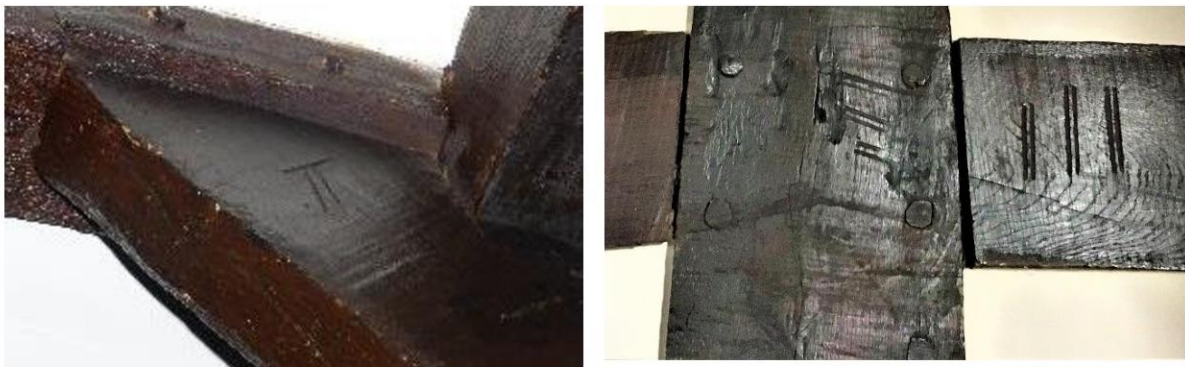
**FIGURE 4 - EXAMPLES OF CARPENTERS MARKS**

There is evidence of traditional carpenter's marks in several locations with the correctly corresponding timber in location. The largest concentration of these that can be easily accessed can be found on the timber frame adjacent to the staircase to the first floor. These would be worthy of further study and may be able to indicate the original plan and extent of the early phase of the building.

The carpenter's marks and ritual burning marks that were noted during the recent survey should be further investigated and a full recording of their locations be made. The assessment of these enrich the significance of this building and would provide further analytical evidence of this building which may be yet unrecorded.
