BUILDING CONDITION AND REQUIRED REPAIRS:

Project | THE LEAS PAVILION, THE LEAS  
FOLKESTONE

Title | LISTED BUILDING APPLICATION: EXISTING ELEVATIONS 1

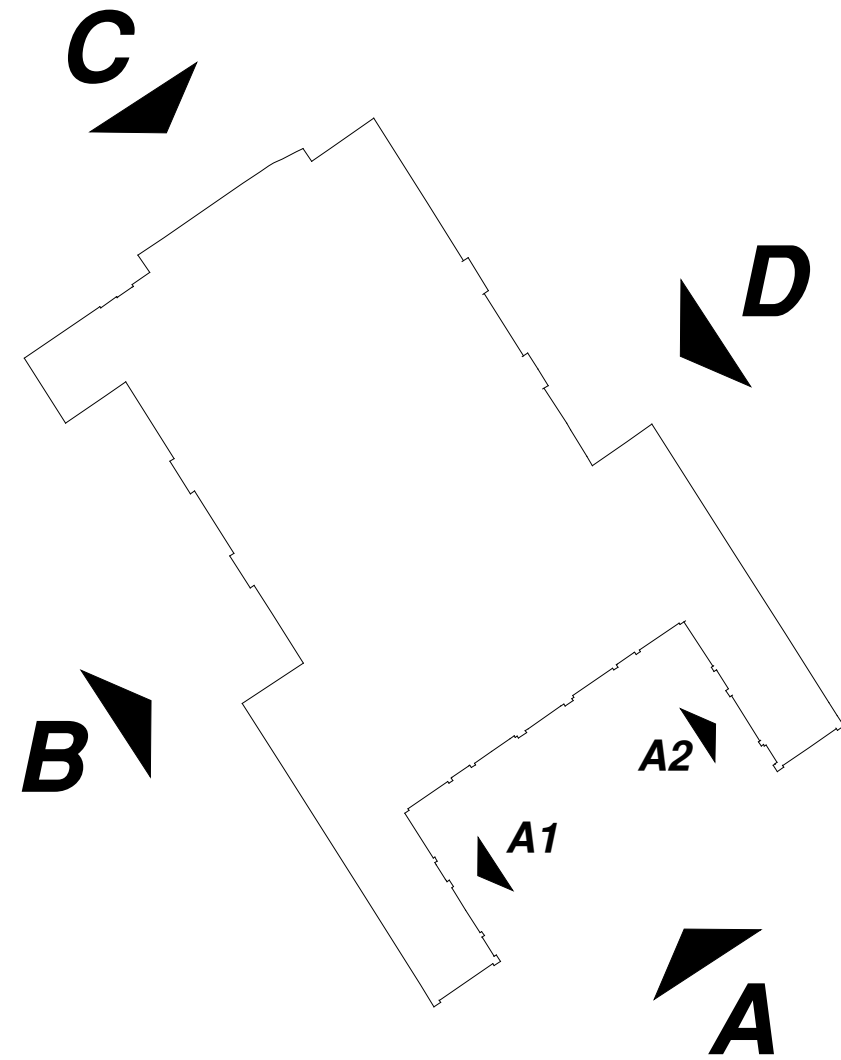
Existing South Courtyard Elevation (Elevation A2)

Therefore, in summary, it appears that the settlement and flattening of the cornices and arches respectively at the southern ends of the wings are due not only to the outward movement of the corner piers caused by a lack of mass (the piers are skinny), but also the downward movement resulting from the removal of supporting walls, probably in 1986.

One arch should be partially dismantled to determine the exact form of construction and support for the terracotta blocks. The temporary works should be adapted to allow this. Repair works should be developed. Options include removal of vegetation, repointing in matching lime mortar, careful pinning of the arches in place, insertion of internal concealed stainless steel ties to restrain the arches (particularly at the corners of the wings), relaying of the cornices and parapet blocks where they have moved, stiffening of the steel supporting beams at basement level, jacking the deflected beams and settled piers up to their original level, dismantling and rebuilding of the facades, and monitoring movement. These will be explored following further inspection, investigation and analysis.
