Canterbury Archaeological Trust Ltd

13<sup>th</sup> September 2023

## RE: Spicers Farm, Etchinghill, Kent

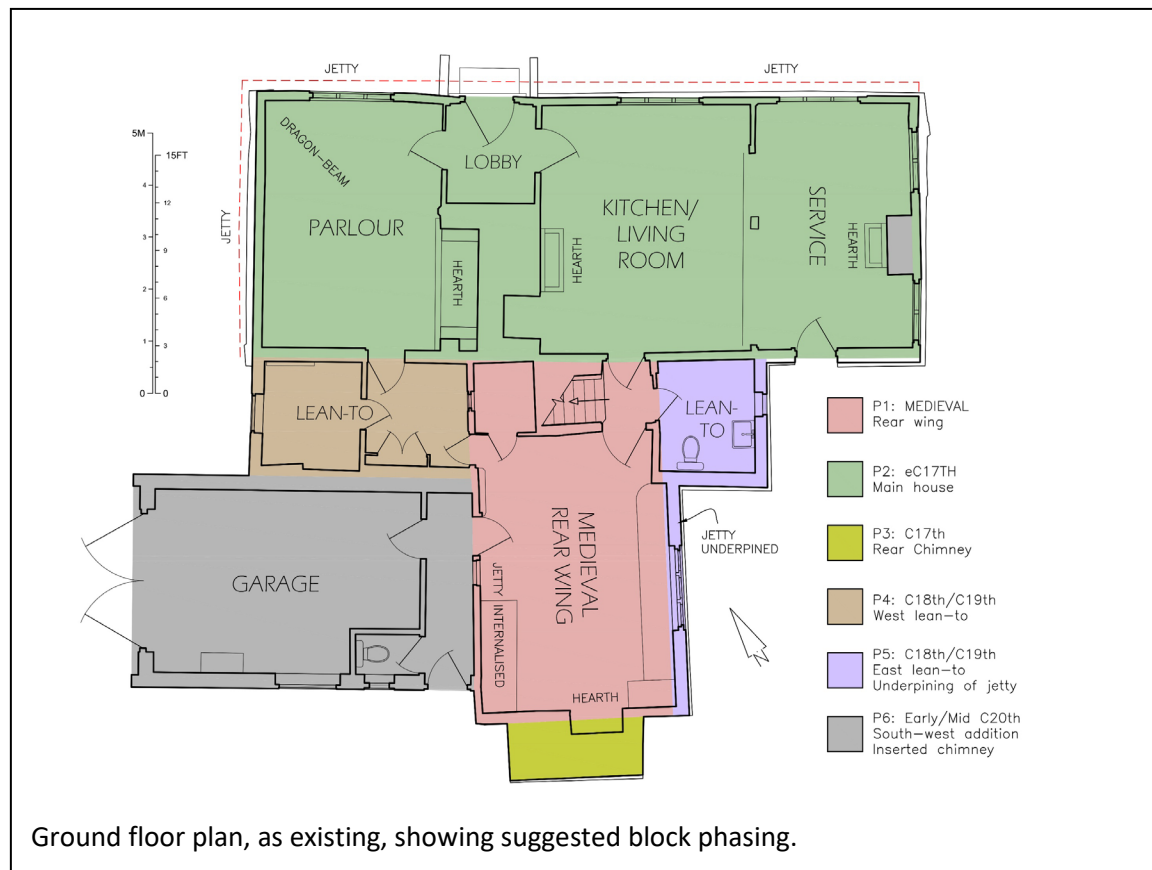
Surprisingly, the oldest part of the property appears to be the north-south aligned wing to the rear. Evidence suggests this is not coeval with the front of the house, as suggested in the listed building description, but is an earlier medieval structure.

This wing comprises its own independent, freestanding frame, that is not reliant on the main body of the house for support. This has resulted in two frames standing side-by-side where the structure abuts the main part of the house, but this is to be expected. The frame appears to have been formed in a conventional manner for the period and locality. It comprises two bays, however, its central tie-beam and arch-braces have been lost and this is not immediately apparent. Notably, the north face of the internalised north cross-frame is heavily weathered.

The framing of the rear wing is now heavily depleted, and the original arrangement is no longer obvious. The east wall and north cross-frame (that abutting the main part of the house) are the most poorly preserved and in need of repair – the framing of the east wall has been largely replaced with brick, that of the west internalised by later additions. Archaeological evidence for the original form of the structure does, however, survive and should be used to inform repairs and restoration. This part of the building has high historic and architectural significance.
