## **Tree survey to BS5837 (2012) with constraints, impacts and Tree protection plan**

**Castle House, Castle Hill Avenue, Folkestone CT20 2TF**

**Report:** 260904 dated 25 September 2026.

**Reference:** Planning application 26/1312/FH.

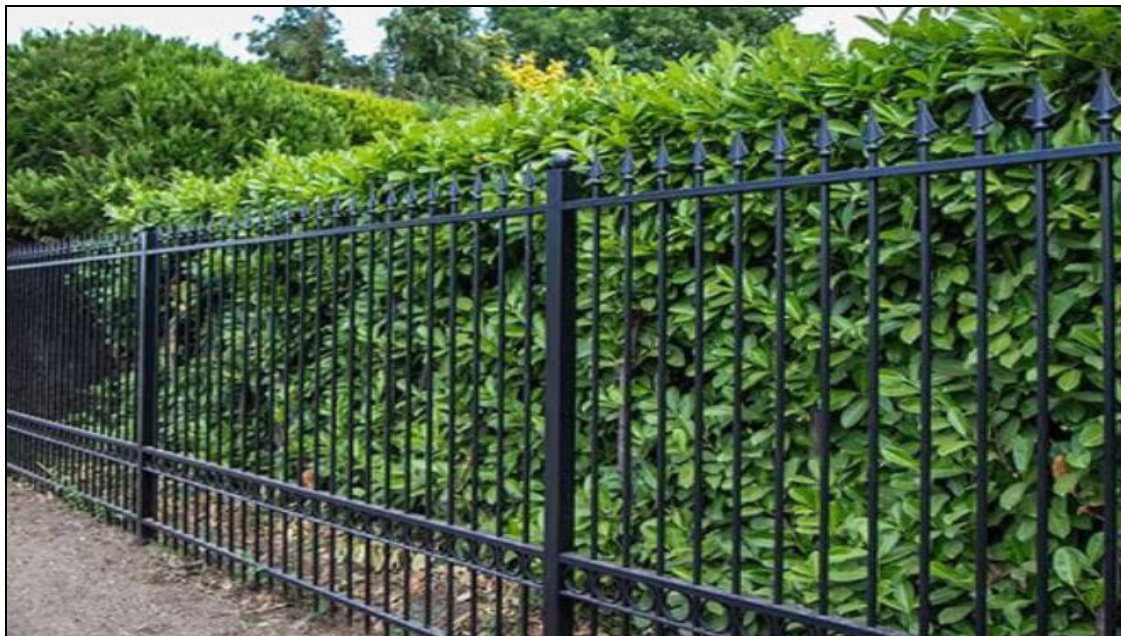
**Photo 1.** The design of the proposed fencing, both ornamental and an enhancement of security. The posts are slender and at a maximum of 3.04m centres.

The main tree-related constraint is the excavation required for the post holes.

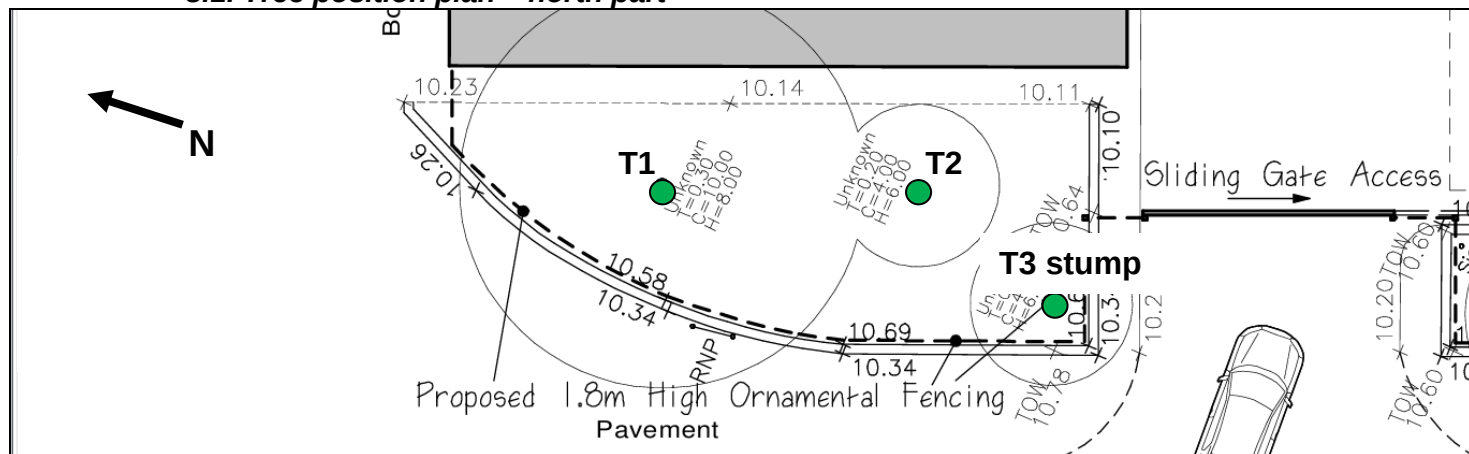
### 8.1. Tree position plan – north part

I plotted the positions of T7, T16 and T19 Horse chestnuts, and believe that I have done so with sufficient accuracy for the purpose.
