**HERITAGE STATEMENT**

**MULBERRY HOUSE  
HIGH STREET  
BROOKLAND  
ROMNEY MARSH  
KENT  
TN29 9QR**

To accompany Planning and Listed Building  
applications for conversion of an  
outbuilding and a new vehicular access

**December 2019**

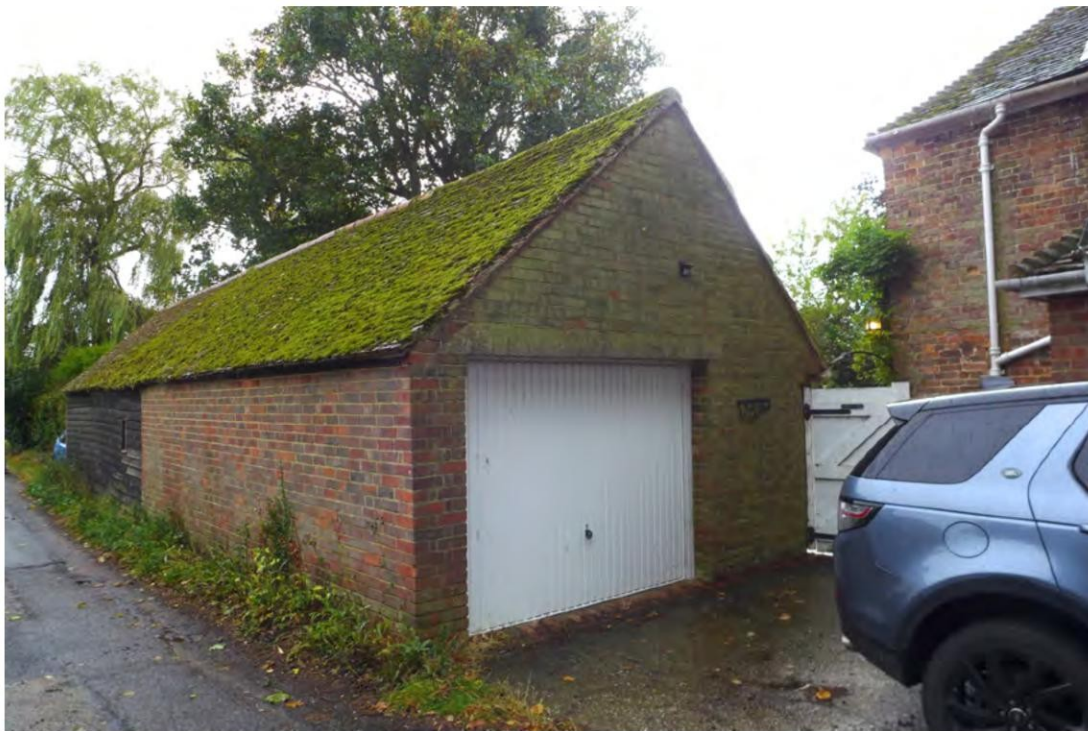
5. Outbuilding from N, house right.

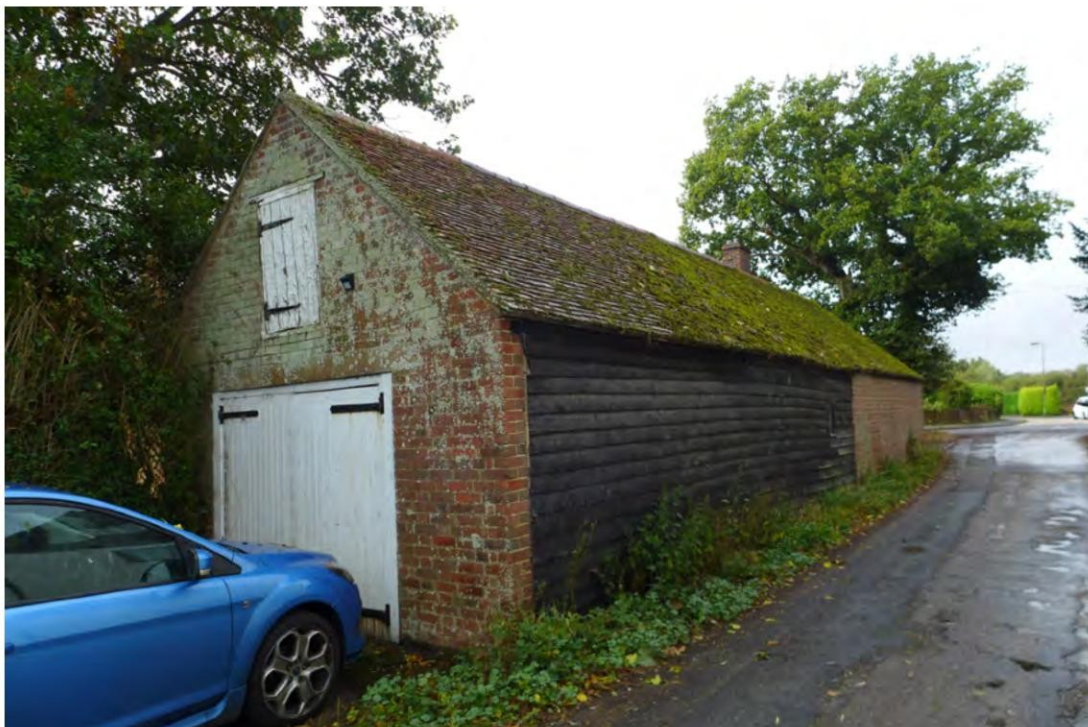
6. Outbuilding from S.

The roof has been rebuilt in its entirety in sawn timber with ridge board and the walls rebuilt in solid brickwork, apparently in the 1950s. The exception is an area at the lane frontage where the heavily tarred weather boarding survives on the studwork. The west roof slope has a pan tiled covering, the east plain tiled.

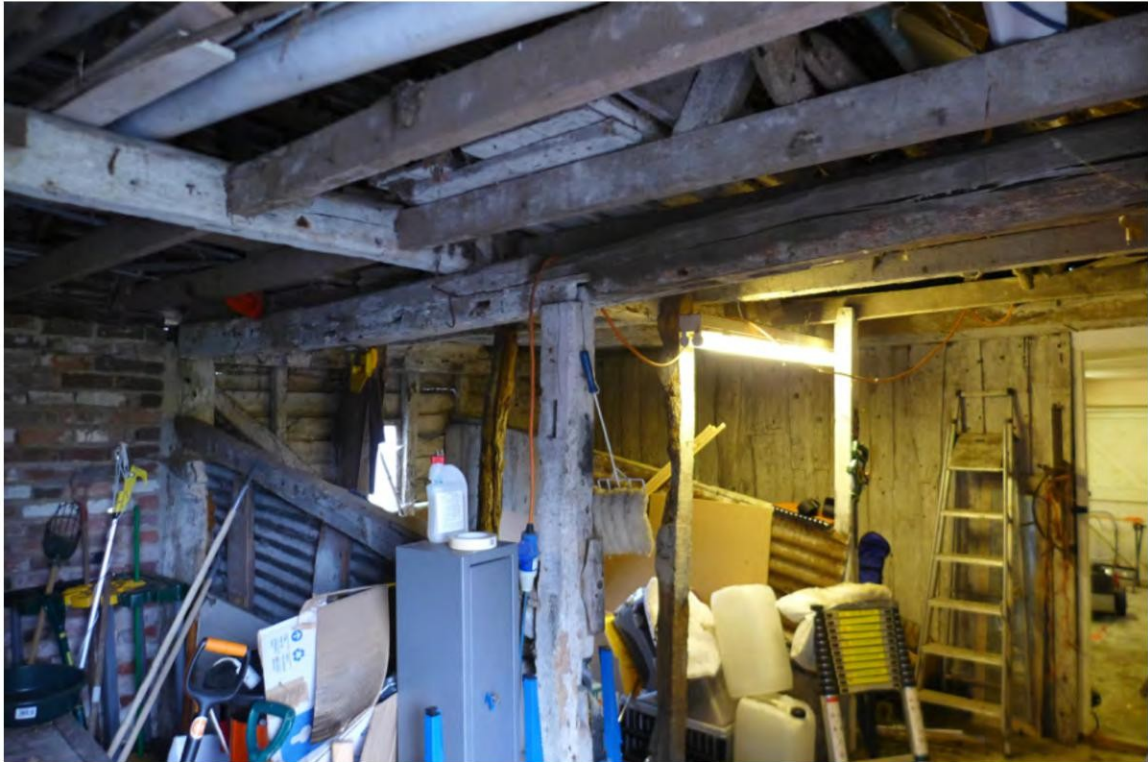
8. Interior of historic centre area looking S showing loft joists top and boarded partition adjoining S garage in background.

It is of stud and raking strut construction having posts without swellings or jowls at their heads but having tie beams in conventional assembly over the wall plates. There is heavy reuse of timbers. A timber joisted loft over has been partly replaced and has lost most of the storage deck floorboards. A plank partition between this area and the southern garage is of uncertain date.

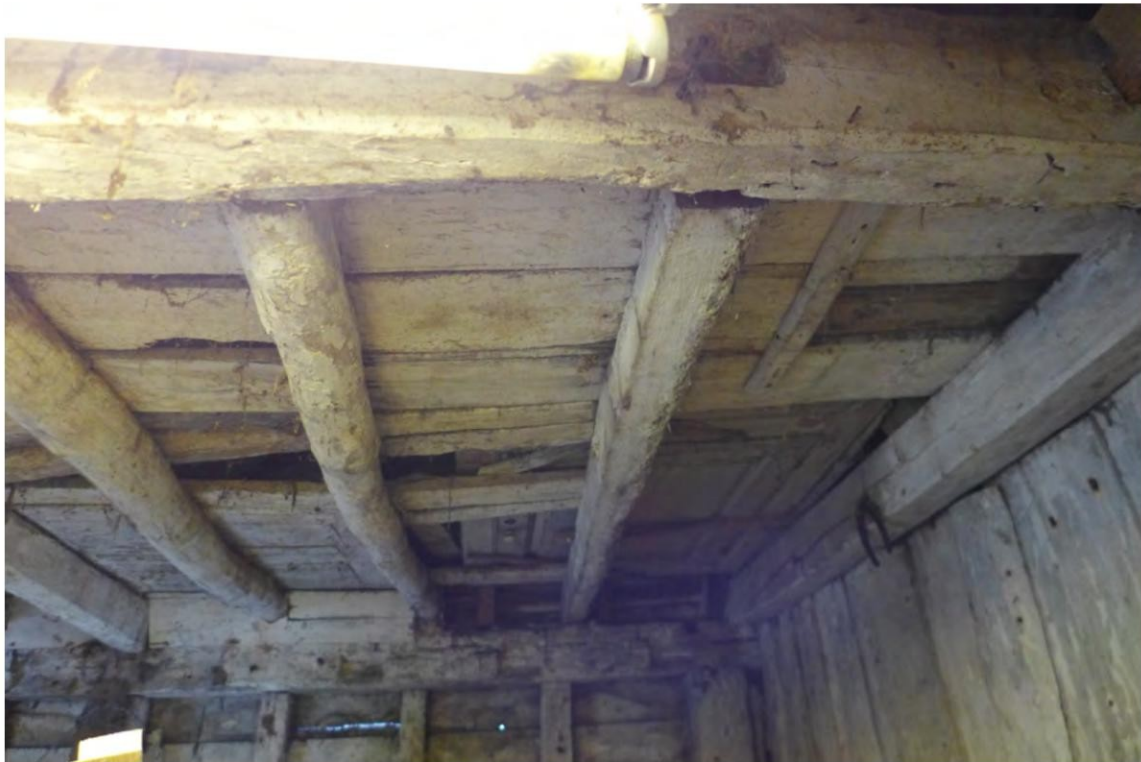
9. Historic centre area looking E showing studs and wallplate background, boarded partition right, loft joists and surviving floorboards top.

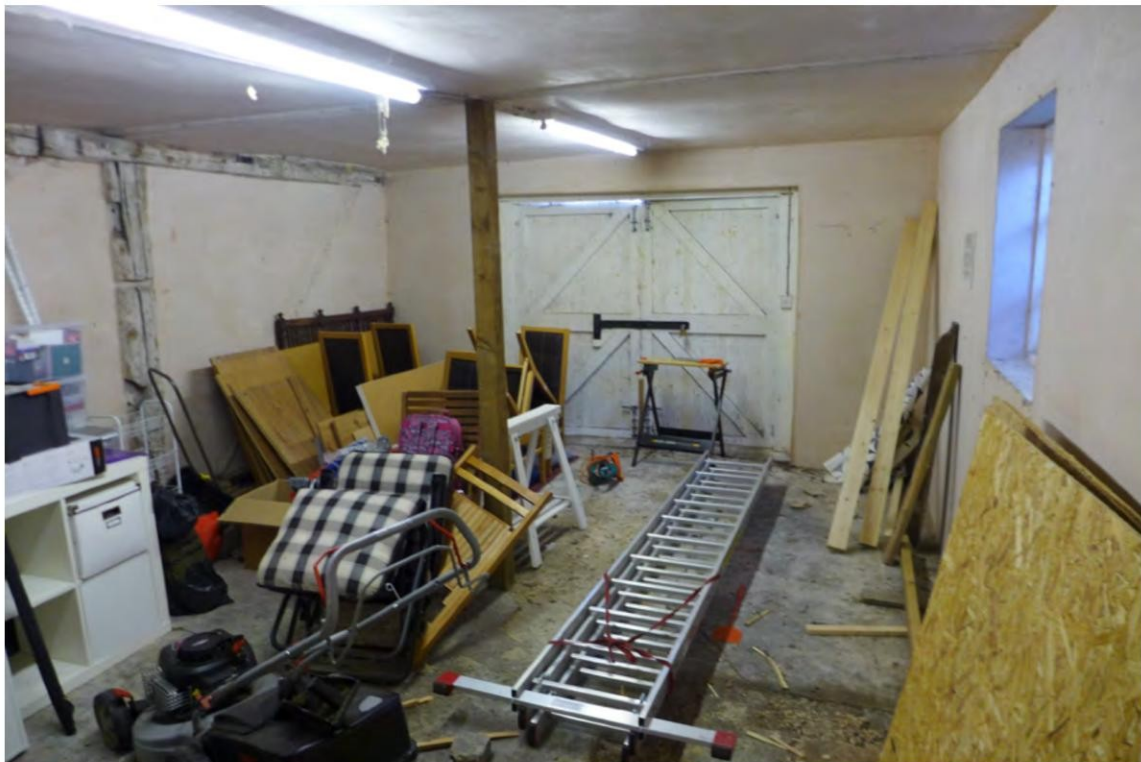
10. Interior of S garage looking S.

- 1) Excavate in the centre area to achieve a finished floor level at the same height in relation to the superstructure (required due to headroom limitations) including a build up of damp proofing and insulation. Due to past replacement of the floor in the southern

garage area, it is proposed to build up over the existing concrete to the same level as the centre area.

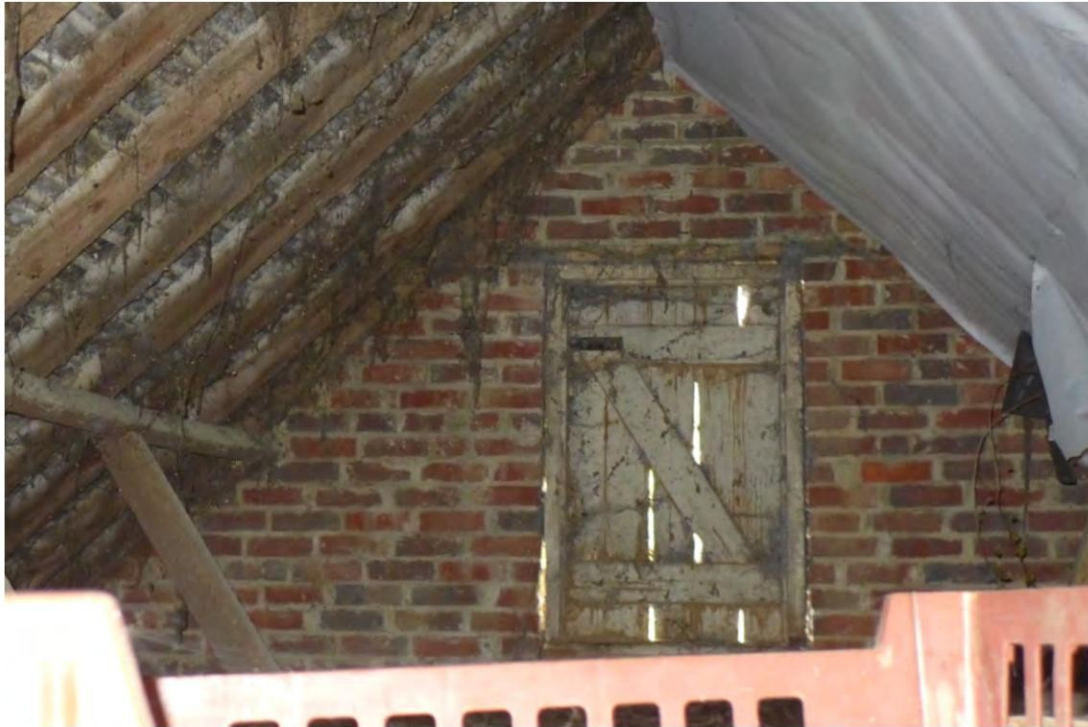
11. Roof space over S garage looking S showing loft external door and rebuilt roof structure.

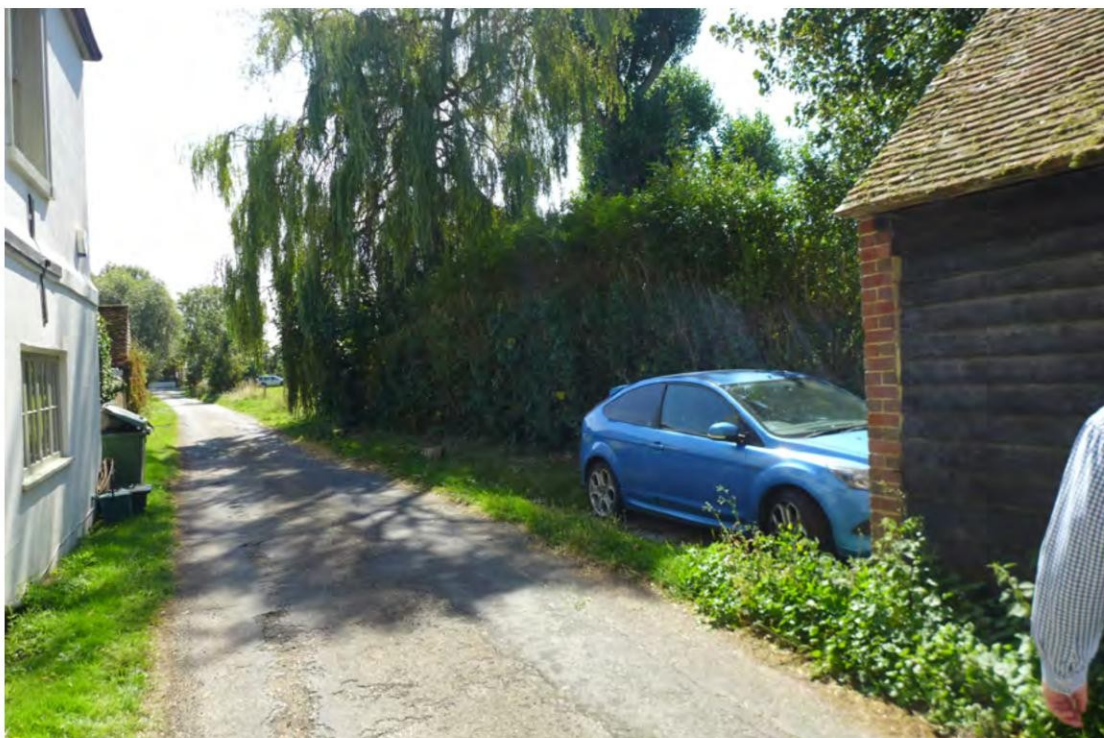
12. Existing access area to S garage proposed to be enclosed by new brick wall, Manor House left.

It is proposed to replace the current low boarded fence with a brickwork boundary wall and piers, matching the existing front boundary treatment and to use a separate new length of new matching wall construction to enclose the area south of the existing garage within the garden.

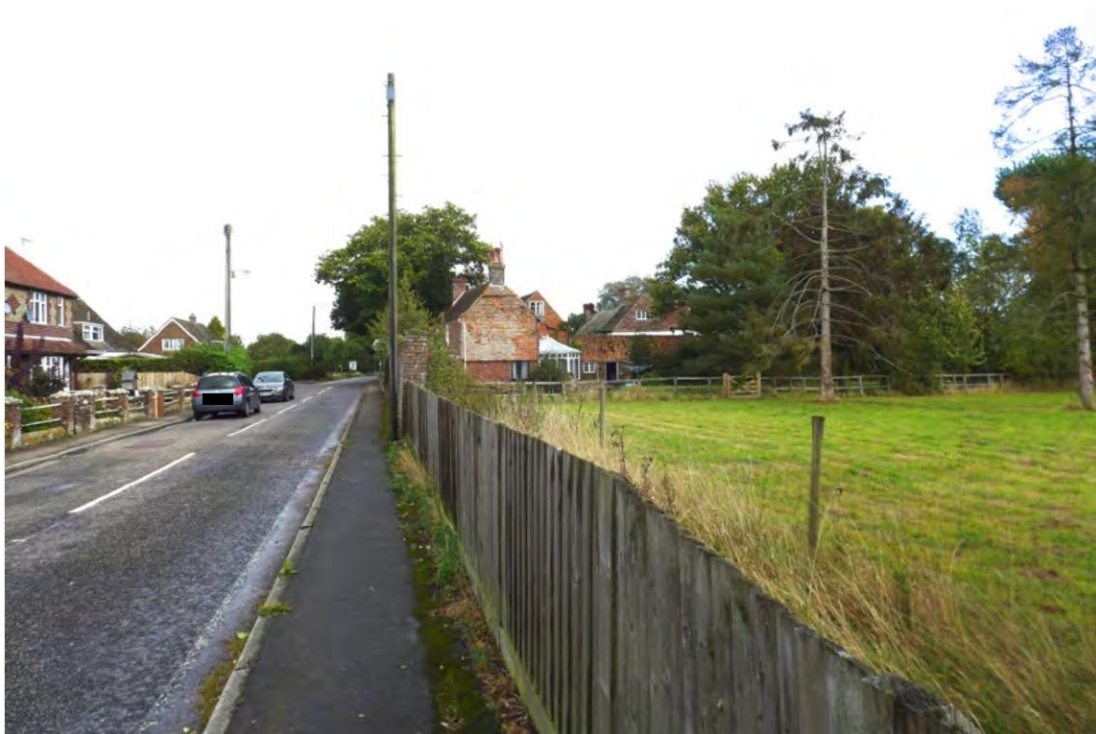
13. High Street frontage looking E showing fence proposed to be replaced by new brick wall and vehicular access.

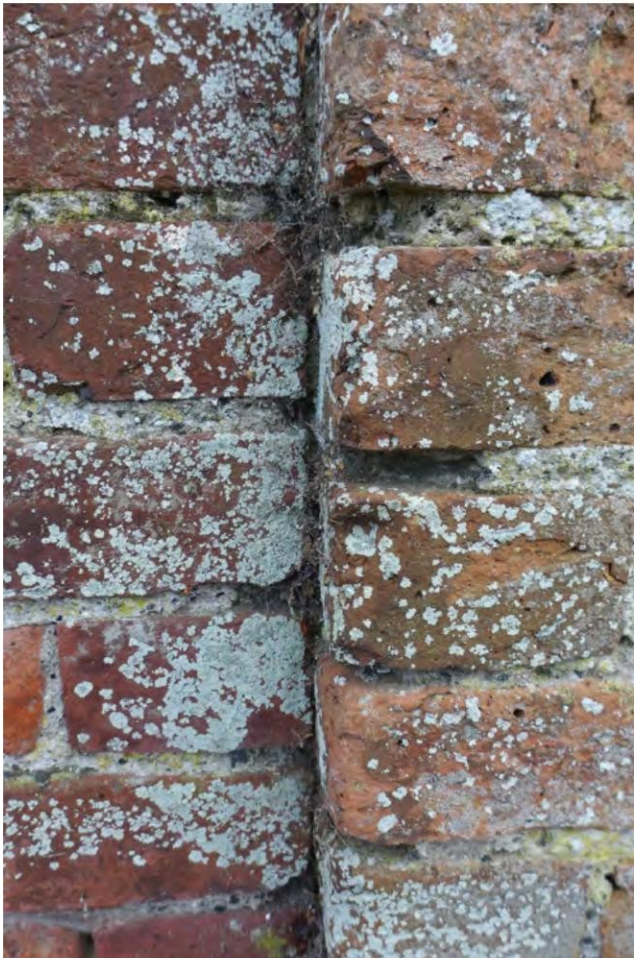
16. Straight joint in existing brick wall on High Street frontage between first phase at former vegetable garden right and second phase at domestic garden left.

An existing brickwork boundary wall at the northern road frontage to the High Street coincides for most of its length with a vegetable garden notation in the 1872 Ordnance Survey. The bond and straight joint evidence in the wall indicate that this was extended at a later date towards the east to enclose a more formal garden area previously separated from the vegetable garden.
