| Rev | Description | Date | By |
|---|---|---|---|
| <div>Project Details:</div> <div>11 Church Street, Folkestone,<br/>Kent, CT20 1SE.</div> | | | |
| <div>Drawing Title:</div> <div>WF10, WF11<br/>Window Details</div> | | | |
| 19.1540.PC130 | | / | |

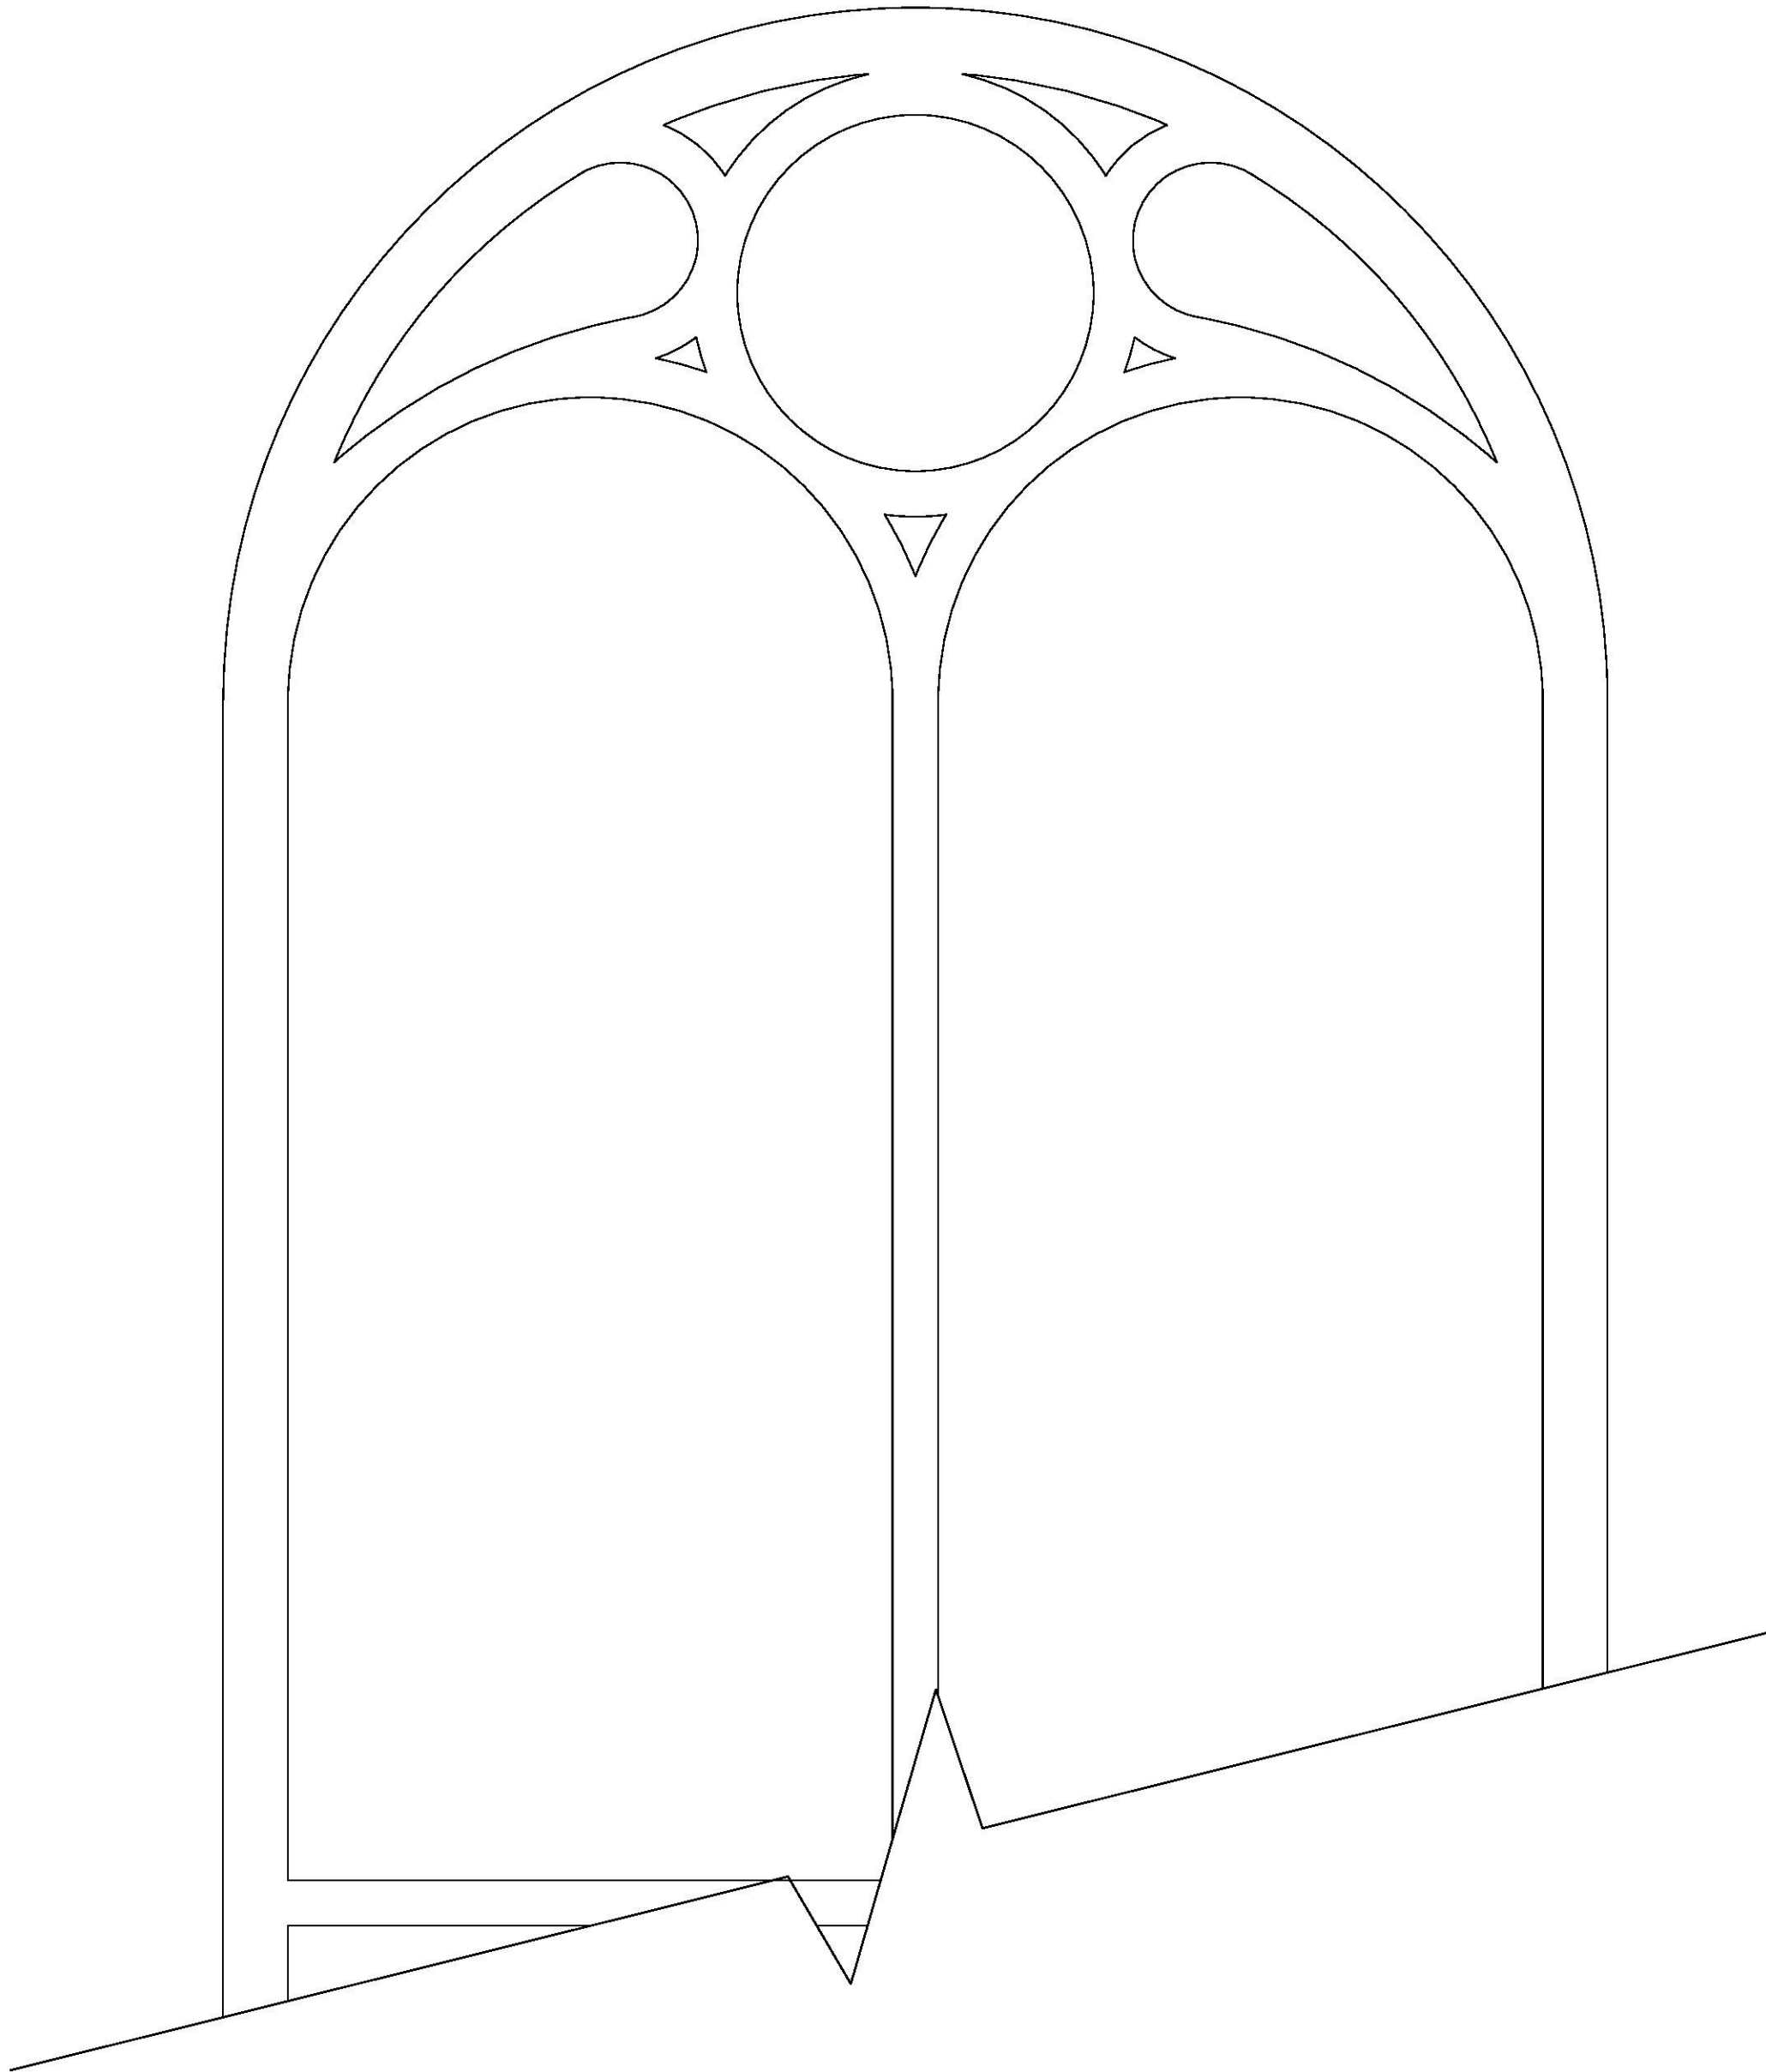
General Repair Specification  
Window WF10  
• Remove glazing putty & single glazing and set aside.  
• Reinstall single glazing with new putty.  
• Install draught proofing to window joints.  
• Strip back decorations, fill, coverment & frames then redecorate, colour strong white.  
• All minor damaged timber surfaces to be resin repaired.

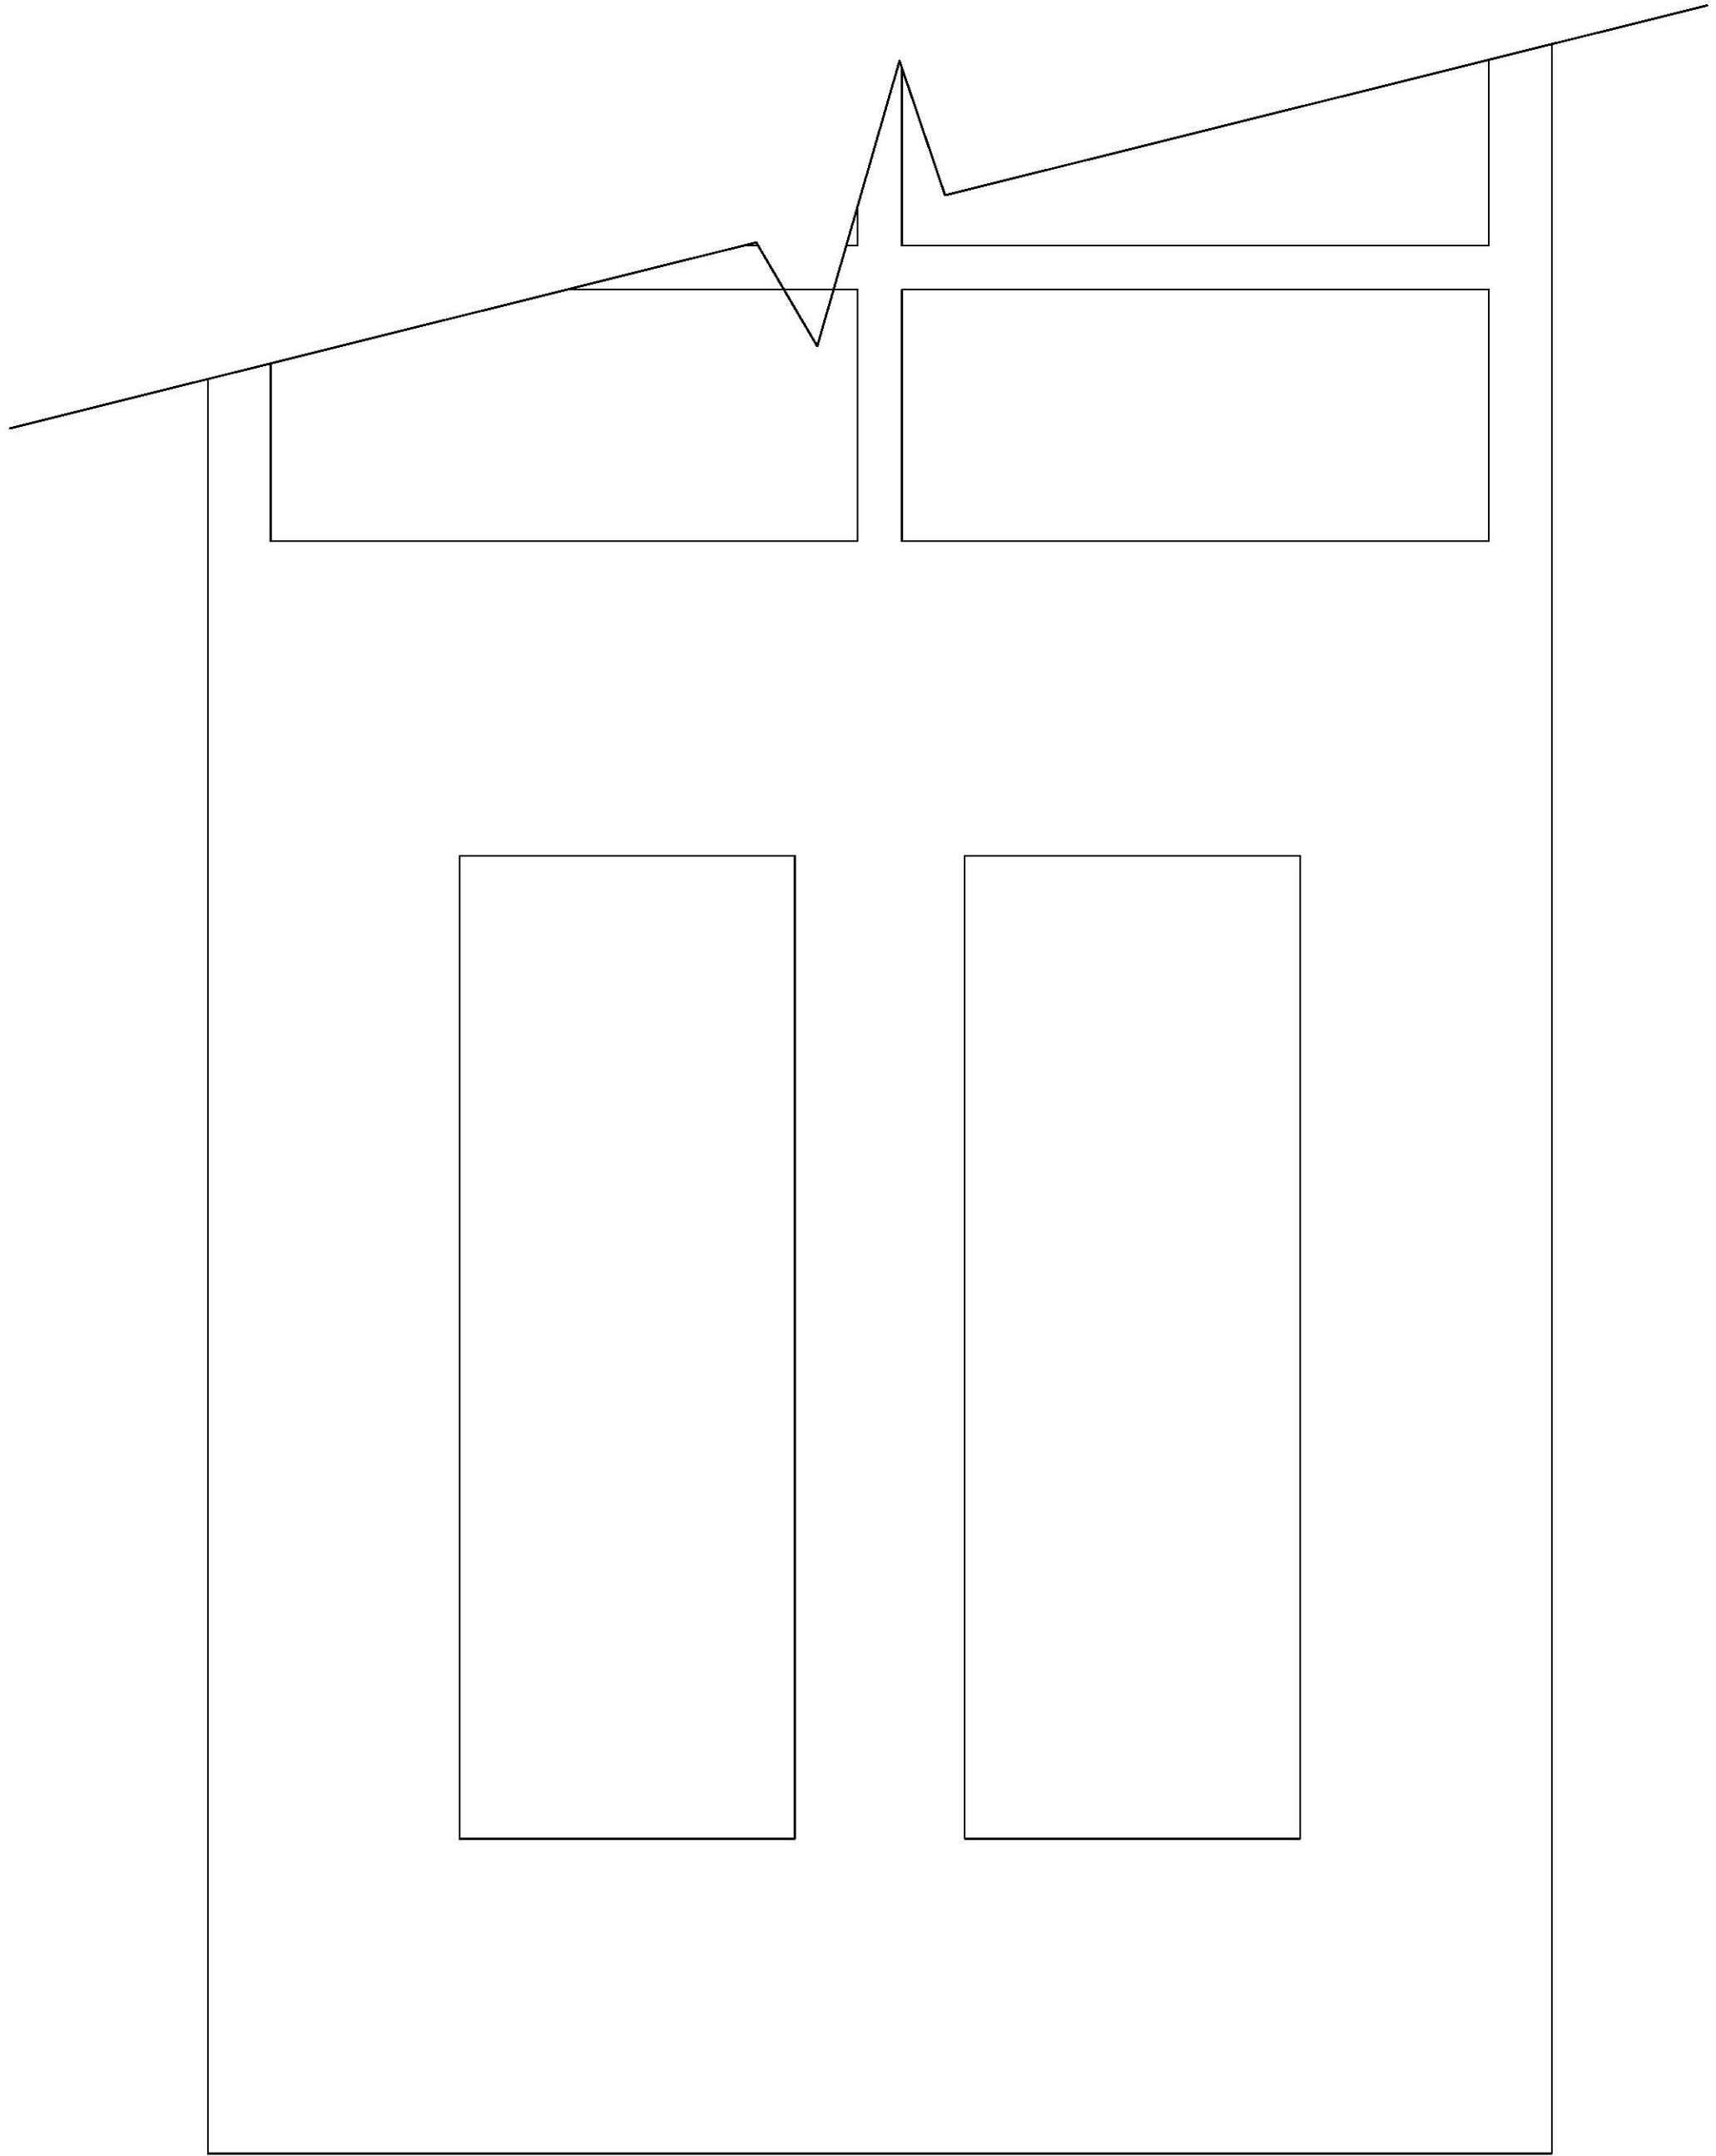
General Repair Specification  
Window WF11  
• Remove glazing putty & single glazing and set aside.  
• Reinstall single glazing with new putty.  
• Strip back decorations, fill, coverment & frames then redecorate, colour strong white.  
• All minor damaged timber surfaces to be resin repaired.
